File No. 119-42

Docket No. SA-58

REPORT OF THE CIVIL AERONAUTICS BOARD

Of the investigation of an accident  
involving aircraft of United States  
registry NC 1946 which occurred near  
Las Vegas, Nevada, on January 16, 1942.

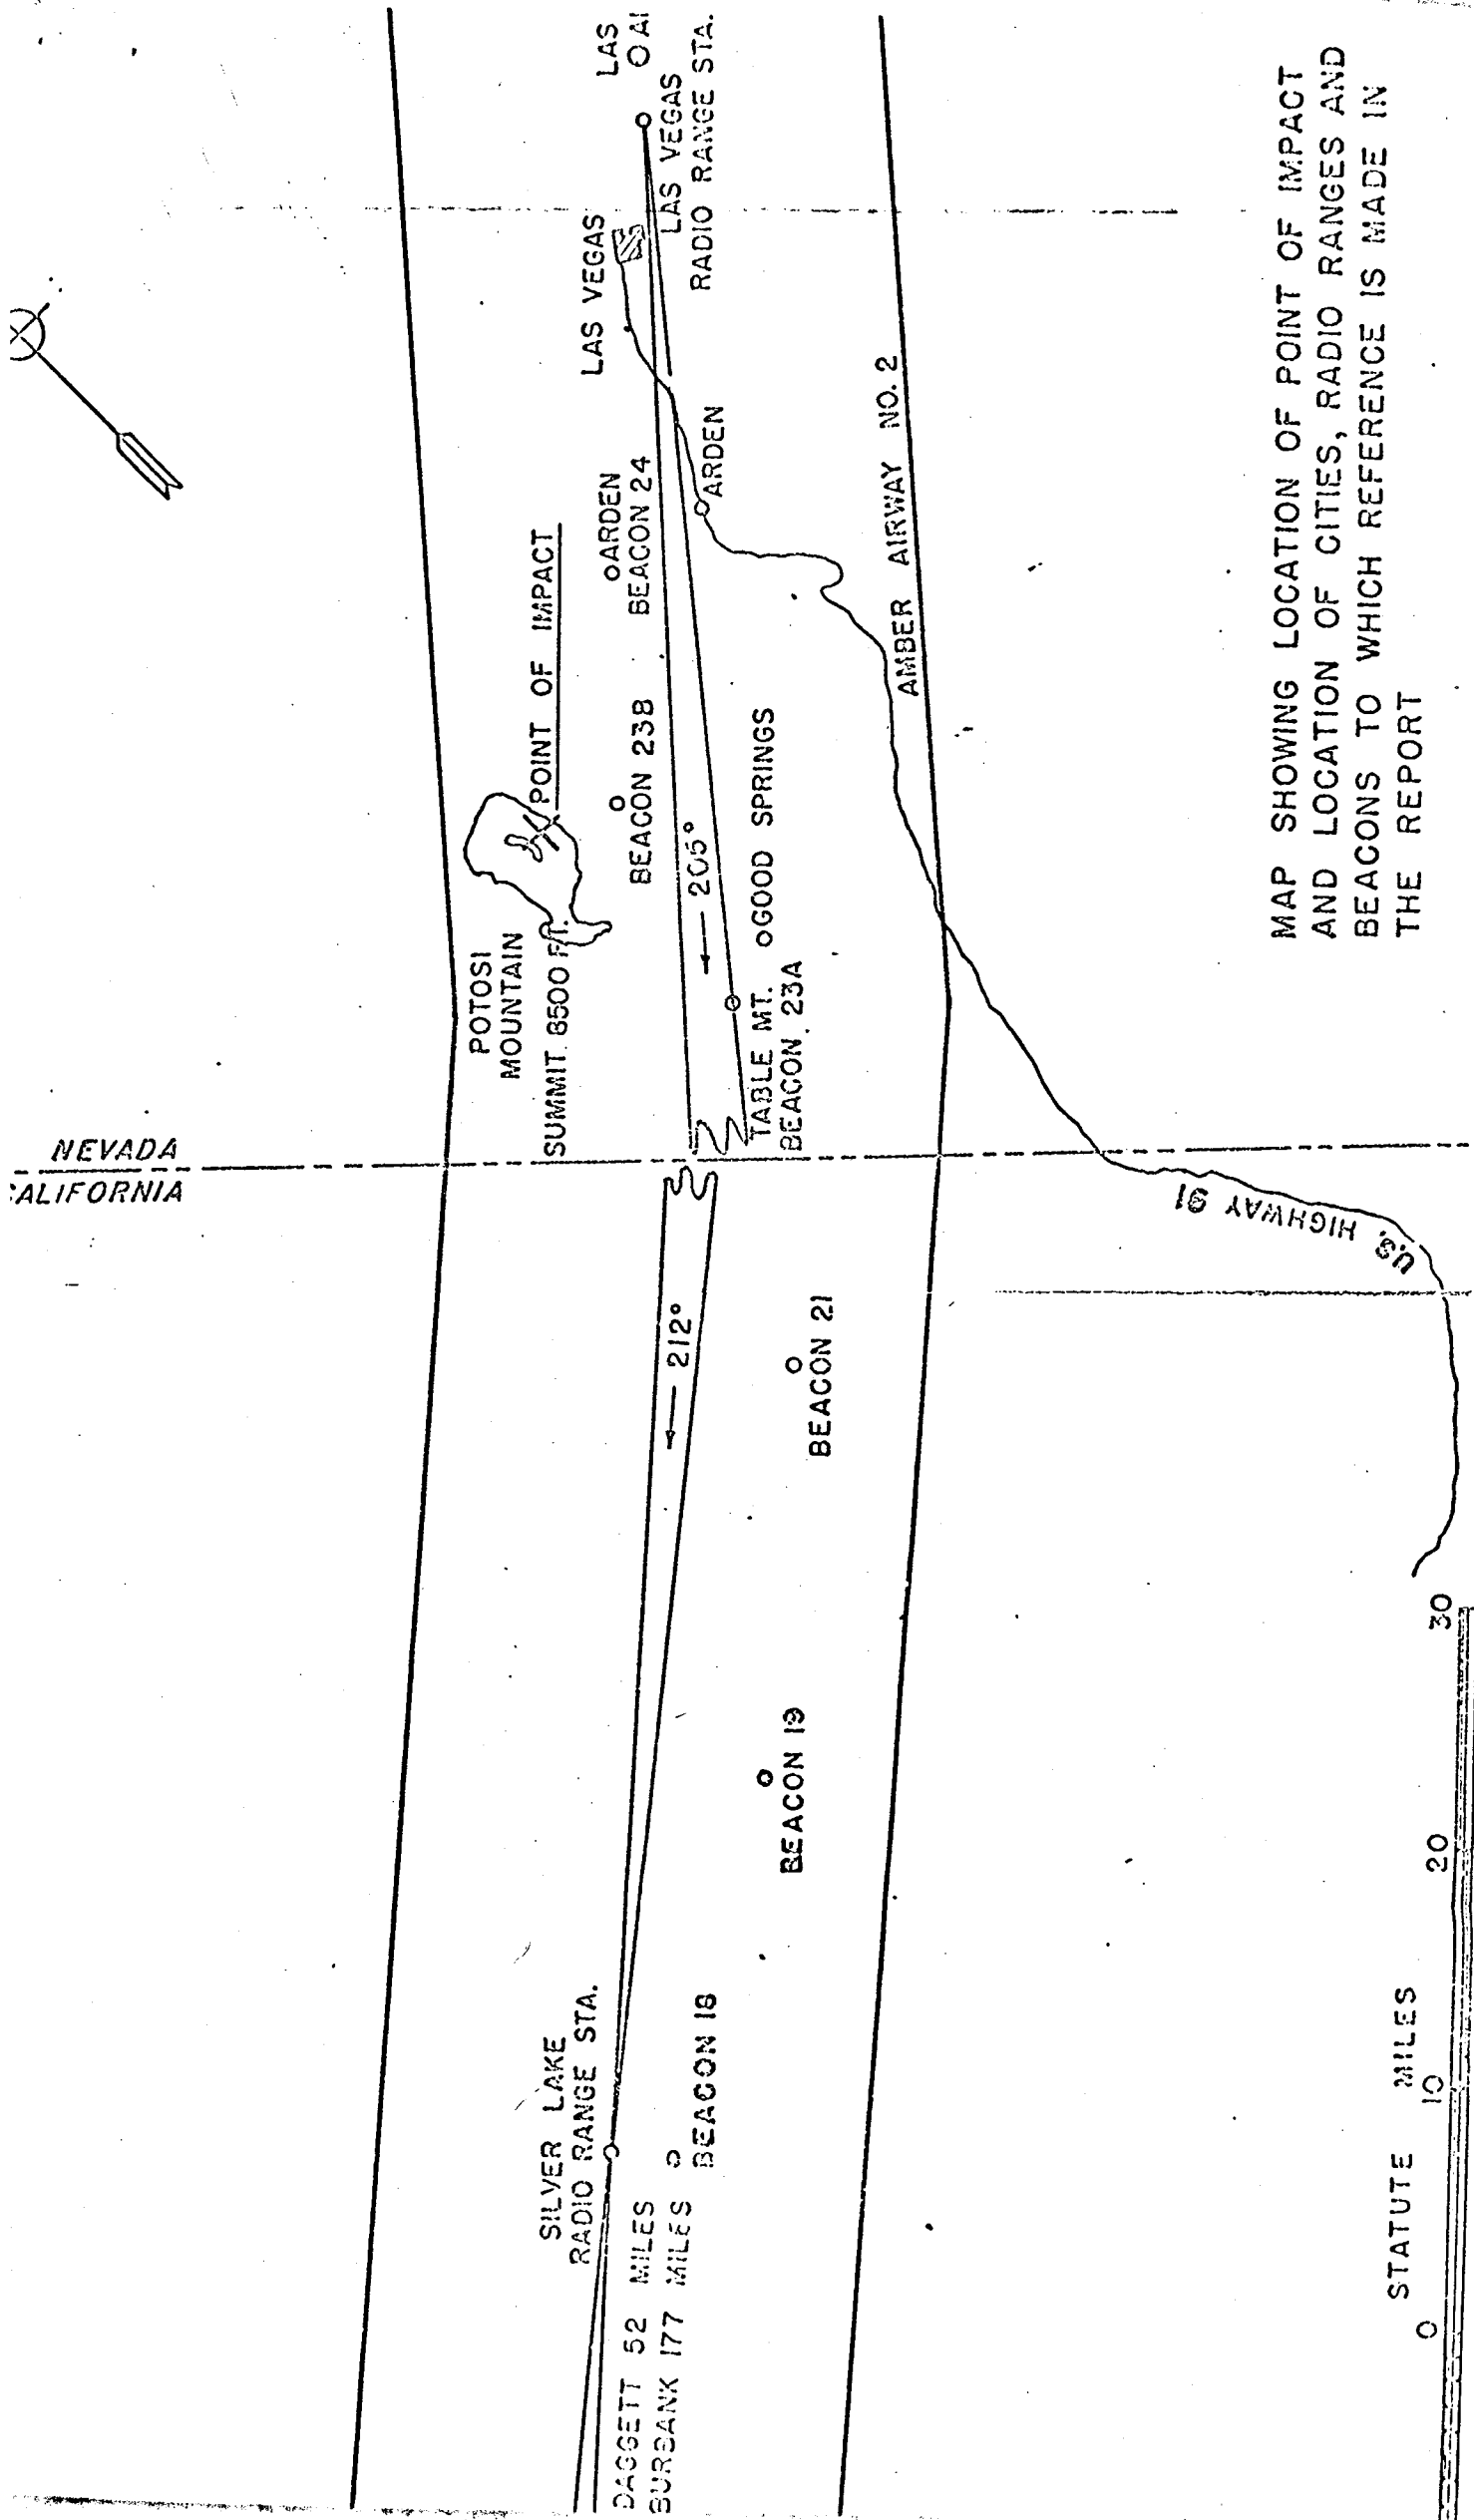
MAP SHOWING LOCATION OF POINT OF IMPACT  
AND LOCATION OF CITIES, RADIO RANGES AND  
BEACONS TO WHICH REFERENCE IS MADE IN  
THE REPORT

We shall now consider the propriety of the course used by the flight. As may be seen from the map opposite page 4, the center line of the southwest leg of the Las Vegas radio range has a true bearing of 221 degrees, or a magnetic bearing of 205 degrees, from the range station. The evidence indicates that a course following this center line, or varying from it by no more than a few degrees, is the only course considered proper for flight out of Las Vegas, on the route toward Burbank, until arrival at a point in the vicinity of the Table Mountain beacon, at which point it becomes necessary to assume a magnetic course of approximately 212 degrees in order to proceed to Silver Lake and on to Daggett.

The point at which the accident occurred has a bearing of approximately 215 degrees, magnetic, from the Las Vegas airport, and, as previously indicated, is at an elevation of about 7,770 feet. In view of the fact that witnesses who observed the airplane as it was flying between Las Vegas and Potosi Mountain testified that its flight path appeared to be in a straight line northwest of the general line of flight on which the airline planes usually travel in that vicinity, it appears probable that the airplane proceeded directly from the airport to the point of impact. This conclusion is substantiated by the fact that the elapsed time between departure from Las Vegas and the time at which the fire was observed was determined to be a normal amount of time for direct flight between the two points.

Although the airplane, at the time of the accident, was within the limits of the airway, it was 6.7 miles from the center line of the Las Vegas radio range leg. Furthermore, the course being flown, if it were continued, would place the airplane outside the limits of the airway.
