AIRCRAFT ACCIDENT REPORT

DELTA AIR LINES, INC.

MCDONNELL DOUGLAS DC-9-14, N3305L

MAY 30, 1972

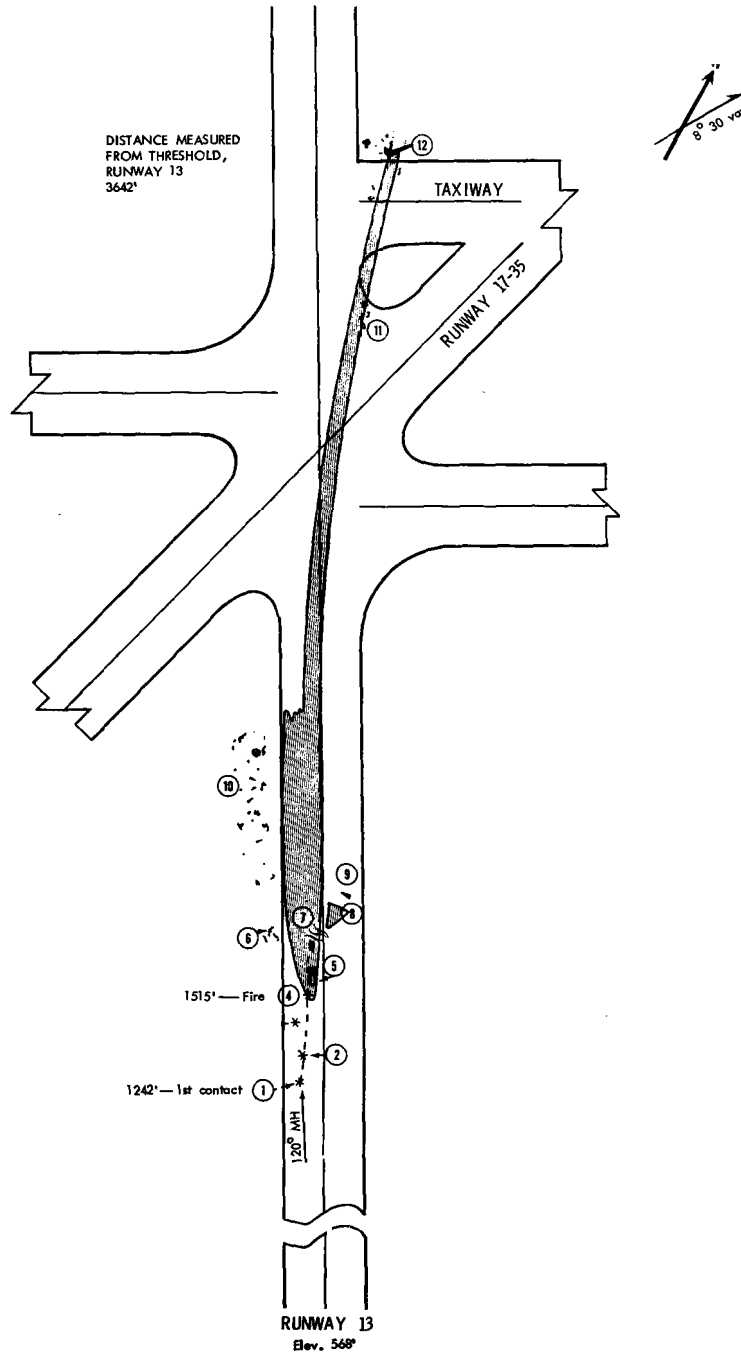
1. First contact - score in runway surface.
2. Unburned fuel on runway surface.
3. Green material from right navigation light.
4. Ground fire area.
5. Mark on runway with paint smears similar to paint scheme on the sides on the fuselage nose section.
6. Pieces of right wing tip and adjacent structure.
7. Gouges and scores in runway surface which approximate the geometry of the inverted empennage.
8. Spray of red and clear material from left navigation light.
9. Window trim panel from cabin interior.
10. Scattered parts from outer portion of right wing.
11. Pieces of radome, cabin interior trim and fuselage structure.
12. Main wreckage.
