NATIONAL TRANSPORTATION SAFETY BOARD

AIRCRAFT ACCIDENT REPORT

**PACIFIC SOUTHWEST AIRLINES, INC.,
B-727, N533PS AND**

**GIBBS FLITE CENTER, INC.,
CESSNA 172, N7711G**

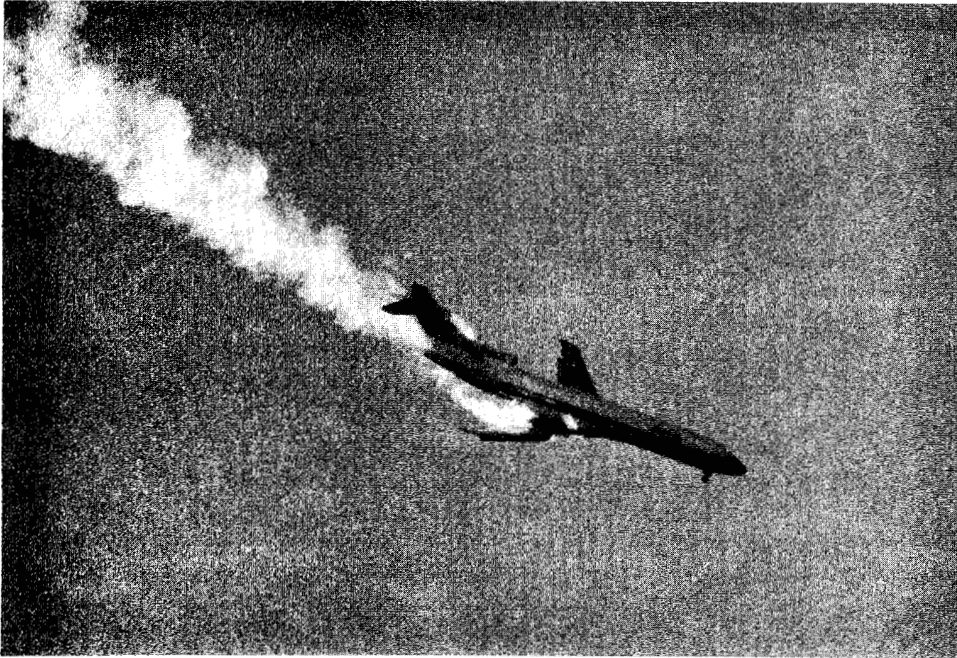
Enlargements of two postcollision photographs were used to try to determine the Boeing 727's flight control displacements and the condition of its fuel and hydraulic systems during the latter portions of the flight. (See Figures 1 and 2.)

Except for the upper and lower rudders, which were centered in the first photograph and positioned 10° left in the second, the deflections of the other control surfaces in both pictures were the same. The left wing flight spoilers were full up; the left wing ailerons were full up; the right wing outboard aileron was down; the elevators were almost full up; the trailing edge flaps were extended to 15°; and the leading edge devices were extended fully.

Figure 1. Flight 182 after colliding with the Cessna.

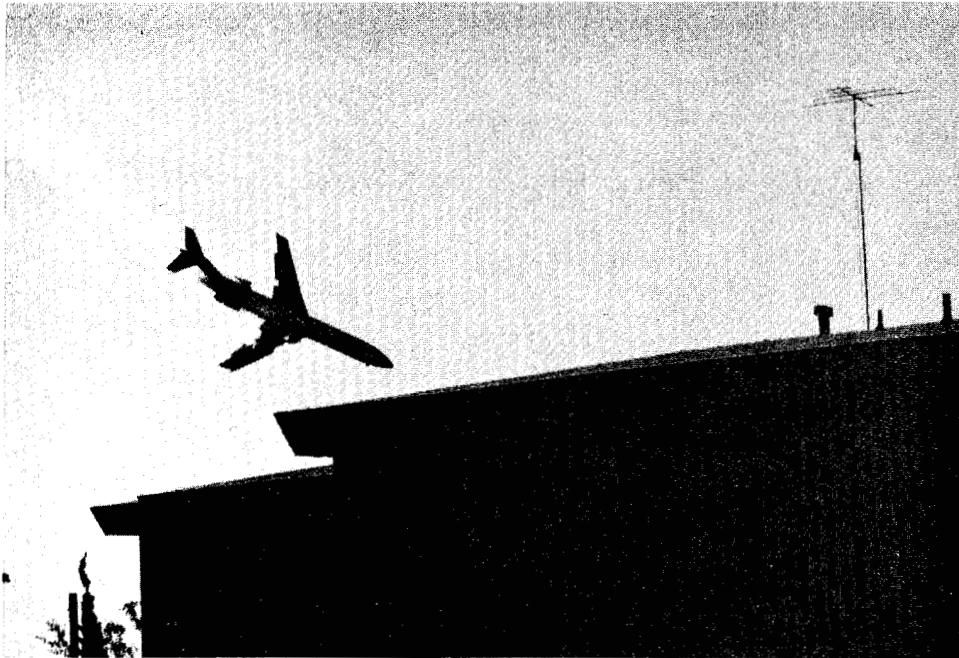
The right wing, as shown in Figure 2, was studied. The examination revealed that the Nos. 5 and 6 leading edge flaps were missing, a portion of the No. 5 leading edge slat was missing, and a large portion of the wing's leading edge back to about the front spar was peeled off the aircraft.

Hydraulic tubing from both the System A and the standby hydraulic systems was routed to the leading edge devices forward of the front spar. It was not possible to determine from the photographs if the tubes were broken or flattened. The B hydraulic system's tubing was located just aft of the rear spar of the wing. Because the extent of damage that could have existed in that area could not be determined, the status of the tubing could not be determined.

Fuel lines from the fuel pumps to the fuel pressure sensors were located immediately behind the leading edge flaps. These lines contain fuel under pressure and, if severed, would spray fuel out as long as the fuel pumps were operating. Because of fire which covered the aft section of the wing in the area of the inboard aileron, it was not possible to ascertain whether any of the surfaces in that area were missing.

Figure 2. Flight 182 descending. (Photo taken after Figure 1)

The study of the two photographs showed that the structural damage to the Boeing 727's right wing leading edge extended from the No. 4 inboard leading edge flap outboard to, and including, the No. 3 leading edge slat--a distance of 30 feet or more. The chordwise penetration of this damage appeared to extend rearward to the front spar of the wing. The calculated positions of the flight controls in Figure 2 show almost full deflection in the proper direction to arrest the abnormal attitude and to restore controlled flight. The deflected position of the flight controls and the left wing flight spoiler surfaces indicated that at least partial hydraulic pressure was available from system A and system B.

The Safety Board was not able to assess precisely what effect the structural damage, the impingement of Cessna parts on the structure, and the existing fire had upon Flight 182 aerodynamic capabilities and control effectiveness. Considering the extent and magnitude of the collision damage, the Safety Board concludes that the aircraft was probably uncontrollable.

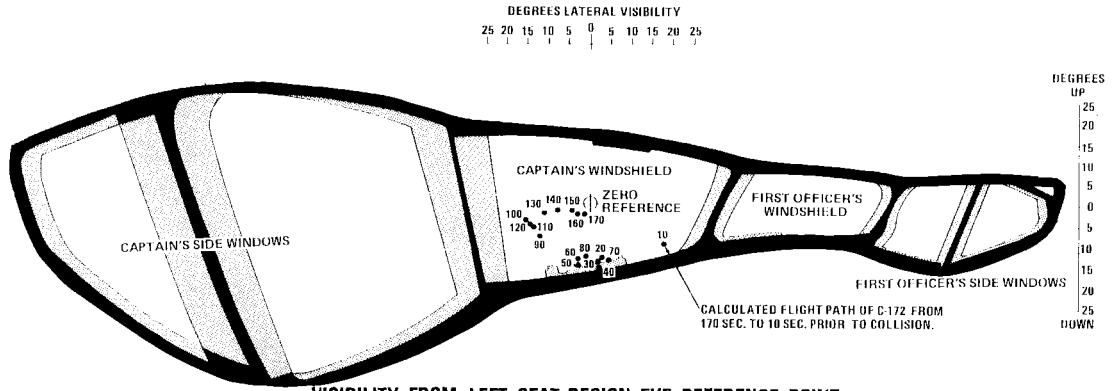
3. The Cessna pilot failed to maintain the assigned heading contained in his ATC instruction.
4. The cockpit visibility study shows that if the eyes of the Boeing 727 pilot were located at the aircraft's design eye reference point, the Cessna's target would have been visible.

VISIBILITY FROM LEFT SEAT DESIGN EYE REFERENCE POINT
