NATIONAL TRANSPORTATION SAFETY BOARD

AIRCRAFT ACCIDENT REPORT

**AMERICAN AIRLINES, INC.,
DC-10-10, N110AA
CHICAGO-O'HARE INTERNATIONAL AIRPORT
CHICAGO, ILLINOIS
MAY 25, 1979**

NTSB-AAR-79-17

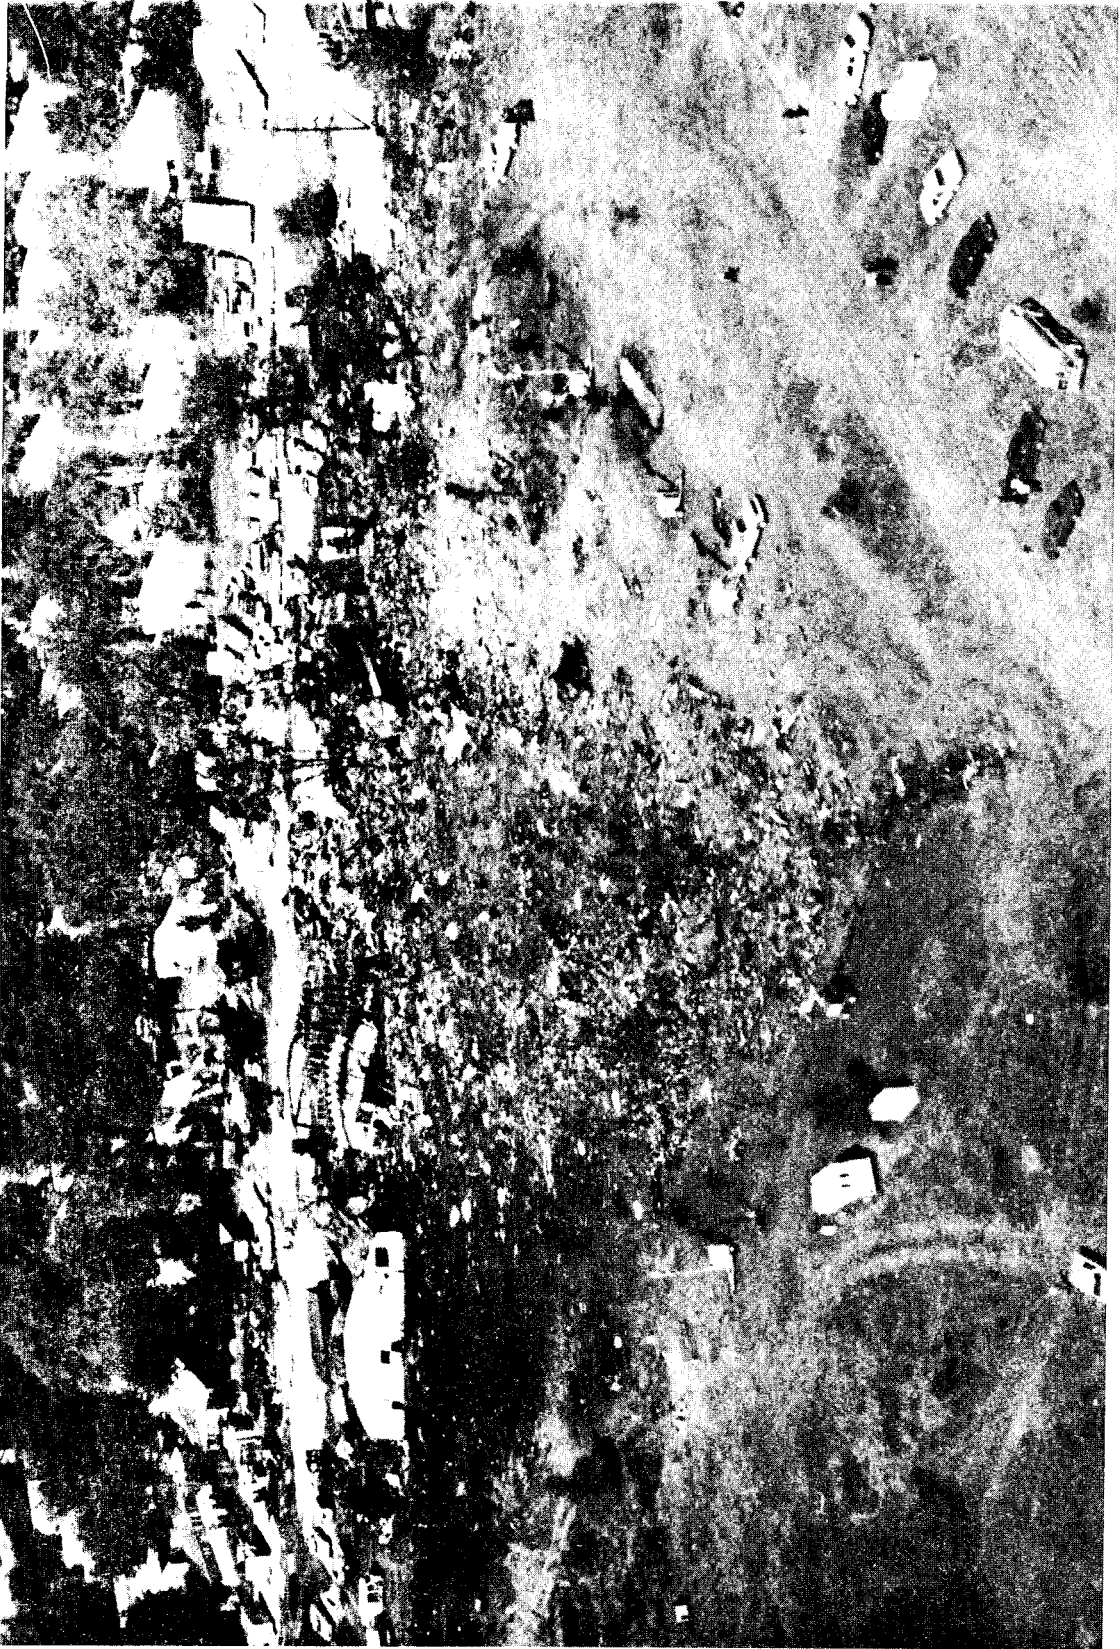
Figure 1. Accident site.

✕ Flight 191 struck the ground in a left wing-down and nosedown attitude. The left wingtip hit first, and the aircraft exploded, broke apart, and was scattered into an open field and a trailer park. The disintegration of the aircraft structure was so extensive that little useful data were obtained from postimpact examination of the wreckage with the exception of the No. 1 pylon, which was found off the right side of runway 32R. (See figure 1.)

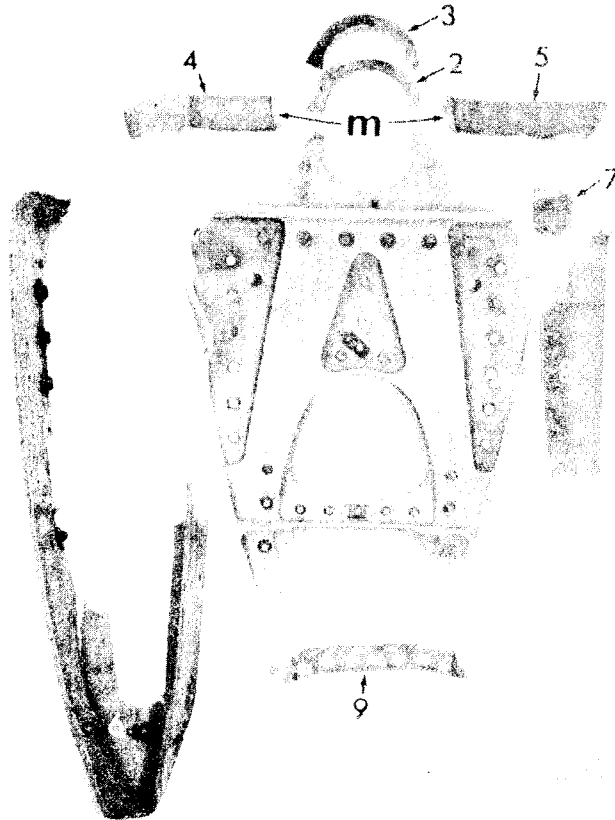
Figure 4. Overall view of the wing pylon aft bulkhead installation portions. Pieces are numbered for identification purposes and placed in relative locations as if intact.

N110AA's pylon aft bulkhead was examined at the Safety Board's metallurgical laboratory. The examination disclosed a fracture of the upper forward flange. (See figure 4.) The larger part of this fracture was just forward of the radius between the flange and forward bulkhead plane and was about 10 inches long in the inboard-outboard direction. (See figure 5.) The fracture characteristics were typical of an overload separation. Chevron and tear marks on the fracture indicated that the rupture progressed downward at the center of the flange, then in inboard and outboard directions on the flange. The bottom portion of the fracture exhibited smearing consistent with the compression portion of a bending fracture. The smear was more prevalent--about 6 inches long--in the thinner center portion of the upper flange structure, but became less prevalent at the outer ends of the fracture. The 10-inch-long fracture resulted from overstress. The overstress was initiated by the application of a downward bending moment at the center section of the flange just forward of the fracture plane. The surface of the fracture appeared to be relatively free of oxidation and dirt.

Fatigue cracking was evident at both ends of the fracture. At the inboard end, the fatigue progressed inboard and aft; then, it progressed downward and inboard to the upper inboard fastener that attached the forward section of the bulkhead to the aft section. The fatigue progressed past the fastener a short distance before exhibiting rapid overstress characteristics in the downward direction as it proceeded along the inboard side of the side flange radius of the forward flange section. At the outboard end of the fracture, the fatigue propagated forward and slightly outboard toward the most forward outboard hole in the upper flange. The total length of the overstress fracture and fatigue cracks was about 13 inches. The remainder of the fractures on the bulkhead and within the pylon structure resulted from overload.

- Item 1. Aft bulkhead center section piece view looking aft.
- Items 2 & 3. Upper lug ears.
- Items 4 & 5. Two pieces of the forward portion of the upper flange. Those pieces mated together along the fracture indicated by arrows "m."
- Item 6. Side flanges and lower portion of the aft bulkhead.
- Item 7. Piece of the flange at the upper outboard corner.
- Item 8. Portion of the outboard side flange.
- Item 9. Piece of the intermediate flange.

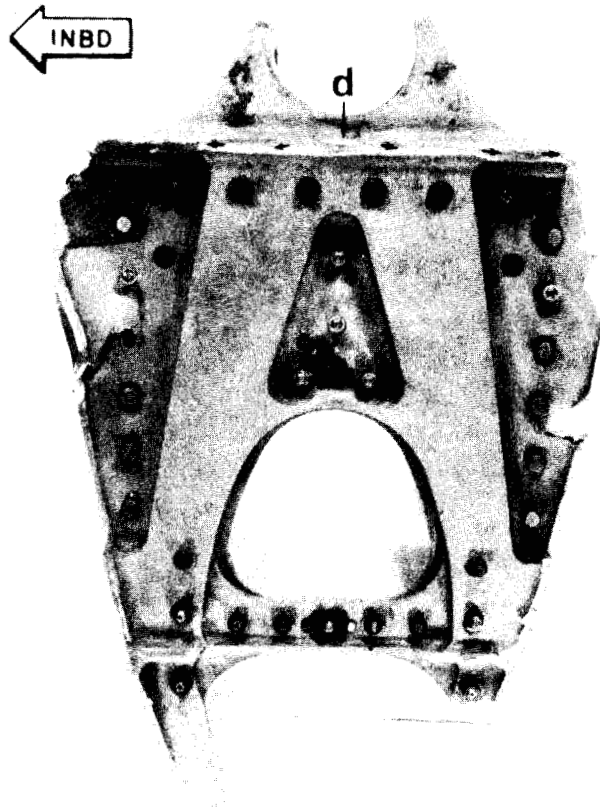
Figure 5. View of the aft bulkhead piece indicated as Item 1 in Figure 4.

The aft fracture surface of the upper flange contained a crescent-shaped deformation which matched the shape of the lower end of the wing clevis. This deformation was in line with the vertical centerline of the aft bulkhead attachment hole as indicated by arrow "d" in figure 7. A deformation was noted in the lower surface of the aft wing support fitting's forward clevis lug in the area indicated by the brackets in figure 9. A small shallow gouge was apparent in the area of the arrow in figure 10. This gouge was in a position which would conform to a fastener location on the top flange assembly of the aft bulkhead.

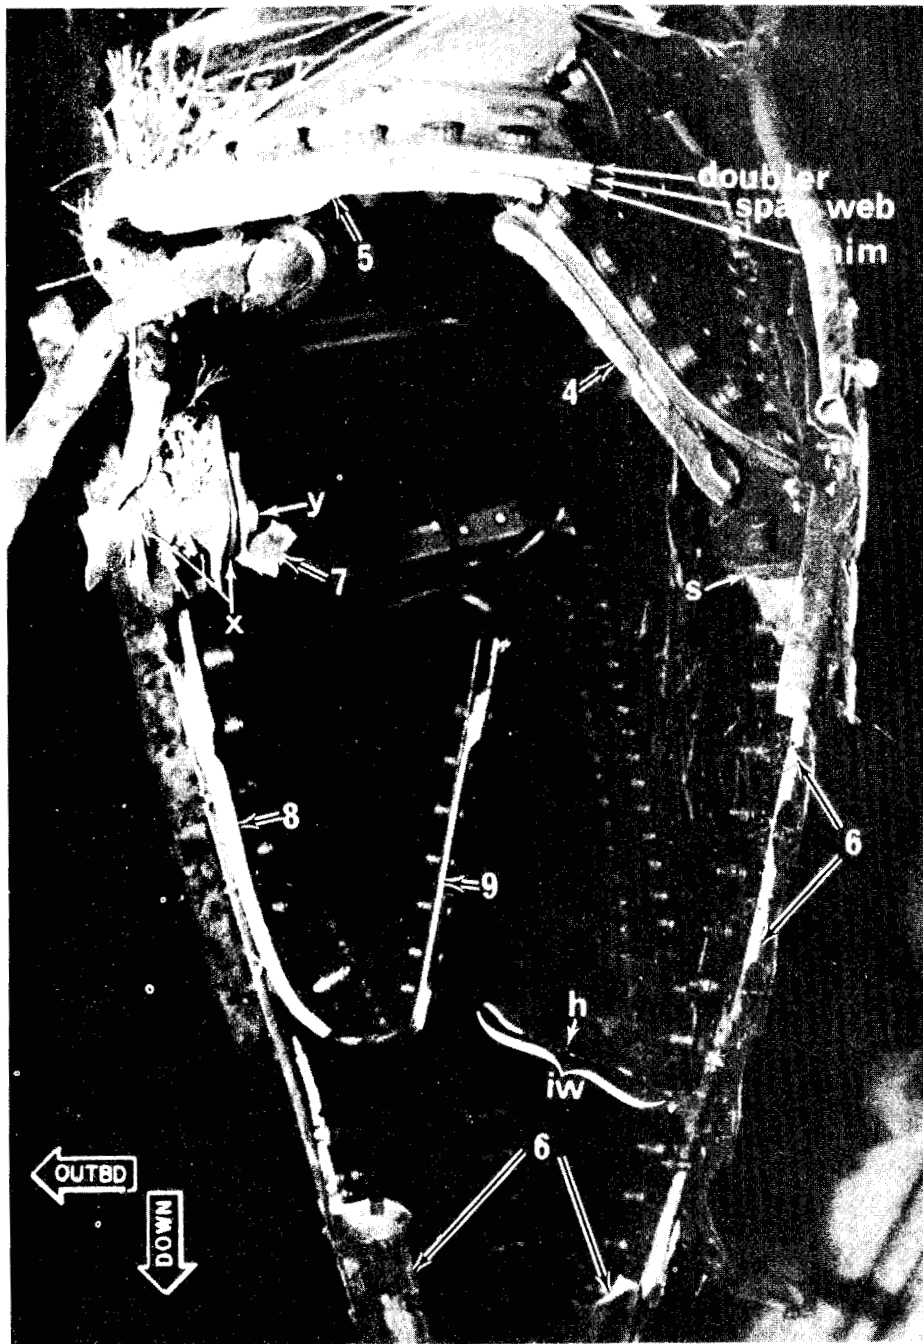
Figure 6. View looking forward and slightly down on the No. 1 pylon before disassembly of the flange pieces indicated as items 4 through 9 in Figure 4. Arrow "x" shows the shim on the outboard side between the angle and the top surface of the upper flange piece No. 7 held in place by the fastener arrowed "y". Arrow "s" shows the location for the shim on the inboard side between the angle and upper surface of the upper bulkhead flange.

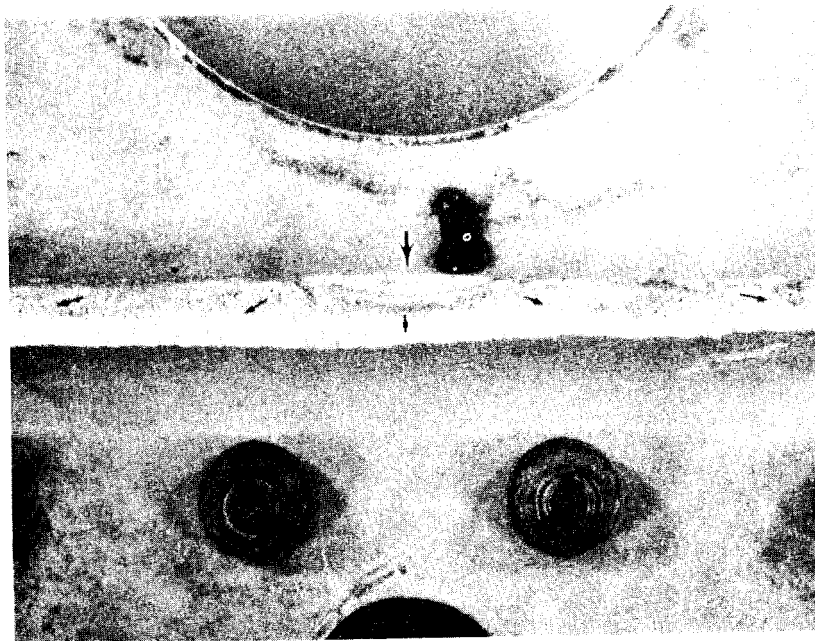
Figure 7. Closer view of fracture on upper flange in the area of deformation (arrow "d", see Figure 5).

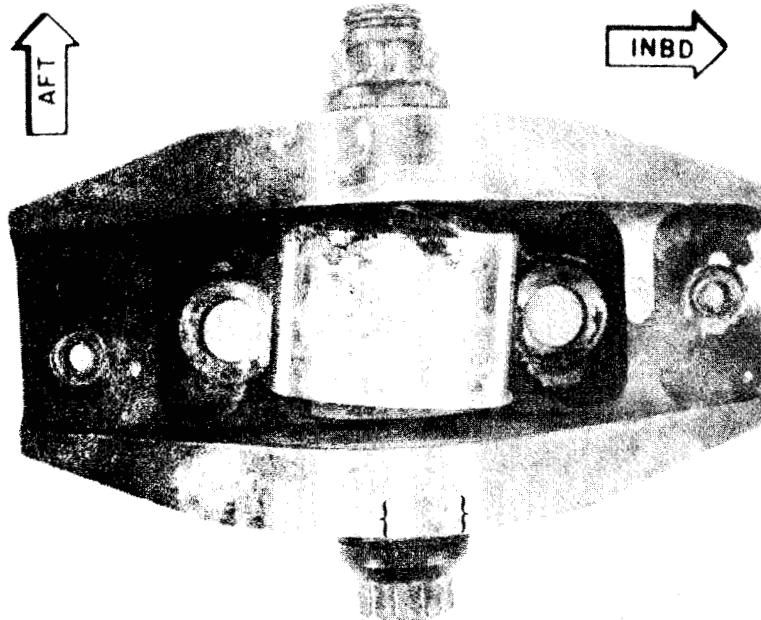
Figure 9. Overall view looking up on the wing mounted aft support fitting with spherical bearing attached.

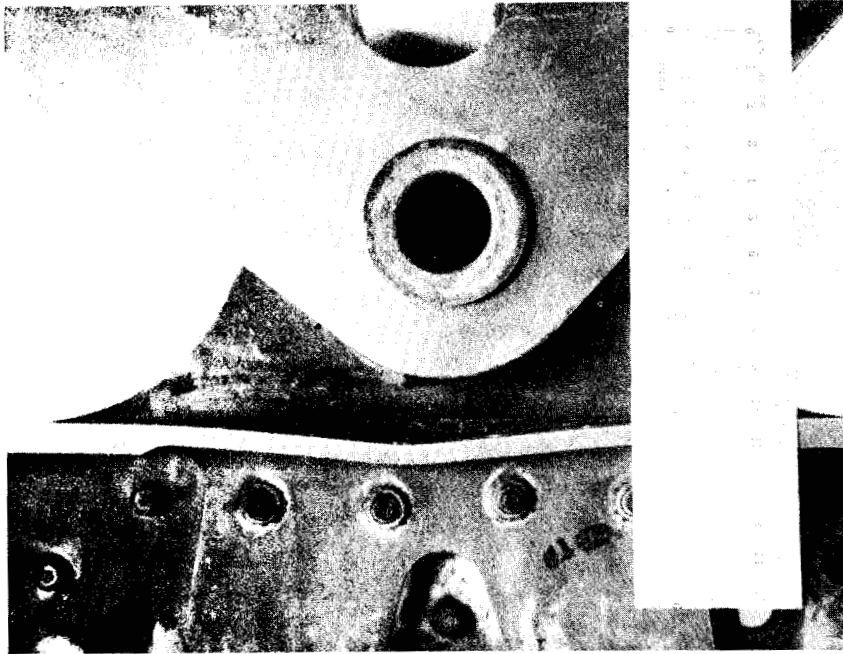
Figure 11. Wing pylon aft bulkhead from N119AA assembled to wing mounted aft support fitting of N110AA showing normal position of wing fitting clevis with respect to the upper forward flange of the aft bulkhead. Note: The wing fitting on this figure is canted relative to the bulkhead to simulate the dihedral of the left wing relative to the bulkhead.

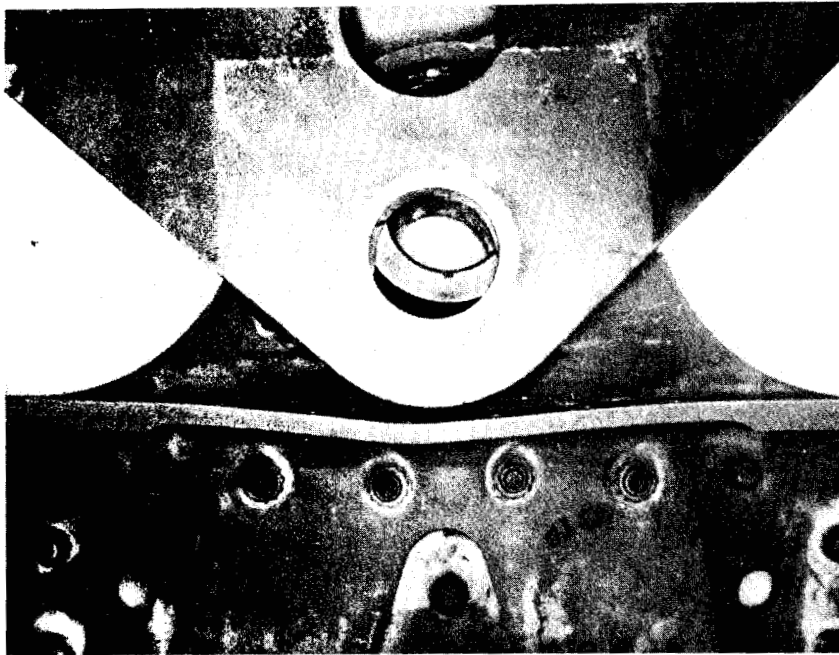
Figure 12. Same as Figure 11 except the attachment bushing was removed and the aft bulkhead was moved up against the far inside portion of the wing fitting. Note the location of the bottom portion of the wing fitting clevis with respect to the fracture on the bulkhead.

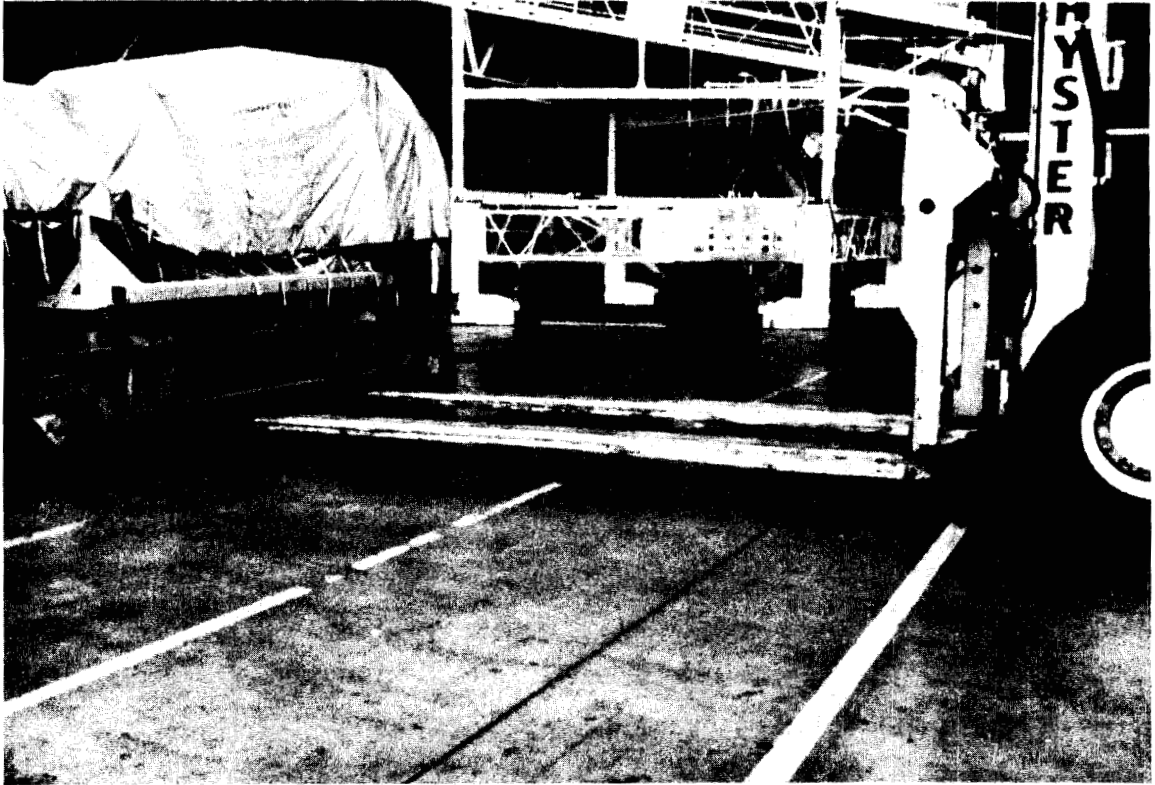
Figure 13. View of forklift and engine stand.

American Airlines' maintenance personnel testified about their experiences with the forklift while handling the engine and pylon assembly. Directions were transmitted to the lift operator either by voice, hand signals, or both. The testimony varied regarding the capability to raise or lower the lifting forks a finite distance. One mechanic said it could be limited to .001 inch; the estimates of others ranged from .25 to .06 inch.

When the full weight of the engine and pylon assembly was on the lifting forks, the pressure gauge reading was 18,000 lbs. Maintenance personnel stated that a 2,000-lb to 3,000-lb pressure bleedoff on the pressure gauge was common; however, they all stated that the lifting forks did not move. Supervisory personnel stated that it was normal for the gauge reading to bleed off 2,000 to 3,000 lbs during a 15-min period without any perceptible load movement. The load remains fixed because of the frictional load on the mast and rollers. Although mechanics testified that the load did not move, they also said that they would manipulate the controls to restore the original reading on the pressure gauge. One mechanic stated that the pylon and engine assembly would "jump" as lowering began. He said the "jerking" motion moved the forks about 1 or 2 inches.
