# NATIONAL TRANSPORTATION SAFETY BOARD

## AIRCRAFT ACCIDENT REPORT

AIR CANADA FLIGHT 797  
McDONNELL DOUGLAS DC-9-32, C-FTLU  
GREATER CINCINNATI  
INTERNATIONAL AIRPORT  
COVINGTON, KENTUCKY  
JUNE 2, 1983

NTSB/AAR-86/02  
(SUPERSEDES - - NTSB/AAR-84/09)

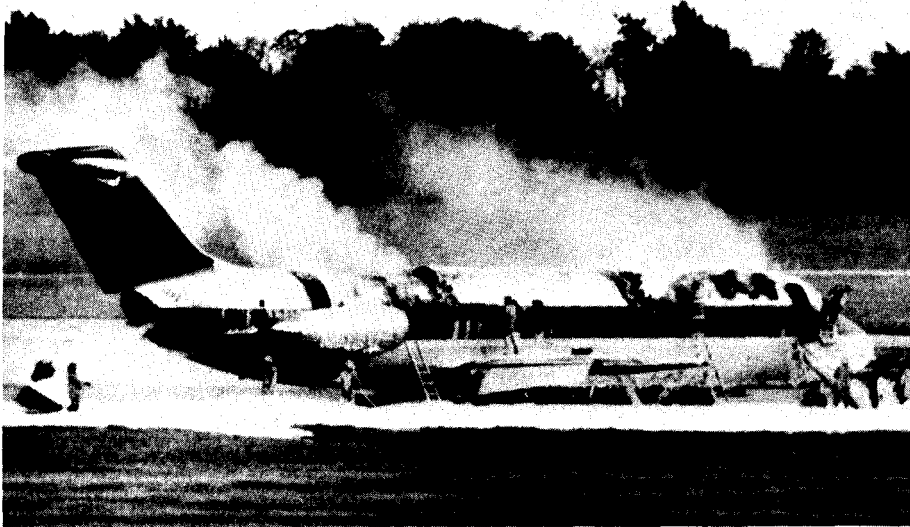
Figure 2.—Airplane after fire burned through top of fuselage.

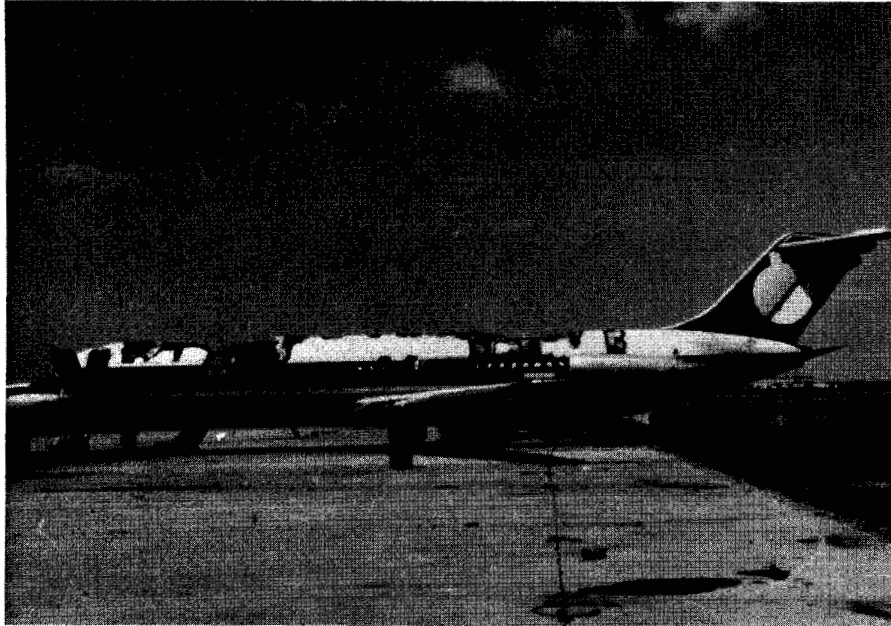
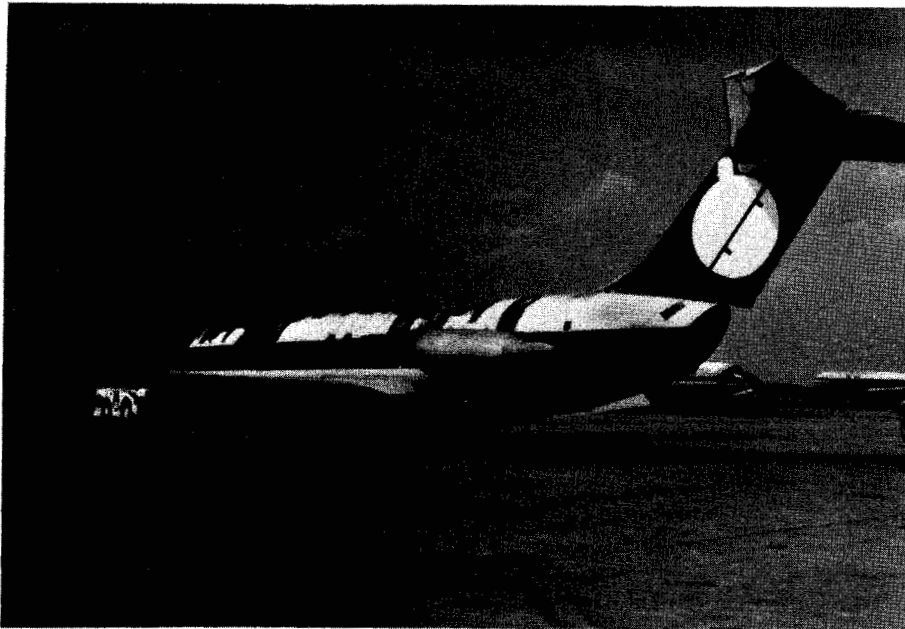
The cabin area of the upper fuselage down to below the level of the cabin windows was damaged heavily by fire; below that level the fuselage was relatively intact. The majority of the cabin windows were either missing or had partially melted out. (See figures 3 and 4.) Forward of the aft pressure bulkhead, the upper areas of the cabin windows were discolored and burned away in several locations. The fuselage skin above the left aft lavatory was intact, but a rectangular area corresponding closely to the shape of the lavatory had been discolored to dark brown and a large area of paint had been burned away. The rectangular area began above the engine pylon and extended to the top of the fuselage. (See figures 3 and 4.)

Figure 3.—Left side of the airplane.

Figure 4.—Left side of the airplane, rear view, depicting rectangular burn pattern and soot trail.

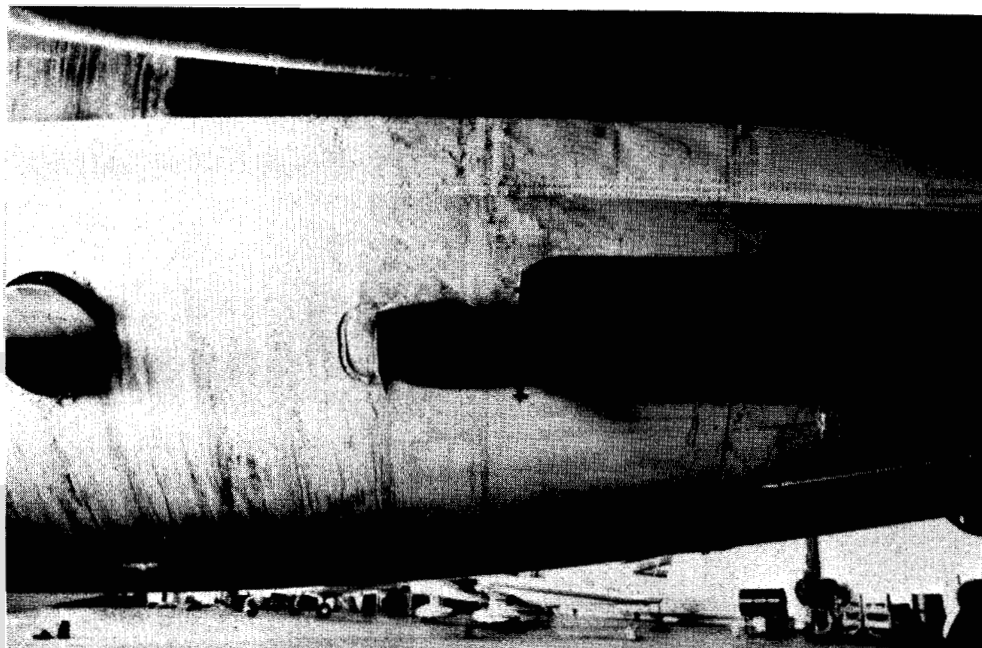
There were thick soot deposits along the lower side of the fuselage beginning at the cabin air outflow valve at FS 945 and from around the access door in the lavatory service panel at FS 965. The soot pattern trailed rearward along the airplane's side,

including the tailcone. The cabin air dump valve, at FS 920, was open, and light soot deposits trailed aft from around the edges of the valve. (See figure 5.)

Figure 5.—Soot trail deposits on left side of fuselage at lavatory service panel and outflow valve.

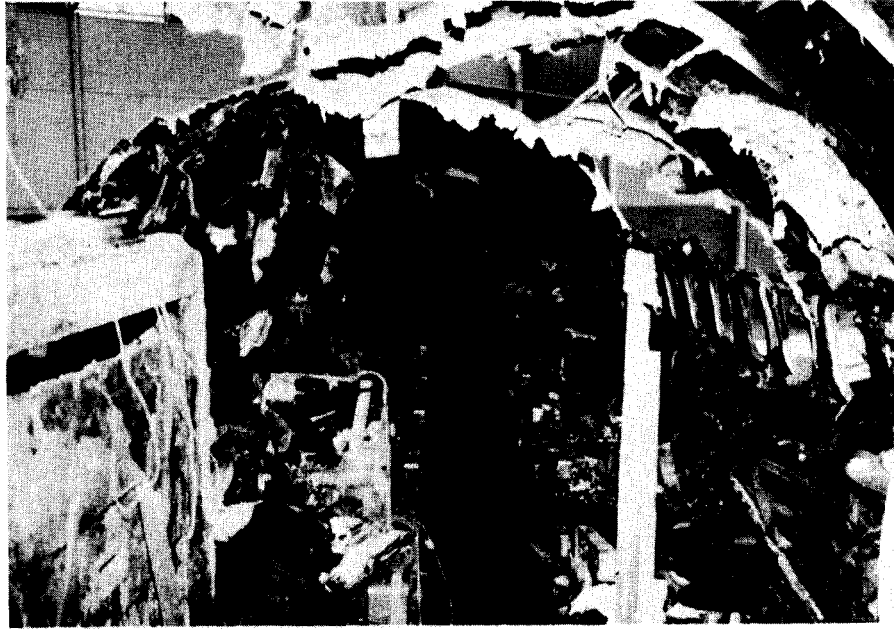
Except for the cabin floor and the aisle carpet, the entire passenger cabin back to the aft lavatory was either consumed or damaged by fire. The aisle carpet was covered by debris but had not been discolored or damaged by heat. Of the 100 passenger seats, only the seat frames and cushions of Nos. 12A and 12B remained intact. Seat Nos. 12A and 12B are adjacent to the left forward overwing emergency exit which had been opened during the passenger evacuation and had been used as access by firemen to apply water to the fire. The remaining seats were either completely or partially destroyed by the fire. (See figures 7 and 8.)

Figure 7.—Cabin interior viewed aft from the forward galley area.

Figure 8.—Cabin interior viewed aft from the midwing area.

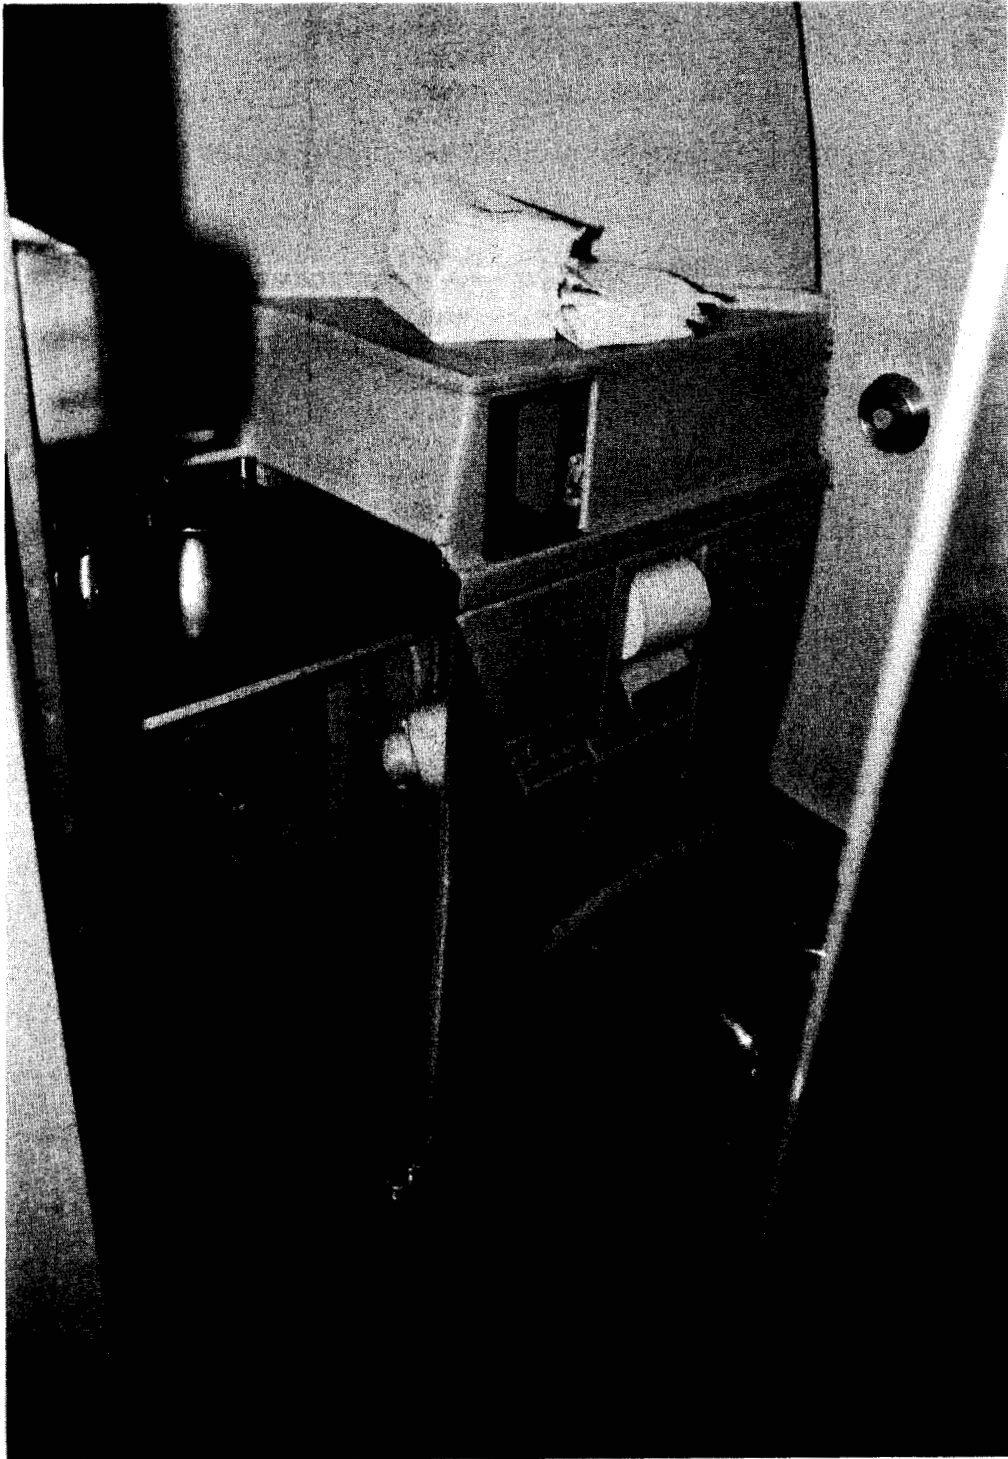
Figure 10.—Aft lavatory viewed toward aft and outboard wall.  
Lavatory sink door is open exposing trash receptacle.  
Toilet shroud has been removed showing the top of the  
flush motor between the commode and forward wall of  
the amenities section.

The aft lavatory was damaged extensively by fire and heat. Most of the lavatory's interior walls had been burned away. The entry door, which had been kept closed, was destroyed except within 16 inches of the floor. The aft pressure bulkhead and fuselage skin which comprised the outermost portion of the lavatory enclosure were intact, but were buckled and discolored to dark brown.

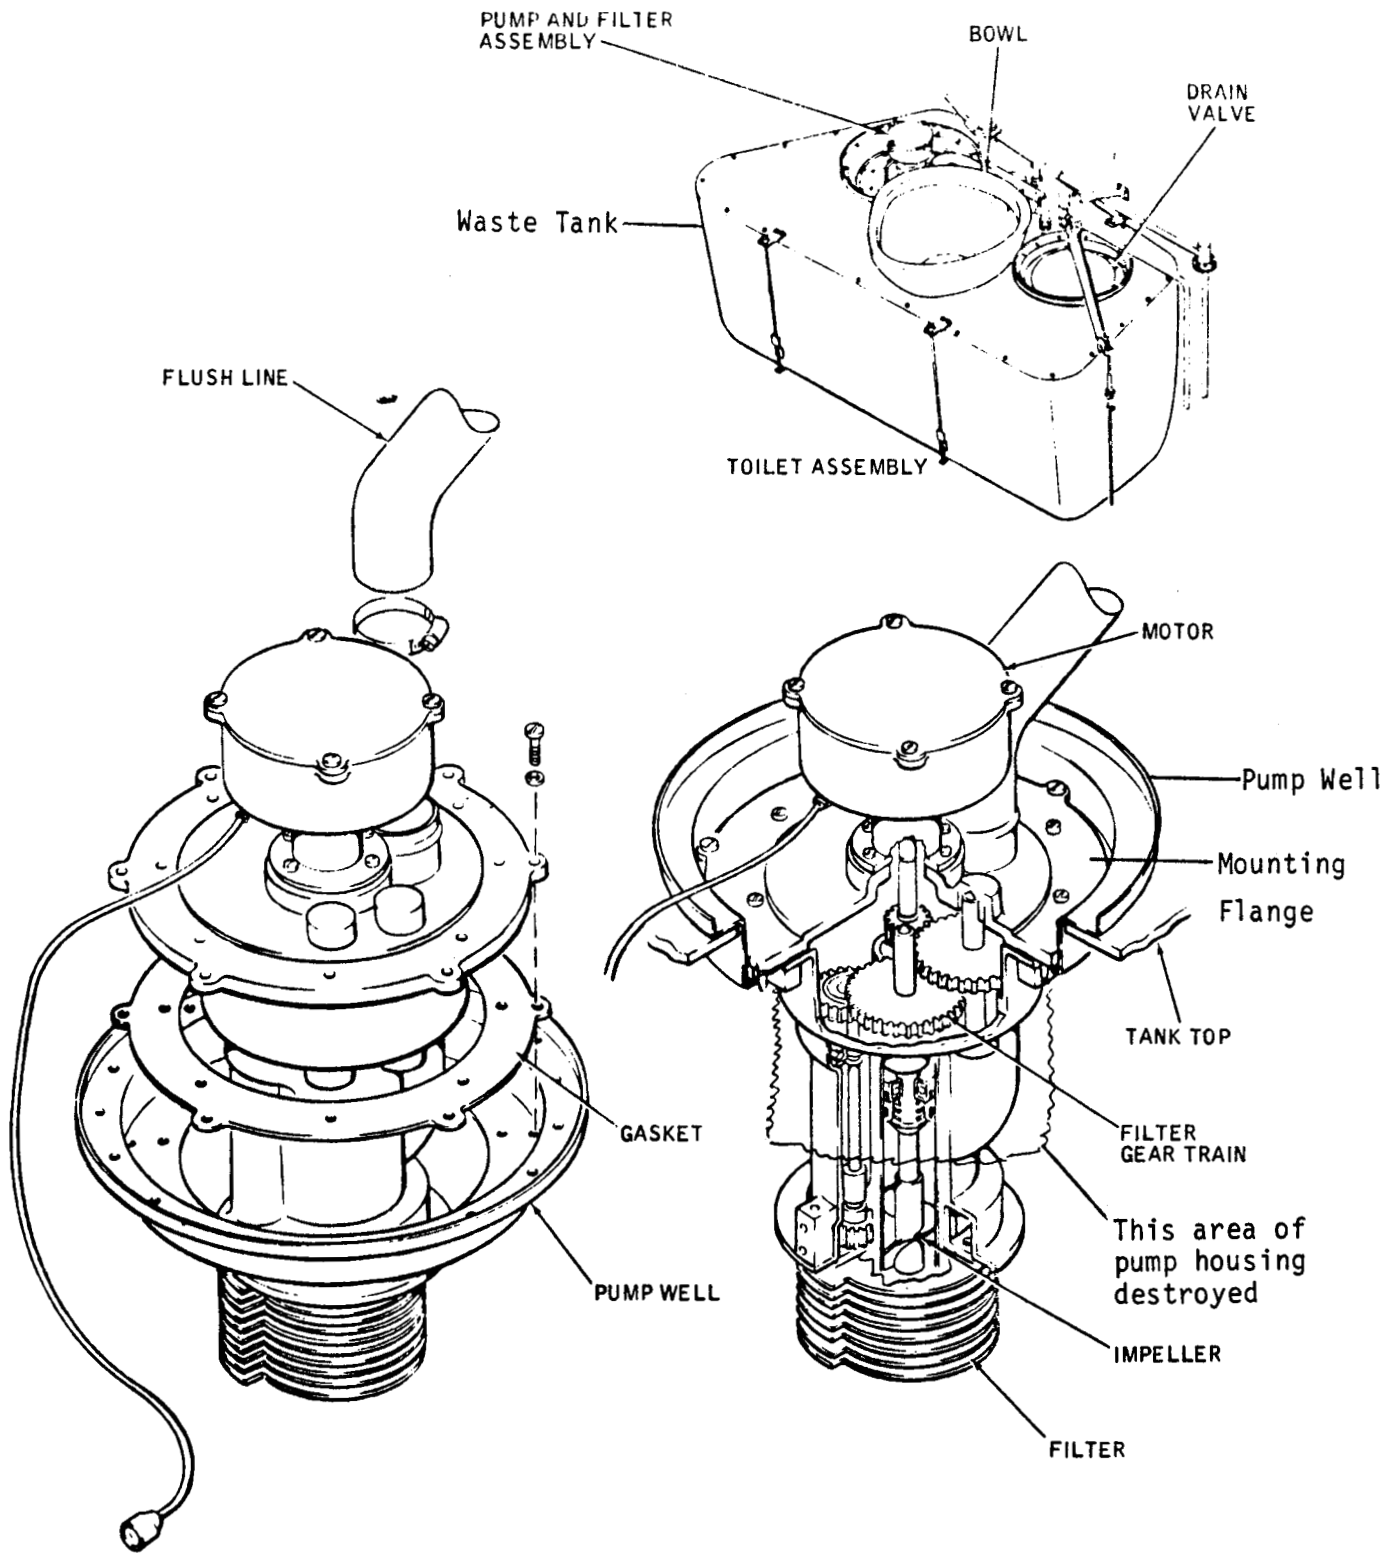
The flush motor was found attached to its mounting flange which was attached to the pump well. The flush motor assembly was found in approximately its normal position in the waste tank next to, but detached from, the flush pump and filter assembly. The motor housing was completely melted. Large concentrations of molten metal were found on the forward side of the mounting flange facing the toilet bowl, and on the aft side where the 3-phase electrical leads enter the motor housing. A portion of the wiring harness which supplies a.c. power to the flush timer, flush motor, and flush button was encased in the molten metal on the aft side of the motor. The rotor section of the flush motor was encased in molten metal above the field windings; however, the rotor did not appear to have been damaged extensively by heat. (See figure 11.)

The flush pump and filter assembly found in the waste tank was partially intact. The filter and pump mechanisms, which apparently had been located below the water line in the waste tank, were in good condition. Above the water line, the plastic housing for the pump and filter was melted away. This housing also encloses the filter gear train and is part of the assembly used to mount the pump and filter to the pump well. The exposed shaft and gears showed heat damage. The gears, which make up the filter gear train that connects the motor to the pump and filter, were found lying in the waste tank. The plastic mounting ring, which mates the pump and filter housing to the pump well, was found intact among the debris in the waste tank. There was some slight melting of the top surface of the mounting ring. All of the components of the flush motor and pump assembly were removed for further examination.

Figure 11.—Lavatory pump and filter system.
