NATIONAL TRANSPORTATION SAFETY BOARD

AIRCRAFT ACCIDENT REPORT

DELTA AIR LINES, INC.,
LOCKHEED L-1011-385-1, N726DA
DALLAS/FORT WORTH -
INTERNATIONAL AIRPORT, TEXAS
AUGUST 2, 1985

NTSB/AAR-86/05

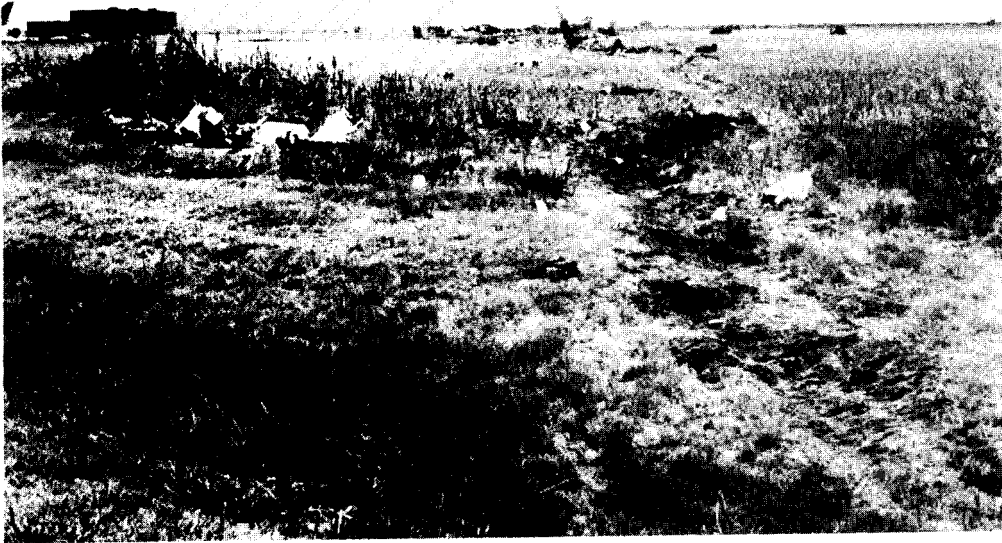
Figure 1.--Flight 191's ground track toward the water tanks.

The airplane grazed the north water tank and then impacted the south water tank--about 3,195 feet beyond initial touchdown--and broke apart. The fuselage, from the nose aft to fuselage station 1365 (FS 1365), was destroyed. Both wing sections outboard of the engine pylons separated during the breakup. The left wing came to rest in two inverted sections about 1,125 feet south of the south water tank. The wing sections and attached sections of the trailing edge flaps and leading edge slats were burned extensively. The outboard section of the right wing came to rest in an inverted position about 775 feet south of the south water tank. The No. 3 engine pylon was attached to the wing and the No. 3 engine was partially attached to the pylon. Both wings left a trail of wing components and burning fuel between the water tank and their final positions.

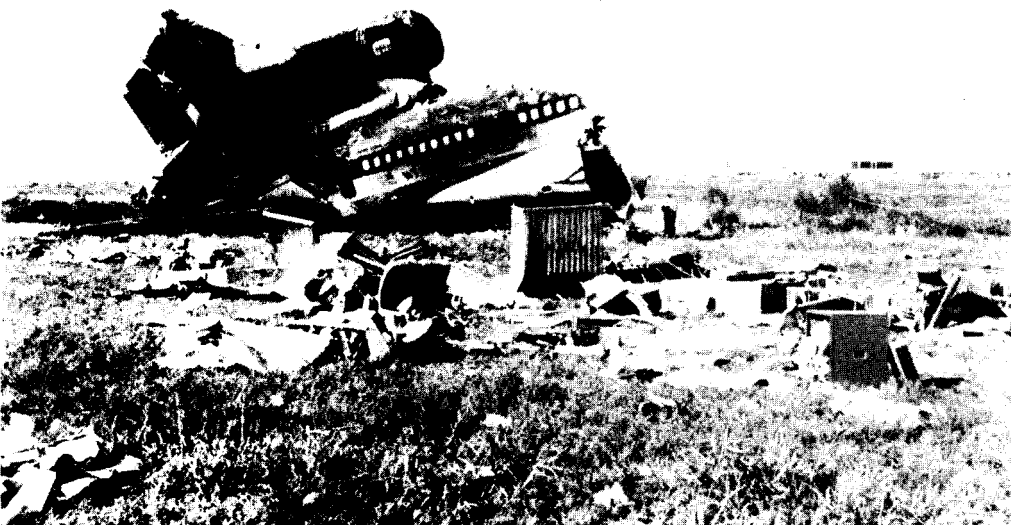
Figure 2.--The aft section of the airplane's fuselage.

The investigation team found the aft fuselage section containing the rear cabin and the empennage was in an upright position. Passengers and flight attendants reported that this section came to rest on its left side and was rolled to the upright position by wind gusts after the arrival of the rescue personnel. The section was relatively intact and included the No. 2 engine and associated ducting, the right stabilizer and elevator, and the base of the vertical stabilizer and rudder. The upper 12 feet of the vertical stabilizer and rudder had separated as a unit during the impact sequence and was found about 100 feet north of the aft fuselage section.

Except for the left cabin wall, which was missing, the remainder of the separated rear cabin section from row 40 aft to row 46 was relatively undamaged. Six passengers seated along the missing left cabin wall were killed. The remaining 16 occupants of this cabin section, including 2 flight attendants, sustained serious and minor injuries, and 2 passengers were not injured.

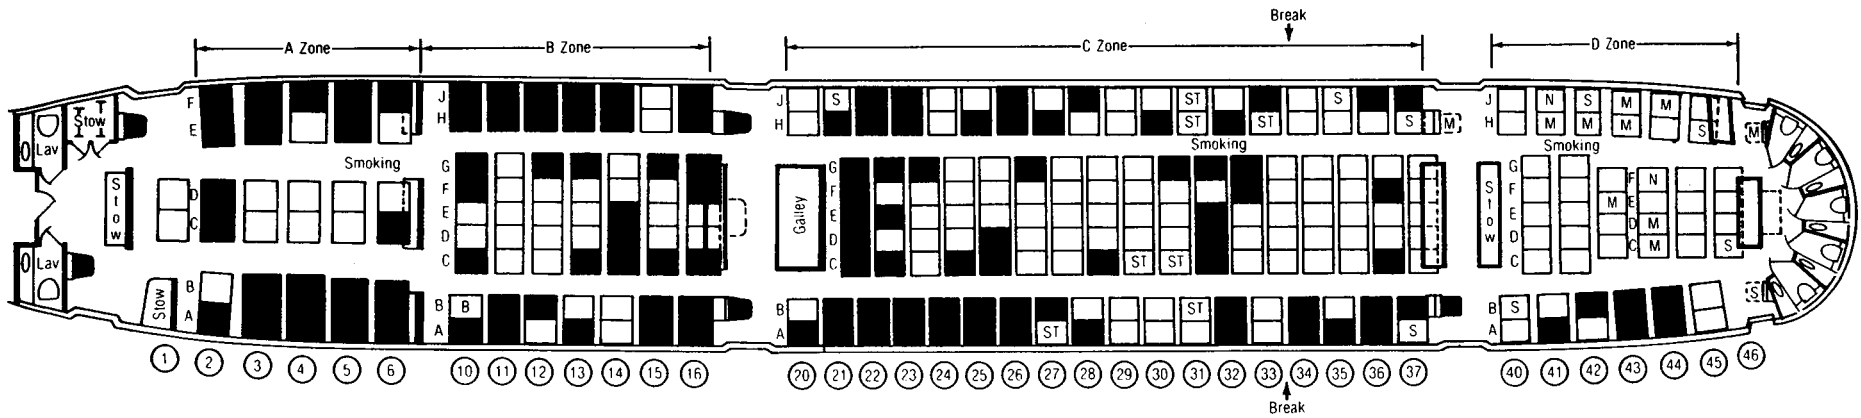
The rear cabin section came to rest on its left side. The survivors were either flung from the airplane in their seats or released themselves from their seats and exited at the forward end of the separated fuselage section or through the missing left wall. One flight attendant and three passengers could not escape from the cabin because of injuries and were removed by fellow passengers and rescue personnel. Two other flight attendants had only minor injuries and were able to escape unaided after shouting commands to the passengers to get out of the cabin. The flight attendant seated at the right rear (R-4) exit had difficulty releasing her seatbelt because the buckle was located on her left hip and her weight was on the buckle. The passengers and flight attendants were covered with fuel and some had fuel on their hands and in their eyes, which caused difficulties in climbing down the cabin to the hole created by the missing left cabin wall. Some persons were able to climb downward to the hole over seats while others fell the width of the cabin to the ground.

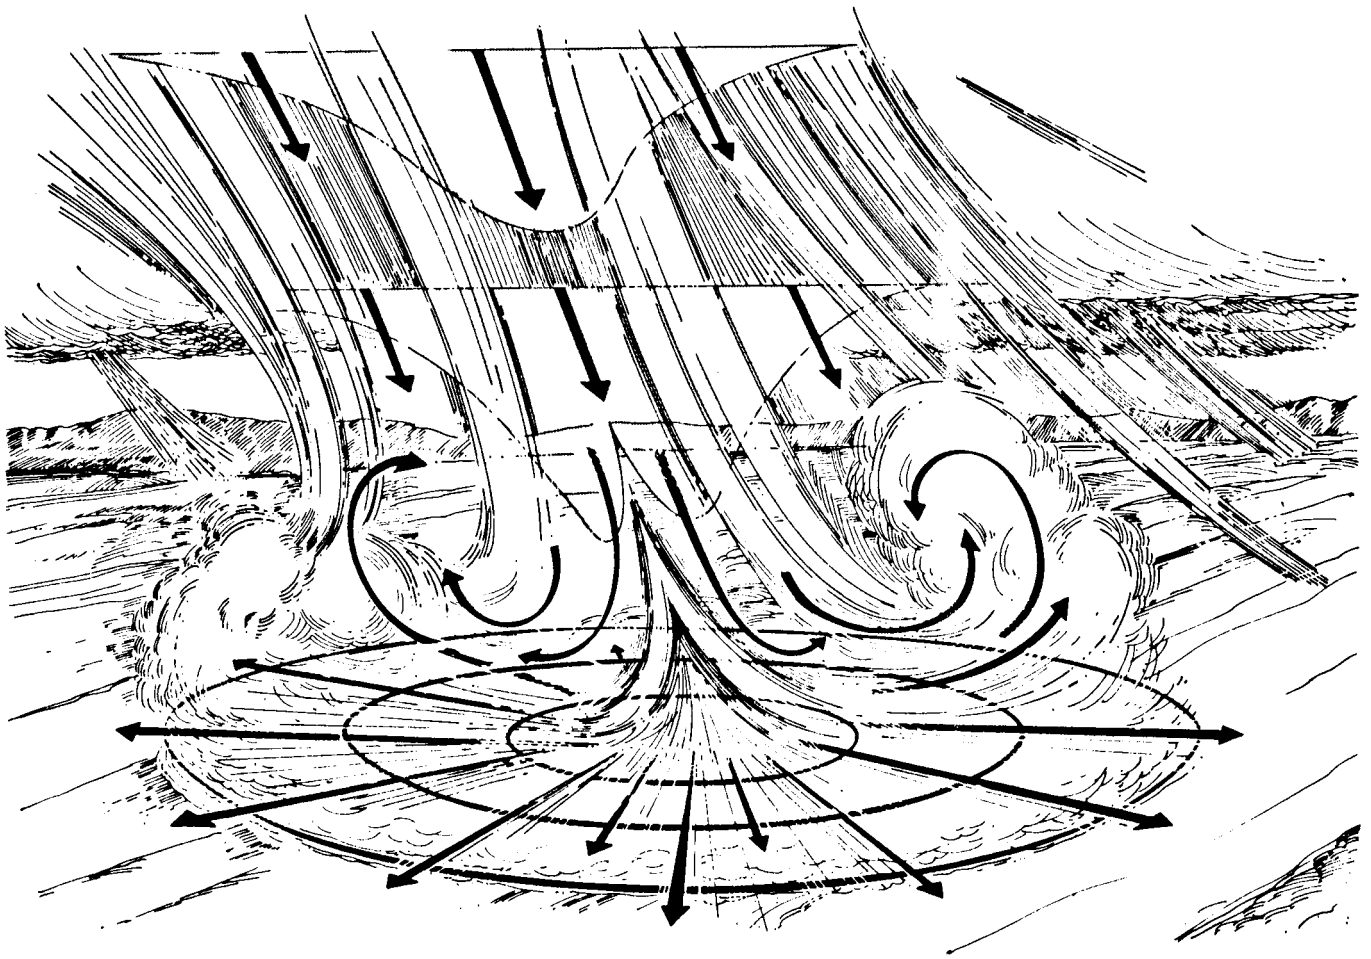
Figure 4.--Typical microburst wind field.

by the ground rises and is replaced by cold air descending from aloft. The low-level wind condition is analagous to pointing a high-pressure air hose at the ground; the vertically descending air fans out in all directions.

When a microburst is encountered during a landing approach, the airplane will typically experience an increasing headwind, a downdraft, and a decreasing headwind in rapid succession as it passes beneath the outflow and descending air column. The increasing headwind will be recognized as the indicated airspeed increases suddenly and the airplane tends to rise above the glidepath. However, this apparent increase in airplane performance is shortlived as the airplane enters the downdraft and encounters the decreasing headwind caused by the reversal in the direction of the outflow. The rapid reversal of wind direction and speed produces sudden changes in the airplane's angle of attack and airspeed, which may reduce the airspeed far below the initial stabilized airspeed. The reduced airspeed will result in reduced vertical lift, causing the airplane to accelerate downward. Furthermore, the airplane's longitudinal stability will cause the airplane to pitch nose downward as it attempts to reacquire its trim speed equilibrium. The extent to which the airplane's flight path changes depends upon the severity of the windshear and the pilot's reaction with flight controls and engine thrust. The microburst might also create horizontal vortices which produces sudden changes of vertical wind speeds to further upset the longitudinal stability and perhaps the lateral and vertical stability of the airplane, exacerbating the pilot's control task.
