NATIONAL TRANSPORTATION SAFETY BOARD

AIRCRAFT ACCIDENT REPORT

**COLLISION OF
AERONAVES DE MEXICO, S.A.
McDONNELL DOUGLAS DC-9-32, XA-JED
AND PIPER PA-28-181, N4891F
CERRITOS, CALIFORNIA
AUGUST 31, 1986**

NTSB/AAR-87/07

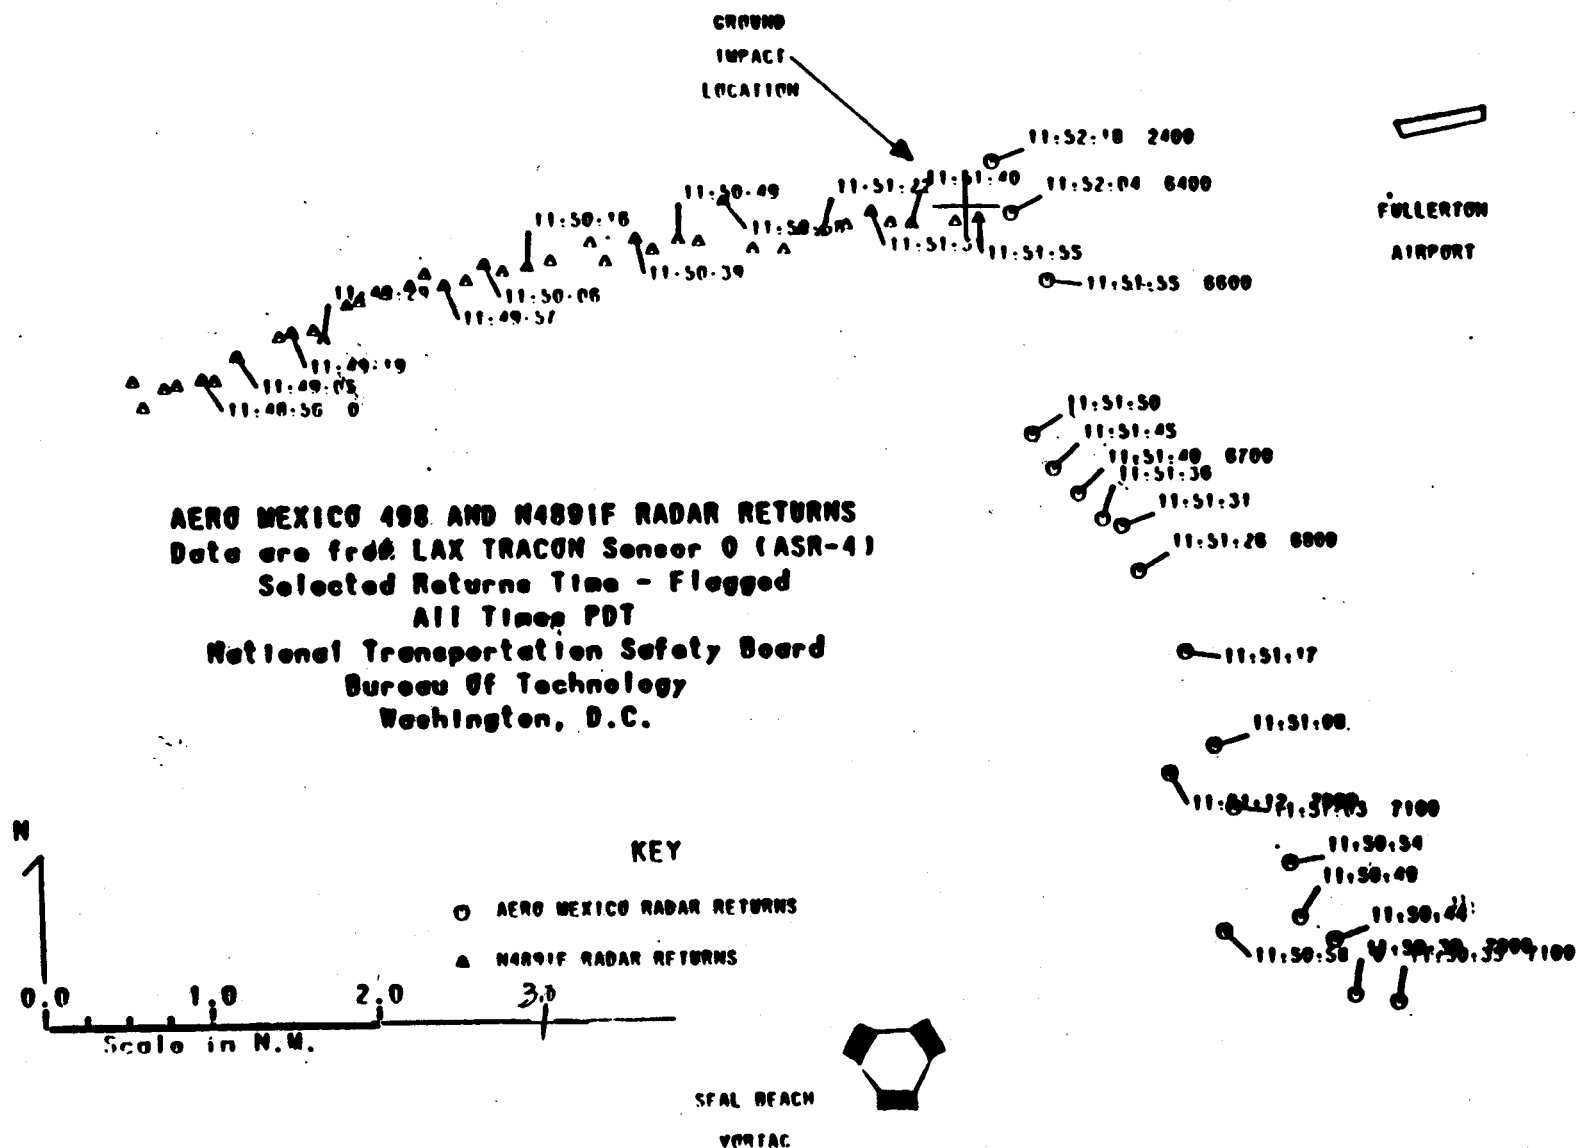
Figure 5.--Beacon targets of DC-9 and Piper during last 3 minutes of flight.

The recorded radar data also indicated that the Piper passed the TCA's lateral boundary about 1149:47 and that the collision occurred about 3 nmi west of that boundary. The manufacturer's climb performance chart was based on a 76-KIAS climb speed. Between 5,000 feet and 7,000 feet, based on the airplane's estimated gross weight and the existing weather conditions, the Piper could have climbed at a rate of about 300 fpm to 350 fpm. Since the collision occurred about 1152:09 at about 6,560 feet, the Piper probably climbed through 6,000 feet—the base altitude of this segment of the TCA—about the same time it crossed the TCA's lateral boundary.

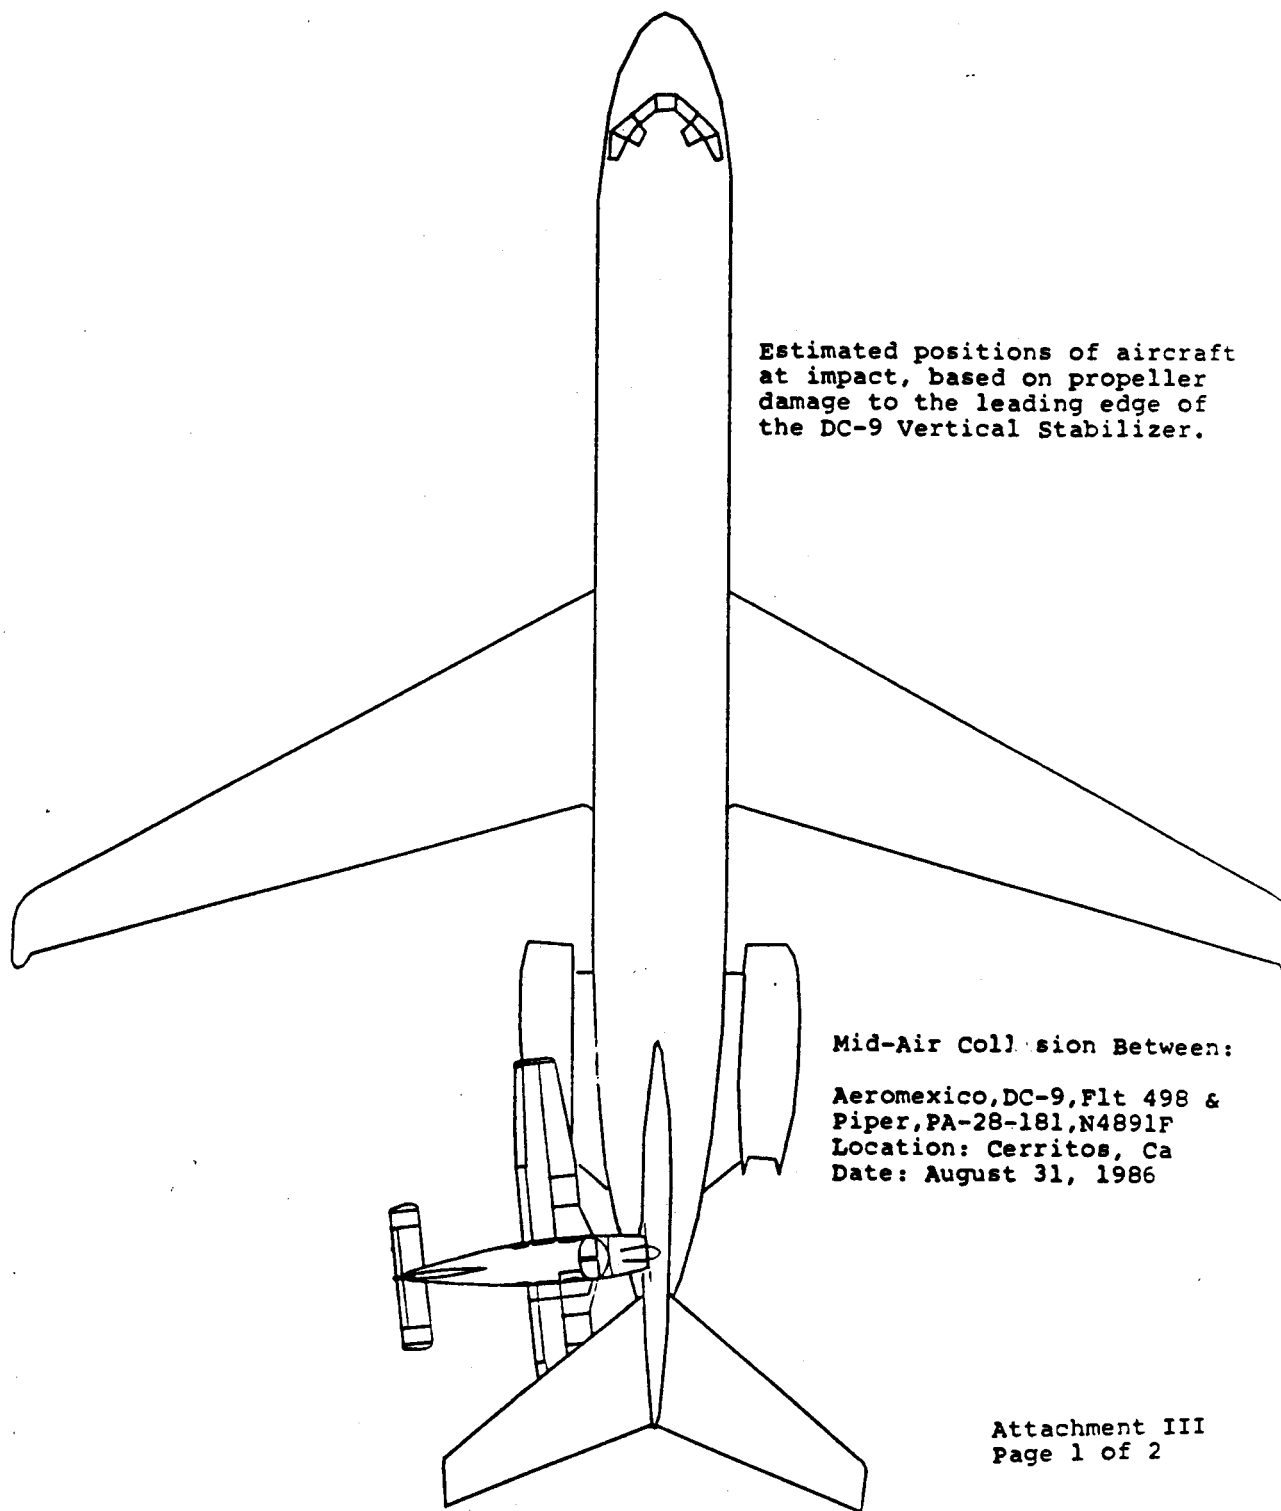
Figure 6.--Collision geometry as viewed from above the DC-9.

The damaged areas on the DC-9 vertical and horizontal stabilizers contained propeller slice marks, paint transfer marks from the nose wheel area and vertical stabilizer of the Piper, and embedded pieces from the cabin roof area of the Piper. The location and angles of these marks and damage on the DC-9, when matched to their respective locations on an intact Piper PA-28, showed that the front of the Piper had struck the left side of the DC-9 vertical stabilizer and that the impact angle was perpendicular to the longitudinal axis of each airplane. (See figure 6.) The impact angle was generally consistent with the flight tracks of the airplanes shown on the radar data plots.

The absence of any impact marks or damage on those portions of the DC-9 left wing and fuselage forward of the empennage that had not been consumed by fire and the damage to the DC-9 vertical and horizontal stabilizers, showed that the PA-28 airplane was about 8 to 10 feet above the top of the DC-9's fuselage and about 15 to 17 feet above its wings when the collision occurred. The damage also indicated that the longitudinal axis of the Piper was almost level at impact and that the initial impact was with the DC-9 vertical and horizontal stabilizers. The debris from the Piper cabin roof, embedded in the leading edge of the DC-9 horizontal stabilizer, and the fact that the roof of the Piper was sheared off at about the same height on both sides of its fuselage, confirmed the fact that the DC-9's horizontal stabilizer struck the top of the Piper's fuselage and that the Piper was in the almost wings-level attitude at impact. (See figure 7.)

Estimated positions of aircraft at impact, based on the propeller damage and scratch marks on the DC-9 Vertical and Horizontal Stabilizers.
