# **NATIONAL TRANSPORTATION SAFETY BOARD**

## **AIRCRAFT ACCIDENT REPORT**

**ALOHA AIRLINES, FLIGHT 243  
BOEING 737-200, N73711,  
NEAR MAUI, HAWAII  
APRIL 28, 1988**

**NTSB/AAR-89/03**

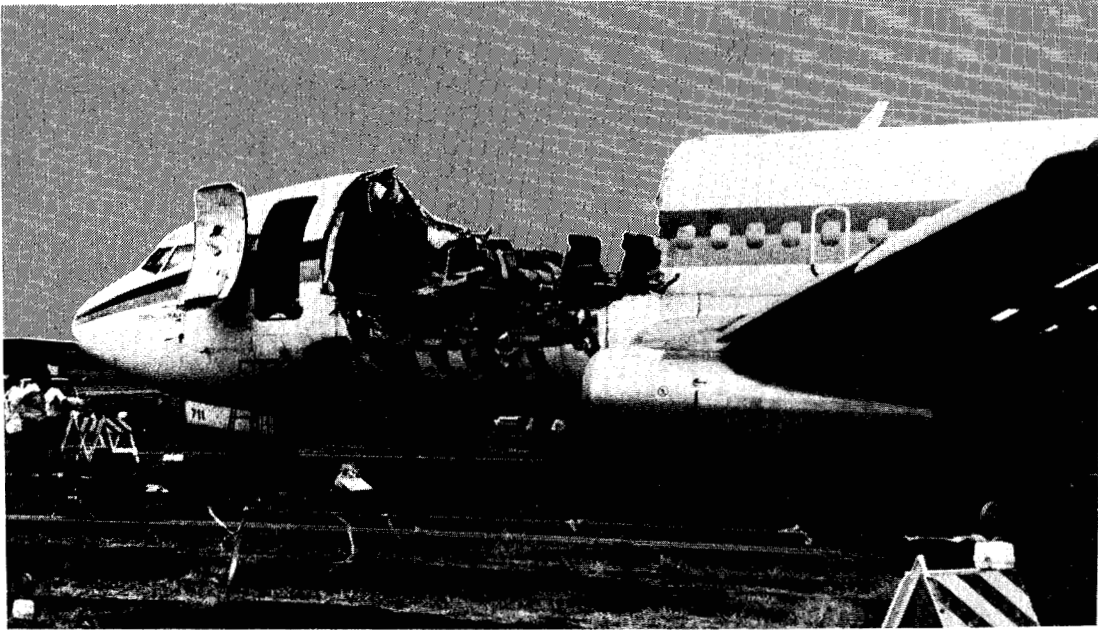
A major portion of the upper crown skin and structure of section 43 separated in flight causing an explosive decompression<sup>1</sup> of the cabin. (See figures 1 and 2.) The damaged area extended from slightly aft of the main cabin entrance door, rearward about 18 feet to the area just forward of the wings and from the left side of the cabin at the floor level to the right side window level.

Figure 2a.--General view, left side of forward fuselage, N73711

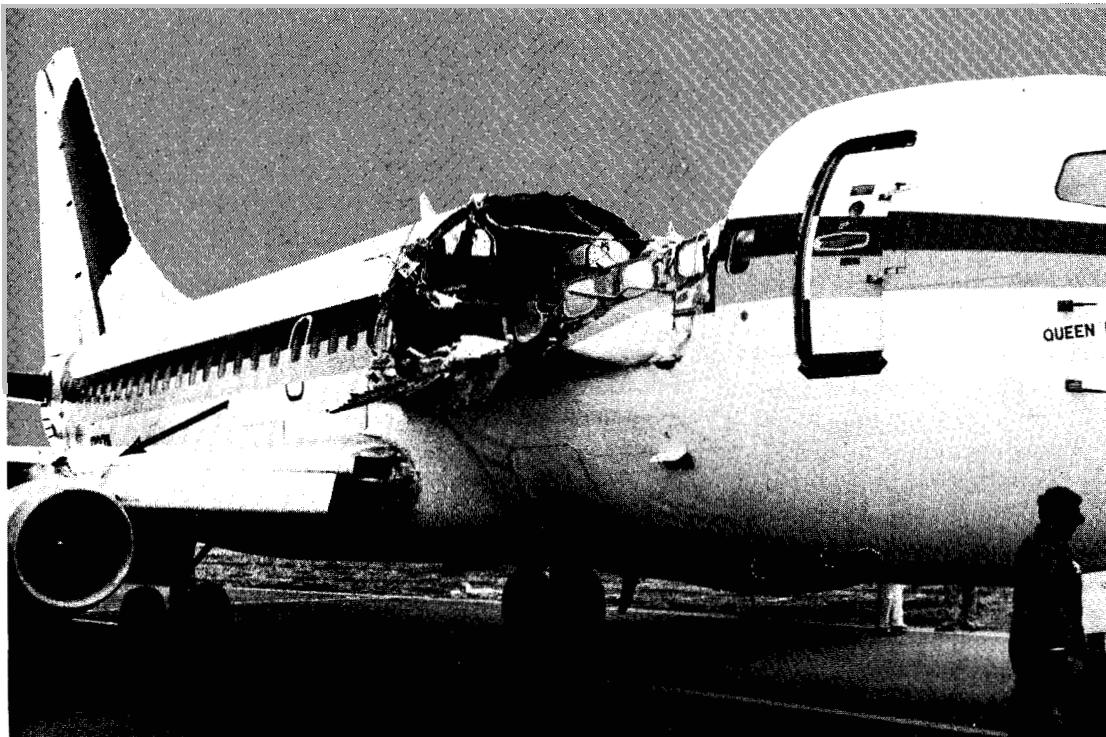
Figure 2b.--General view, right side of forward fuselage, N73711. Arrow marks fragments of S-4R lodged in the leading edge flap.

A fuselage section from BS 365 to BS 420 between S-4R and S-8R was trapped between the leading edge flap and inboard side of the right engine strut. This was the only significant piece of structure from the damaged

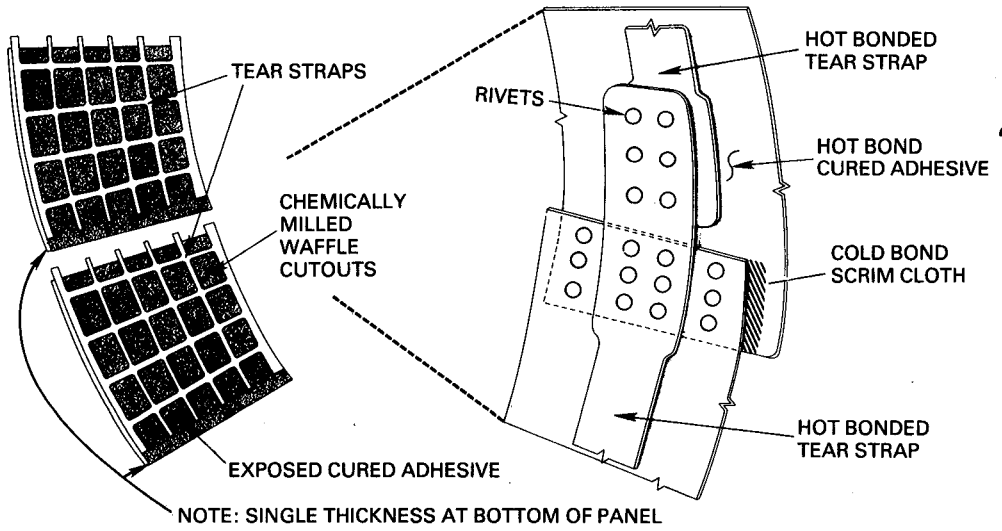
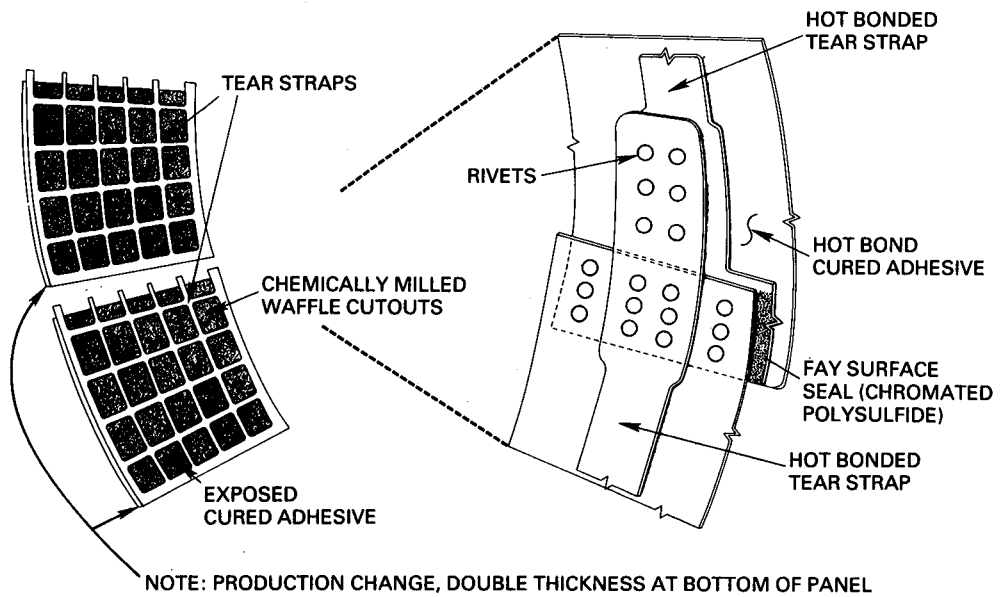
Figure 3.--B-737 Lap splice configuration

According to Boeing engineers, when disbond occurs in the bonded lap joint, as designed for the B-737, the hoop load transfer through the joint is borne by the three rows of countersunk rivets that mechanically fasten the skin panels together. Because of the single thickness skin surface that was facilitated by the bonded construction, the countersink for the flush rivet heads extended through the entire thickness of the outer 0.036-inch sheet. A knife edge was created at the bottom of the hole which concentrated stresses. These stresses were cyclic with pressurization loads, and fatigue cracking ultimately occurred at the site.

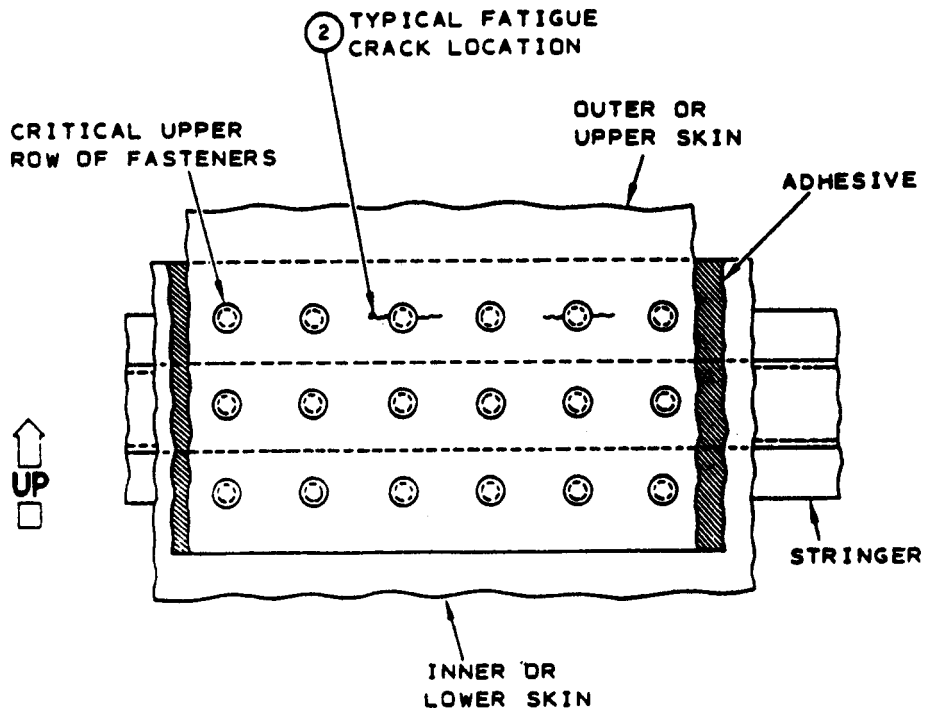
FIGURE 1. LAP JOINT INSPECTION

- ① Accomplish Part I Visual Inspection of skin panel lap joints for corrosion and/or delamination, located at Stringers 4, 10, 14, 19, 20, and 24.
- ② Accomplish Part II Inspection of the lap joint upper row of fasteners.

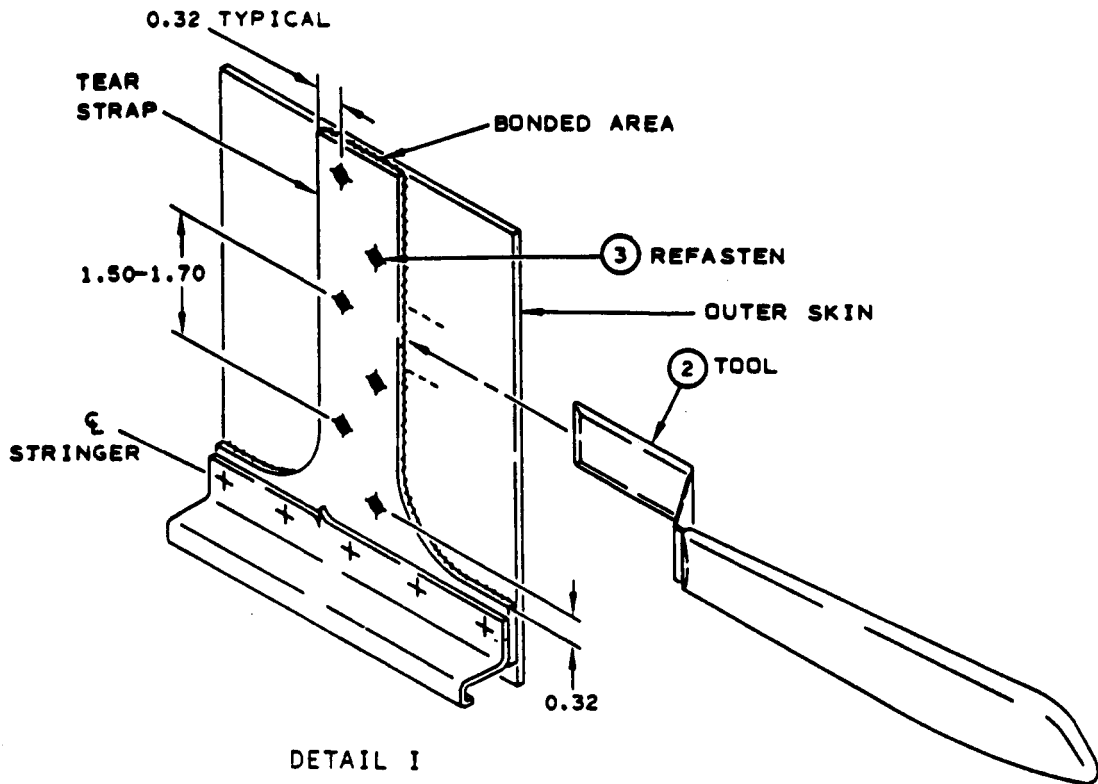
FIGURE 2. TEAR STRAP INSPECTION AND REPAIR

- ① Perform close visual inspection of the bonded edge of the tear strap for disbond and/or corrosion, over a minimum tear strap length of 2 stringer bays above and 1 stringer bay below the lap joint.
- ② If corrosion or disbond is suspected, insert tool (ECONO-PRY or equivalent) between skin and strap to determine if strap is disbanded or if corrosion has occurred. An outward push on skin while inserting tool will aid in identification of weak or disbanded tear strap connections.
- ③ Drill 0.159-0.171 diameter hole at locations shown and install fastener MS20470D5-5 wet with sealant (Ref. BMS 5-95).
