PB91-910409  
NTSB/AAR-91/08

## AIRCRAFT ACCIDENT REPORT

RUNWAY COLLISION  
OF USAIR FLIGHT 1493, BOEING 737  
AND SKYWEST FLIGHT 5569 FAIRCHILD METROLINER  
LOS ANGELES INTERNATIONAL AIRPORT  
LOS ANGELES, CALIFORNIA  
FEBRUARY 1, 1991

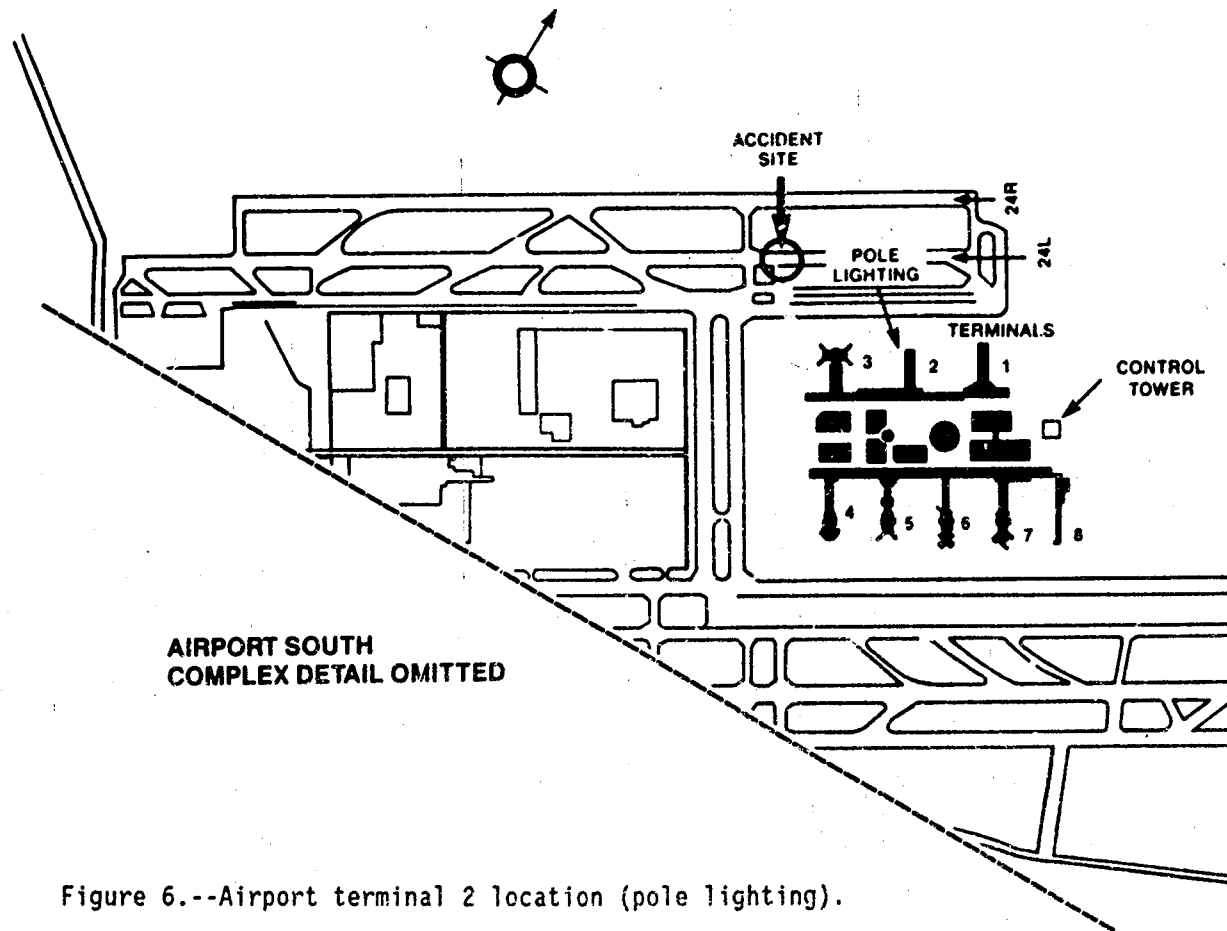
Figure 6.--Airport terminal 2 location (pole lighting).

During interviews, tower personnel stated that a series of four ramp lights on the northernmost portion of the Terminal 2 complex were a restriction to vision during the hours of darkness because of their height, brightness, and relative line-of-sight location to taxiways 45 and 47 and runway 24 left.

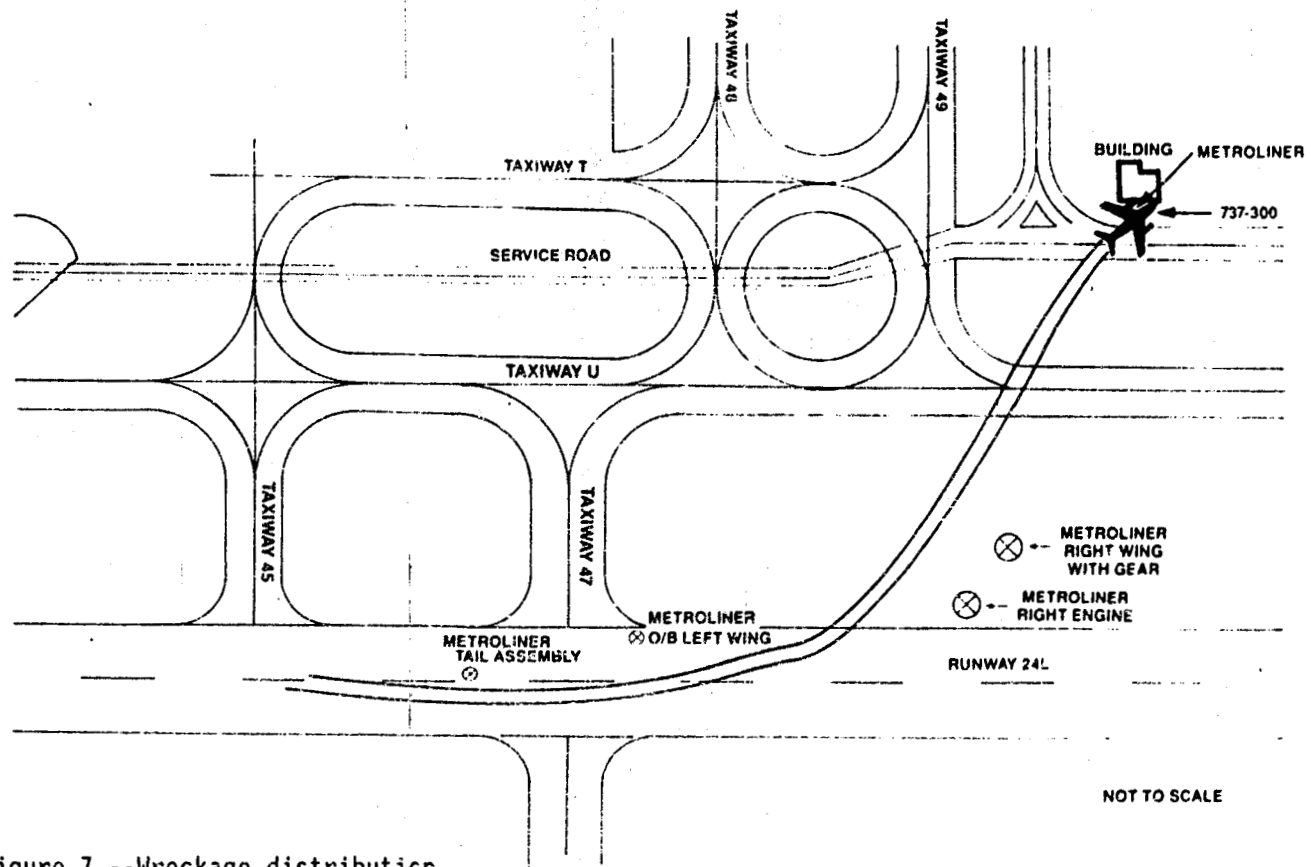
Figure 7.--Wreckage distribution.

The empennage with the vertical stabilizer, rudder and left horizontal stabilizer were located approximately 240 feet from the initial impact location. The left wing section outboard of the engine was located at the intersection of taxiway 47 and the runway. The right wing separated at the root and was found, with the right landing gear attached, between the runway and taxiway Uniform.

The right engine (minus the propeller section) was found along the debris path. The right engine propeller was found embedded in the B-737's right engine lower cowling. The left engine and propeller remained attached to the main wreckage.

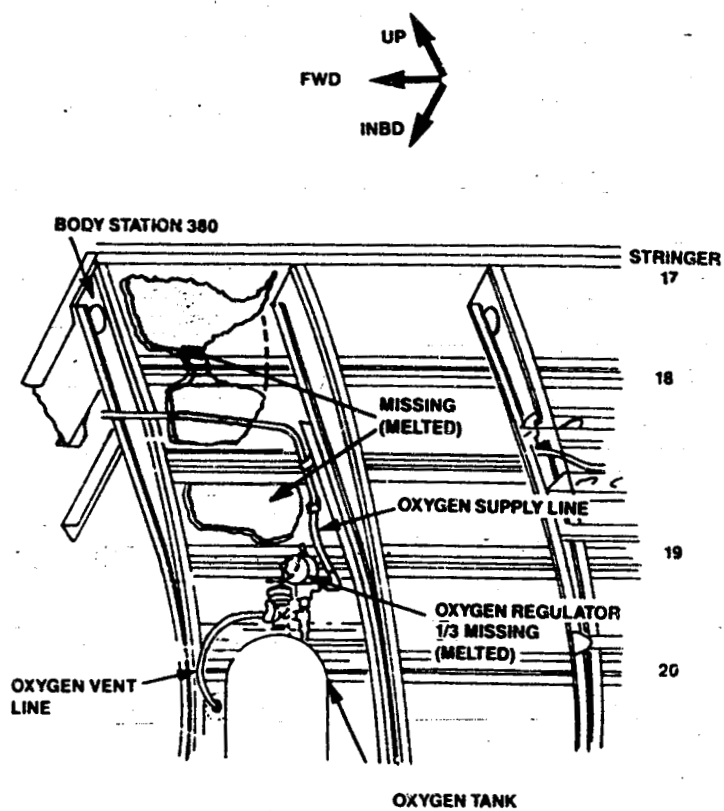
Figure 12.--Fuselage damage/crew oxygen system installation.

The fuselage skin near the oxygen system installation was damaged mechanically, prior to high temperature exposure.
