AIRCRAFT ACCIDENT REPORT

DELTA AIR LINES, INC.

MCDONNELL DOUGLAS DC-9-14, N3305L

MAY 30, 1972

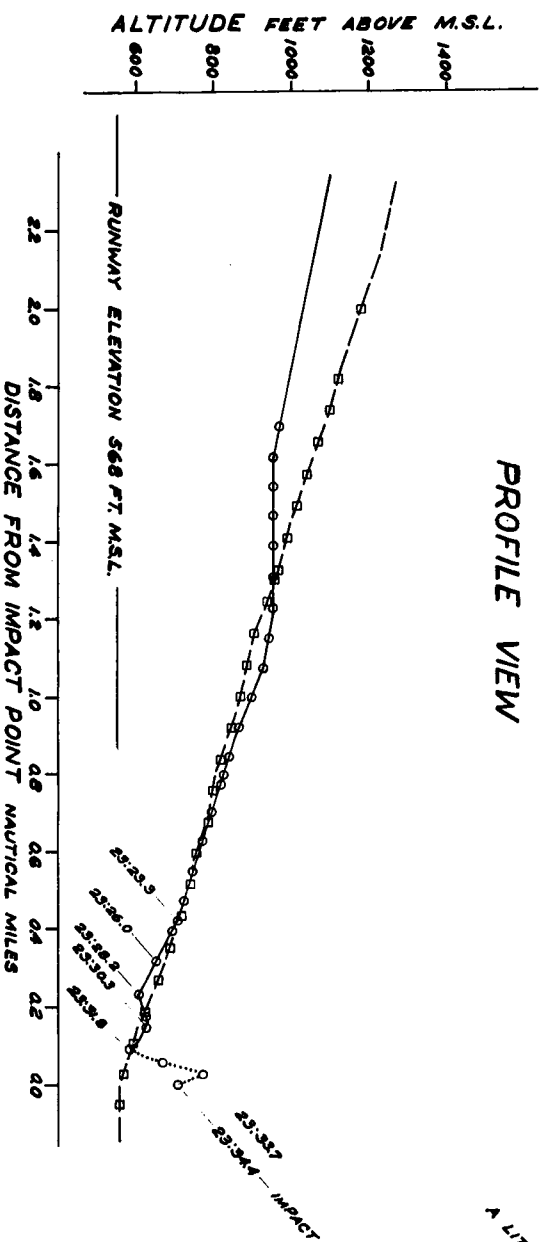
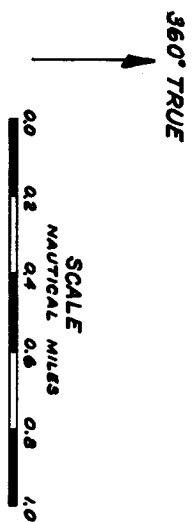
PROFILE VIEW

FLIGHT TRACK OF AMERICAN
DC-10 TRAINER 1114

SURFACE WIND
FROM 340°/7KTS.

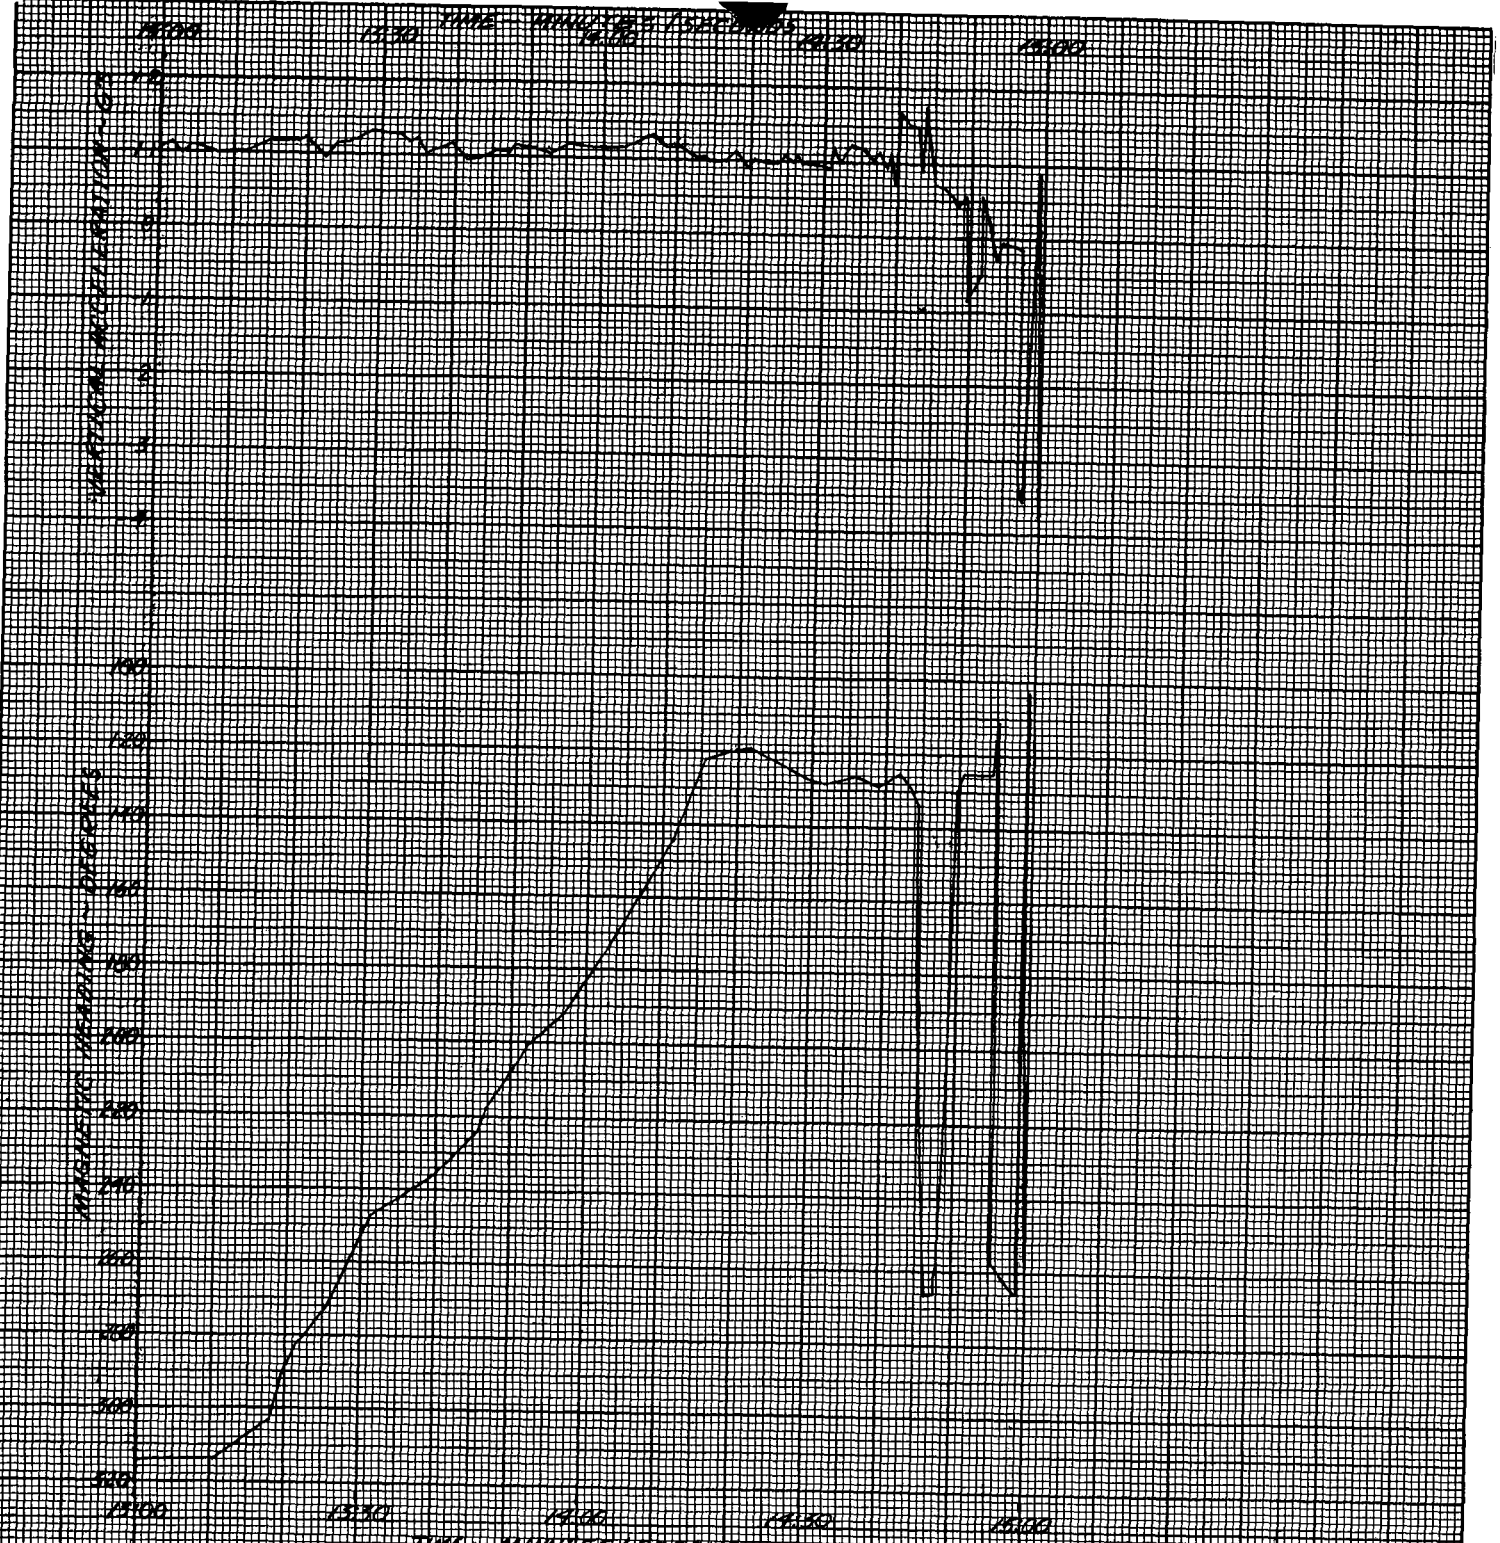
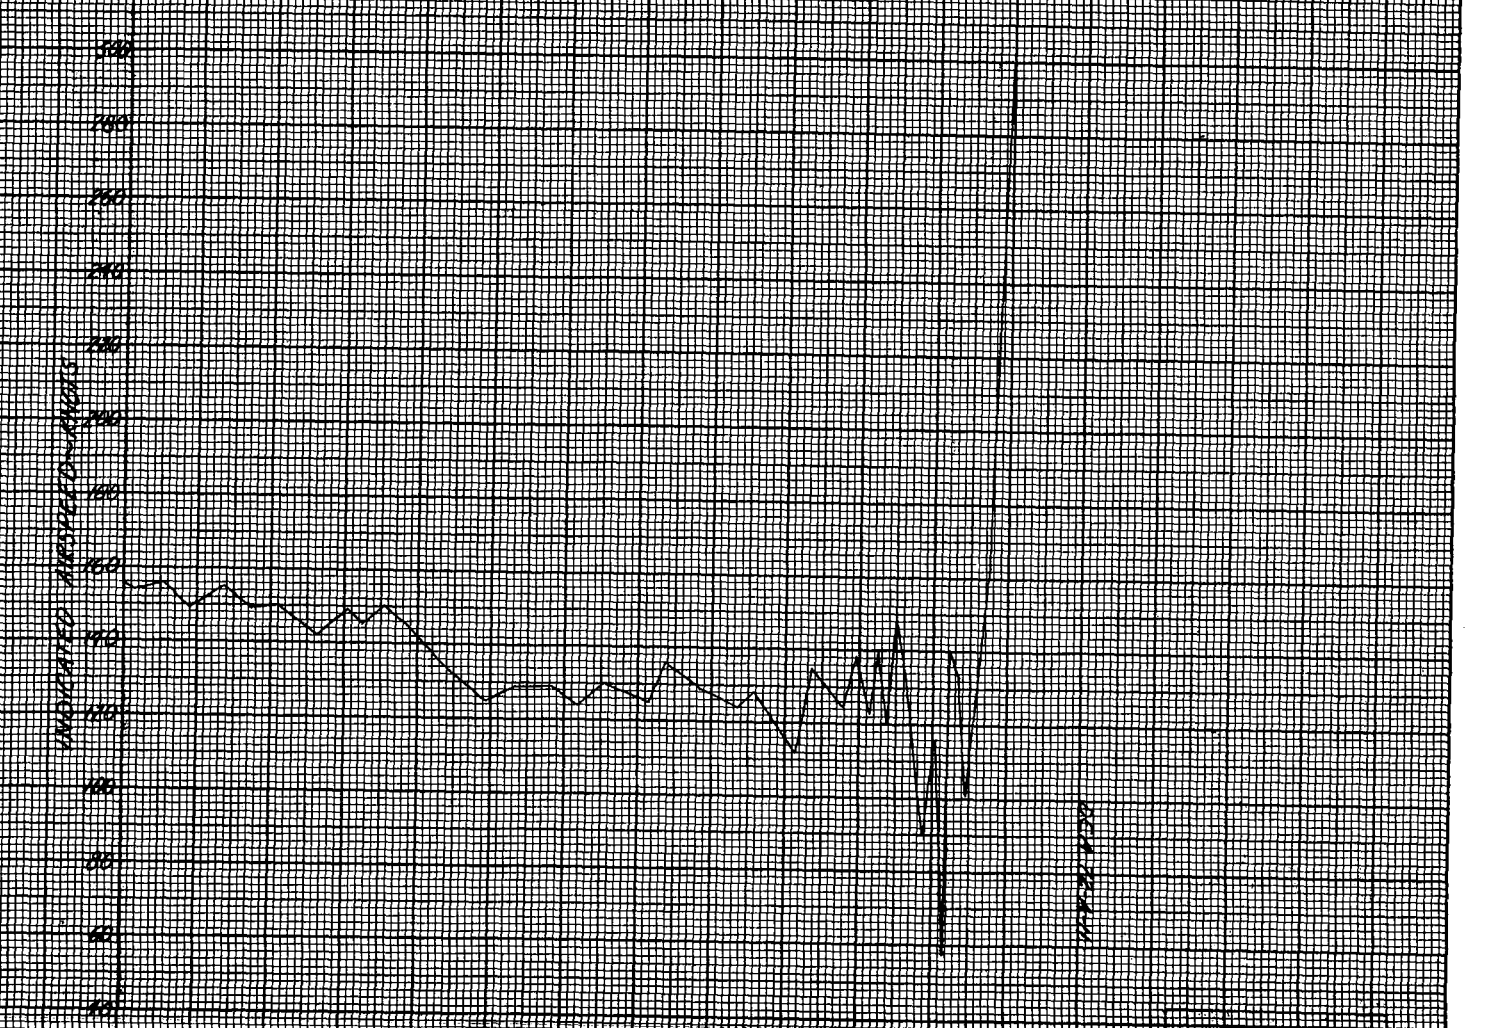
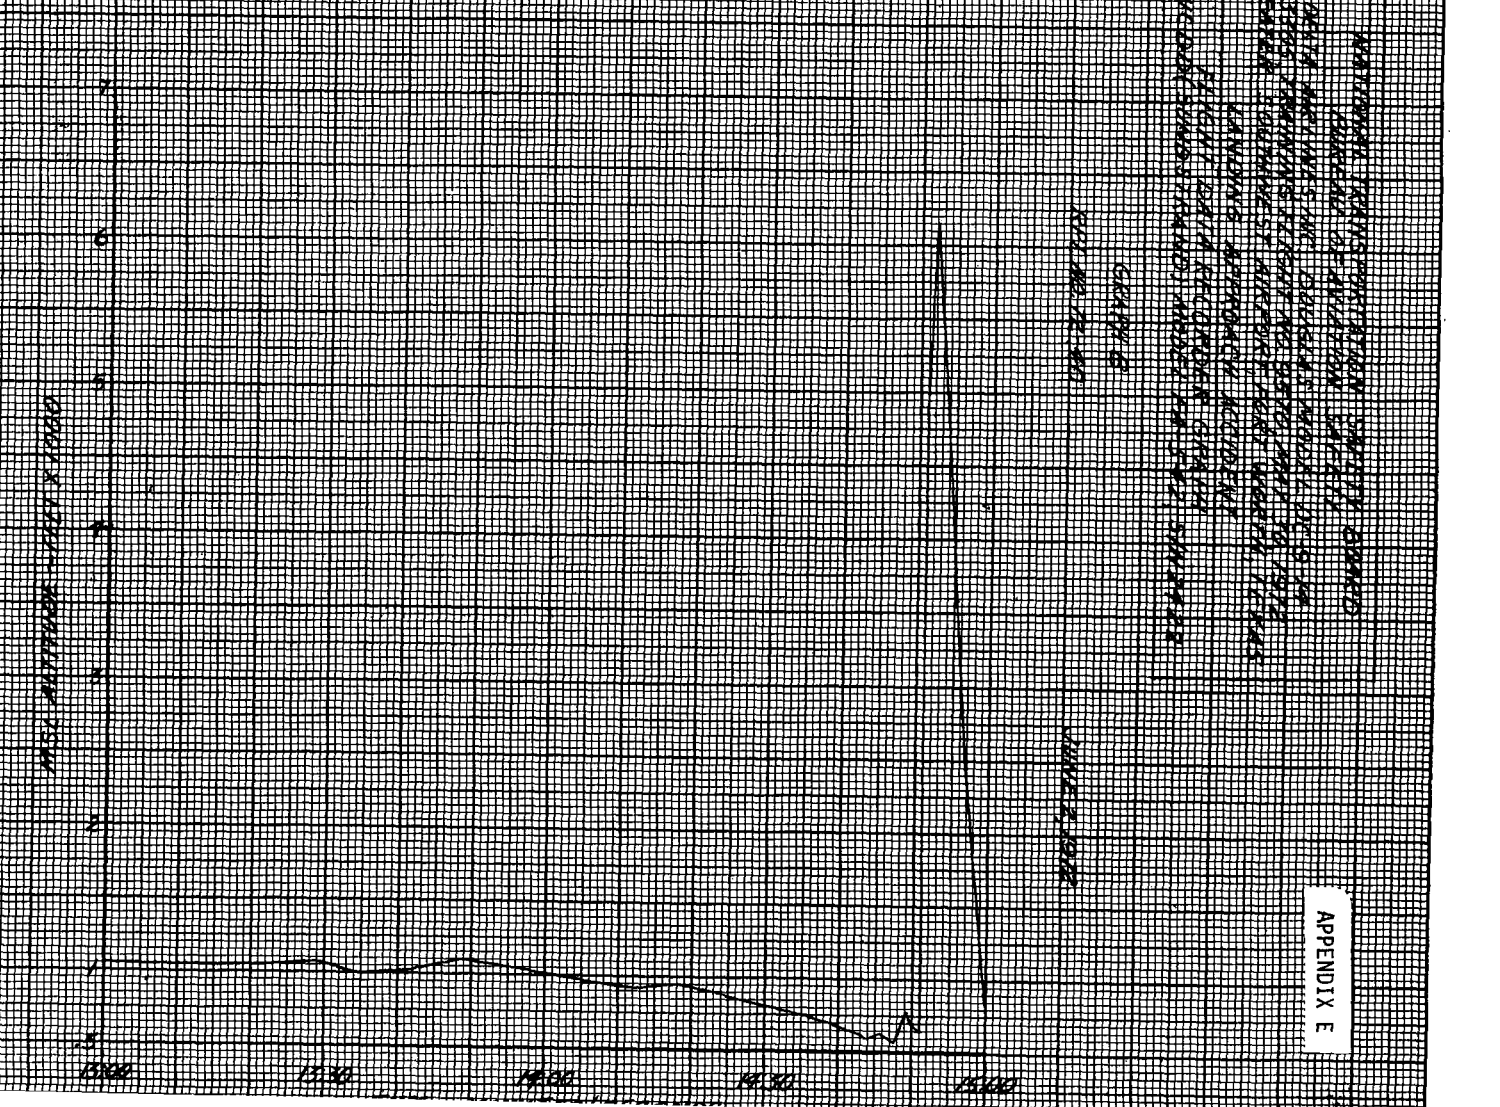
APPENDIX D

NATIONAL TRANSPORTATION SAFETY BOARD
WASHINGTON, D.C.
FLIGHT TRACK PRESENTATION
OF
DELTA AIR LINES INC. DC-9 TRAINING FLIGHT 9570
AND
AMERICAN AIRLINES INC. DC-10 TRAINING FLIGHT 1114
AT GREATER SOUTHWEST AIRPORT, FORT WORTH, TEXAS
ON MAY 30, 1972
