NATIONAL TRANSPORTATION SAFETY BOARD

AIRCRAFT ACCIDENT REPORT

**AMERICAN AIRLINES, INC.,
DC-10-10, N110AA
CHICAGO-O'HARE INTERNATIONAL AIRPORT
CHICAGO, ILLINOIS
MAY 25, 1979**

NTSB-AAR-79-17

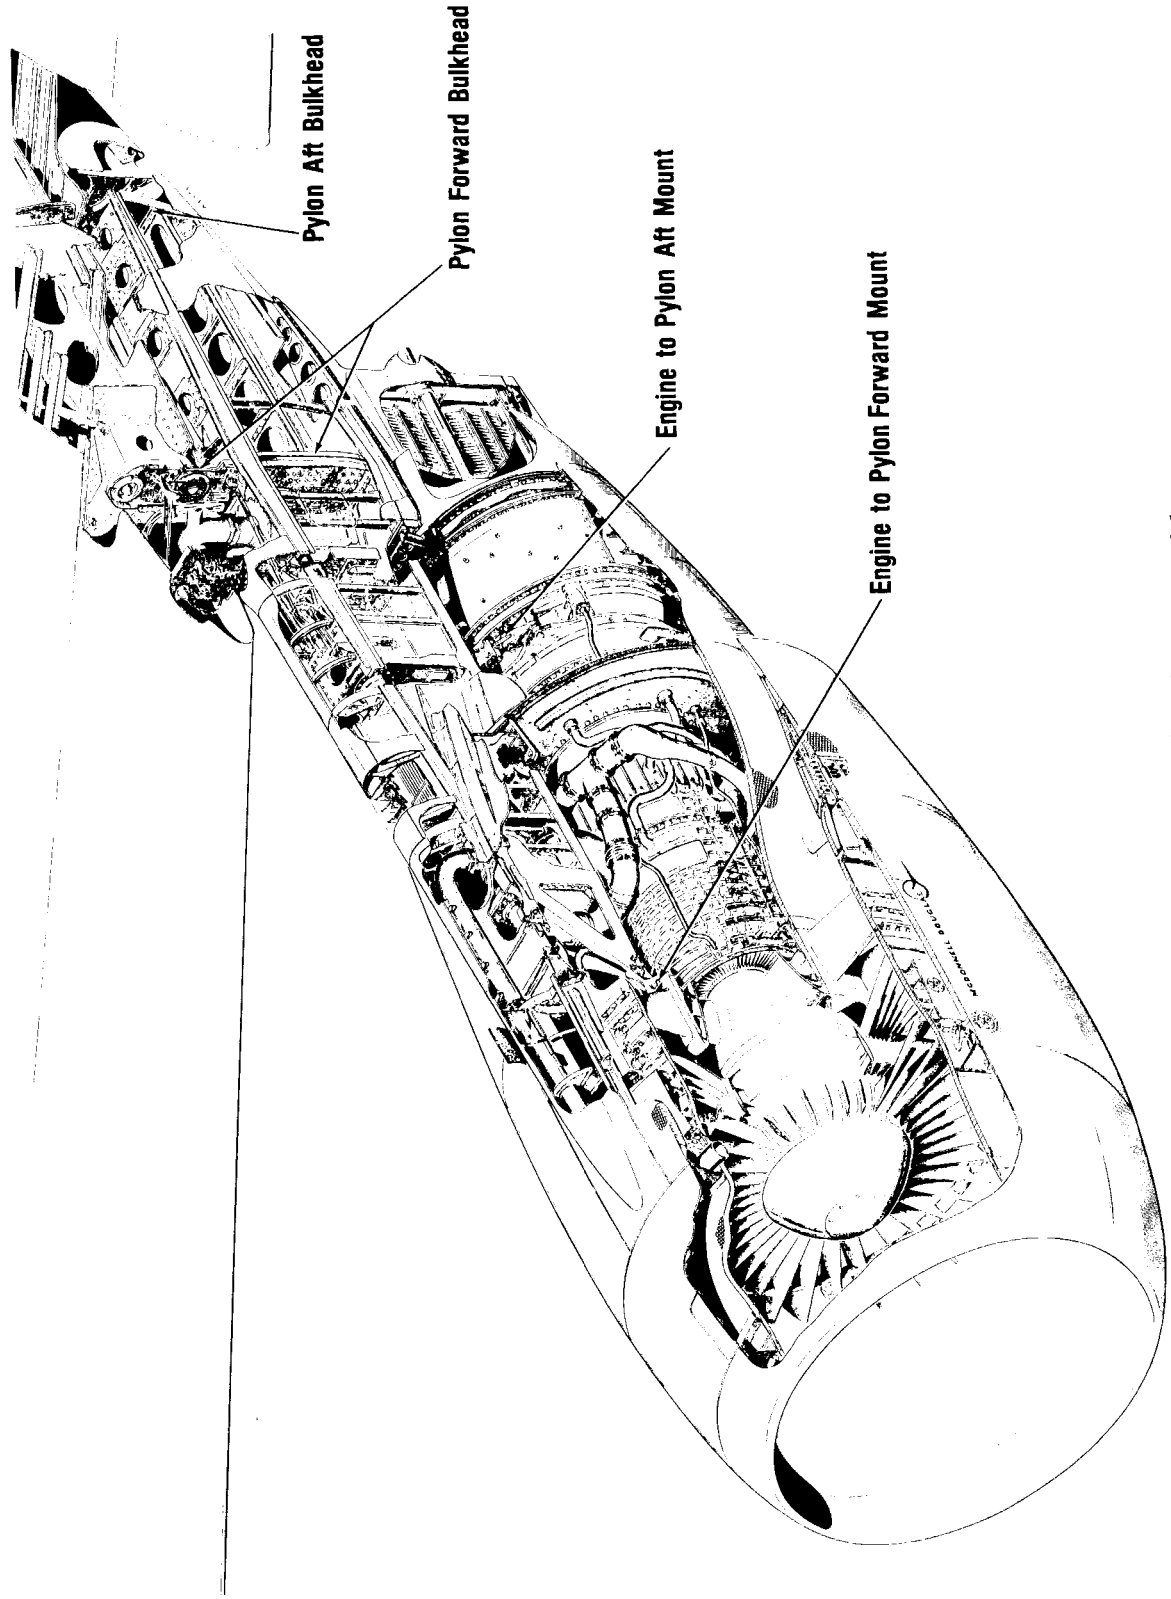
Figure 2. Engine and pylon assembly.

† The pylon is attached to the wing using spherical ball joints in three different structural elements. Two of the spherical joints are aligned vertically in a forward bulkhead which is attached to structure in the wing forward of the front spar. Another spherical joint behind the forward bulkhead transmits thrust loads from pylon structure into a thrust link which in turn is connected through another spherical joint to structure on the lower surface of the wing. The third attachment point is a spherical joint in the pylon aft bulkhead which attaches to a clevis mounted on the underside of the wing. The pylon forward bulkhead and portions of the flange from the pylon aft bulkhead either remained with the separated No. 1 pylon or were scattered along the runway. (See figures 2 and 3.) The No. 1 pylon's aft clevis attach assembly and portions of the pylon aft bulkhead, wing thrust angle assembly and thrust link, and pylon forward bulkhead attach assembly remained with the wing.

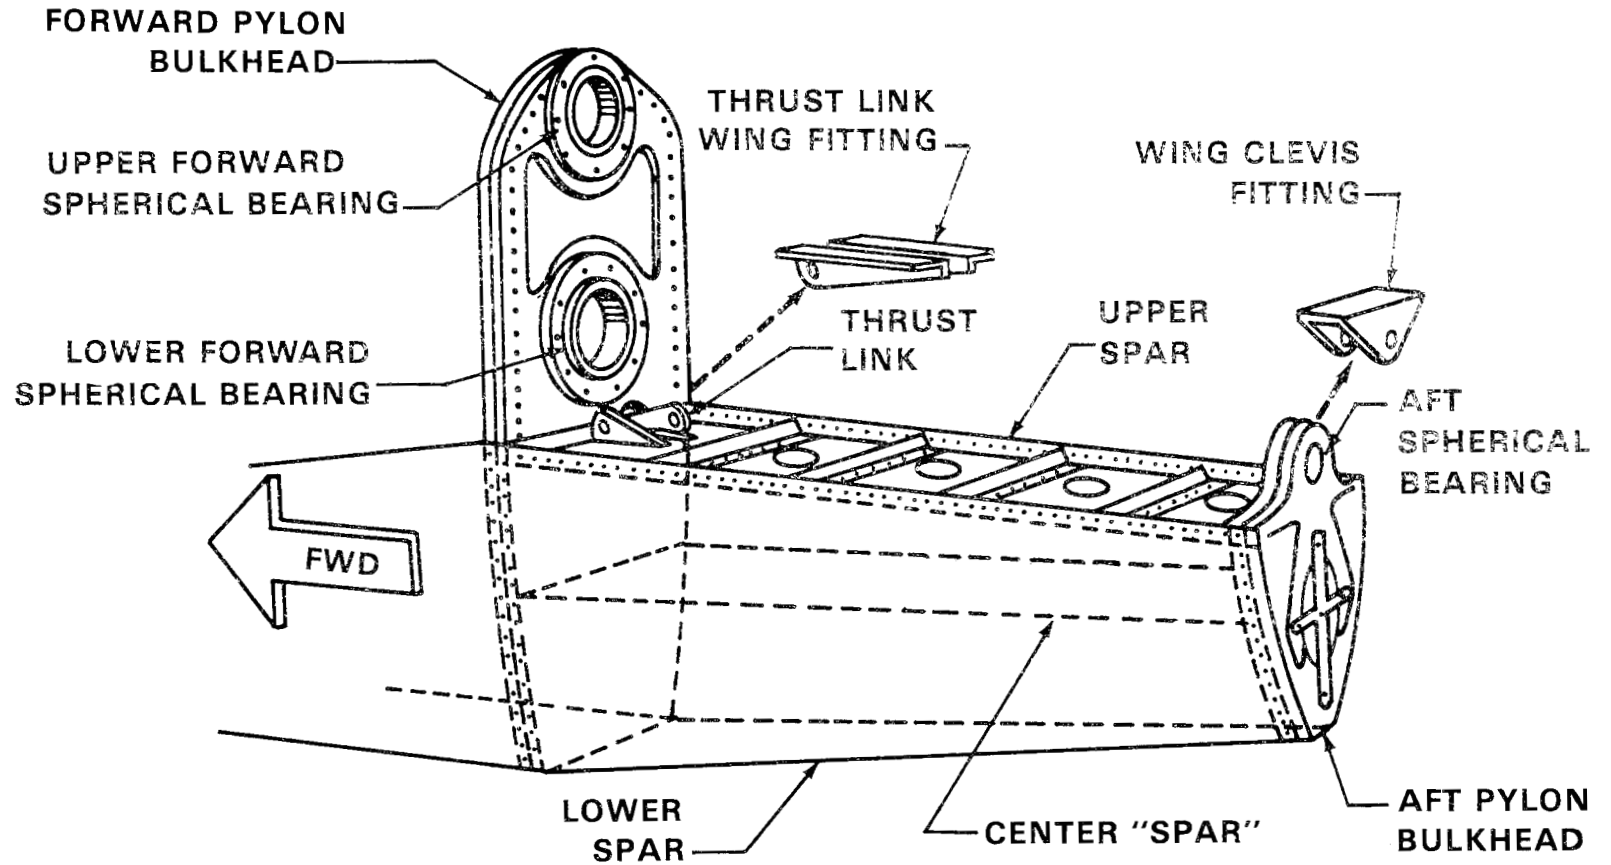
Figure 3. Pylon assembly.

The wing's forward support fitting, which attached the pylon forward bulkhead to the wing at the upper and lower plugs and spherical bearings, was found at the main wreckage site. The upper and lower plugs and their attaching hardware were intact, and the upper and lower spherical bearings were attached to the fitting.

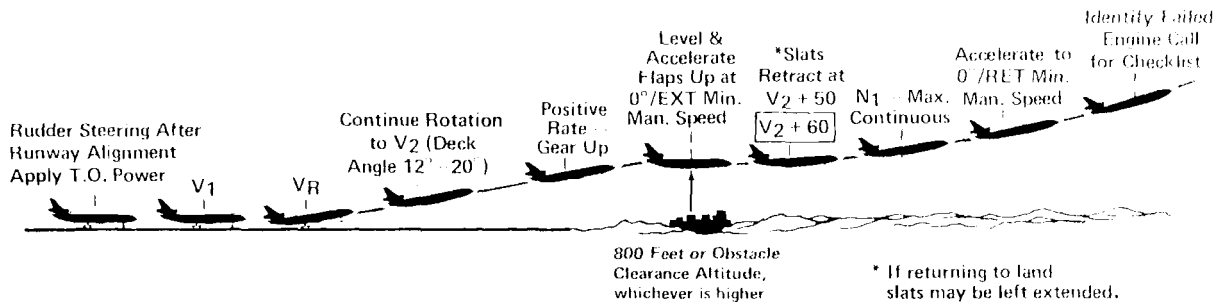
Figure 14. Diagram of AAL emergency procedure.

The Operating Manual's discussion of the procedure contained an annotated profile drawing of the takeoff. (See figure 14.) The annotations accompanying the profile sketch state (after the aircraft is airborne), "Continue rotation to V₂ (Deck angle 12°-20°)." Over the next picture of the aircraft is the note, "Positive rate-Gear up." The next picture shows the aircraft level at 800 ft AGL and contains the accelerate instructions noted above.

On July 23, 1979, American Airlines issued Operations Bulletin No. DC-10-73 which amended the procedure. The bulletin states, in part:

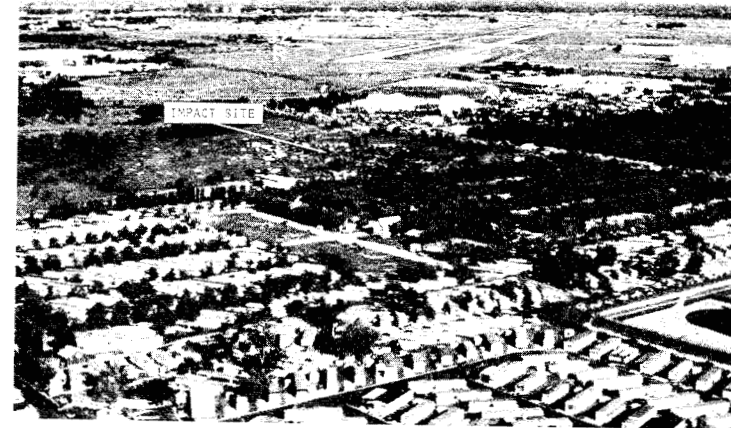
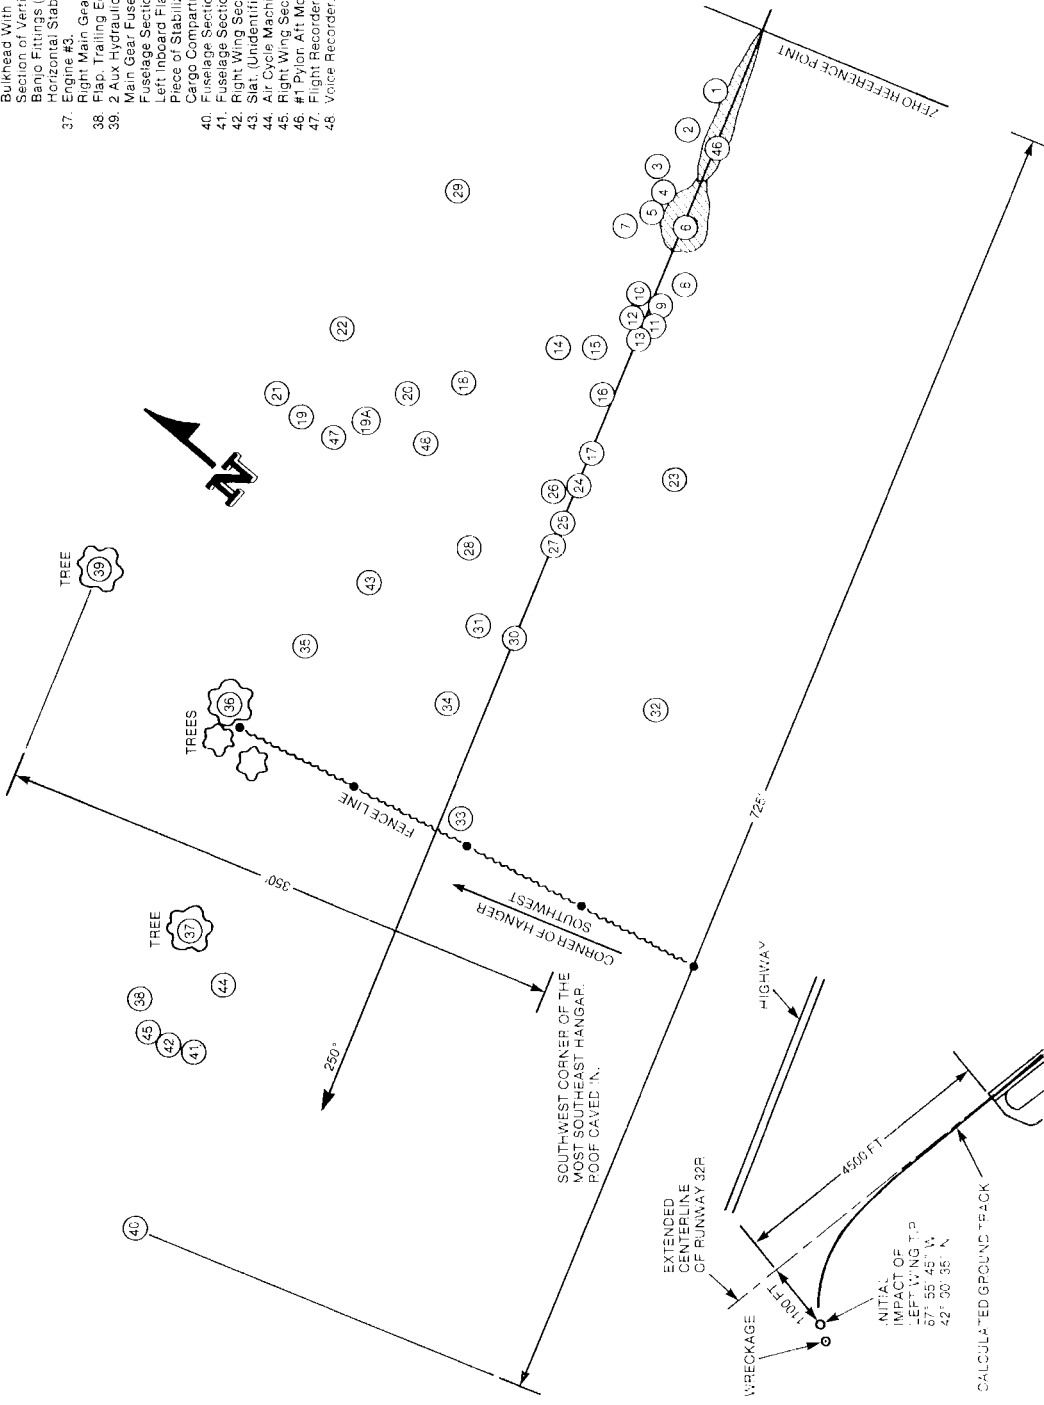
APPENDIX D

56. Right Wing Section.
57. #1 Pylon Aft Monoball Mount.
58. Flight Recorder.
59. Voice Recorder.
