# NATIONAL TRANSPORTATION SAFETY BOARD

## AIRCRAFT ACCIDENT REPORT

AIR CANADA FLIGHT 797  
McDONNELL DOUGLAS DC-9-32, C-FTLU  
GREATER CINCINNATI  
INTERNATIONAL AIRPORT  
COVINGTON, KENTUCKY  
JUNE 2, 1983

NTSB/AAR-86/02  
(SUPERSEDES - - NTSB/AAR-84/09)

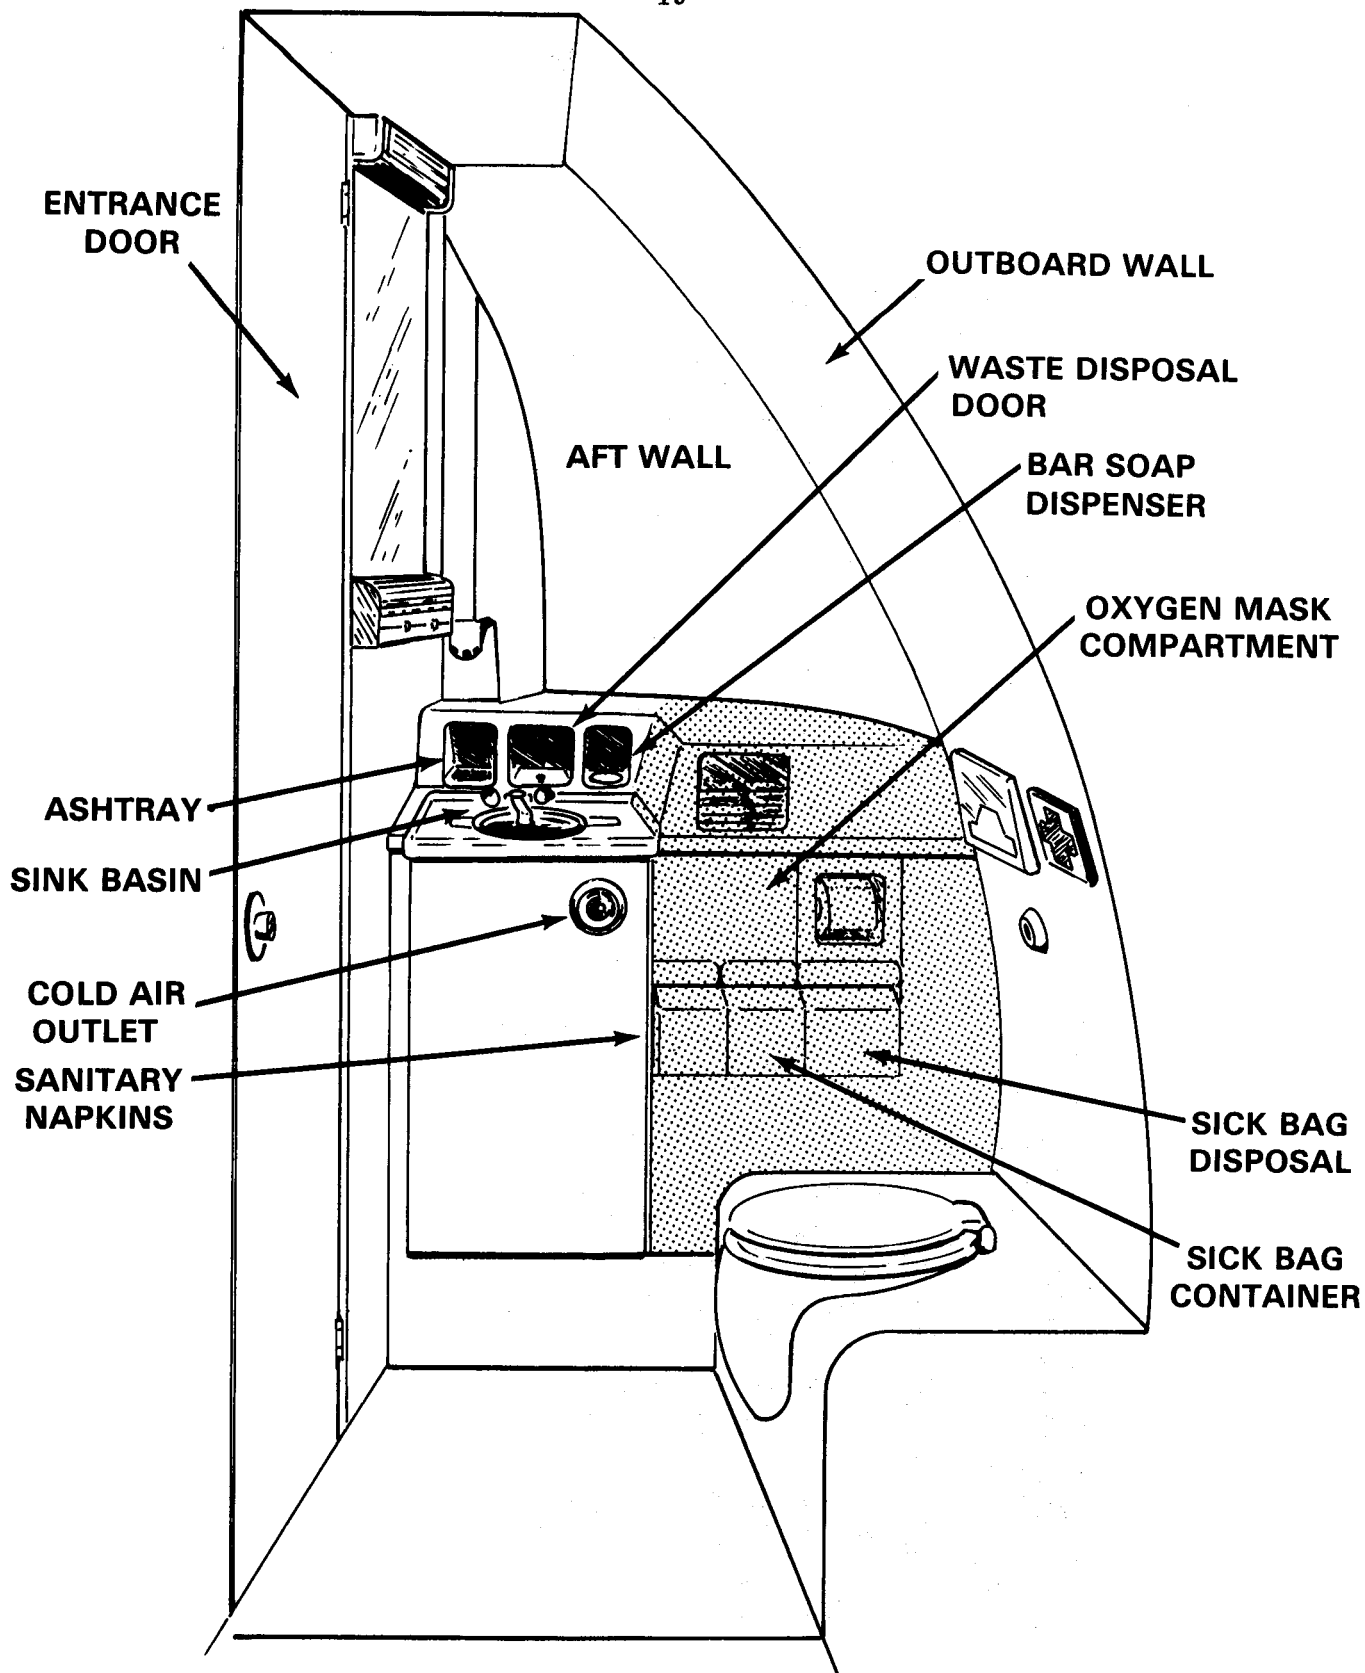
Figure 9.—Diagram of aft lavatory, viewed aft.

The aft lavatory was on the left side of the cabin, and began at FS 965 and extended aft to FS 1019, or just forward of the aft pressure bulkhead. The lavatory's outboard wall conformed essentially to the shape of the airplane's fuselage. There was a vanity section containing a stainless steel sink and amenities located along and extending forward from the aft wall. The commode containing a flushing motor was located along the lavatory's outboard wall. A trash chute and container were located below and behind the sink, and a fresh air supply outlet was positioned below the sink in the door of the vanity. Also, below the trash container, an aluminum shelf was installed. In addition, there was an oxygen outlet located in the oxygen mask compartment in the amenities section. (See figures 9 and 10.)

The amenities section of the vanity extends from the sink to the lavatory outboard wall and from the commode to the lavatory aft wall. The section contains the oxygen mask compartment and containers or dispensers for paper towels, toilet paper, sanitary napkins, and sick bags. (See figure 9.)

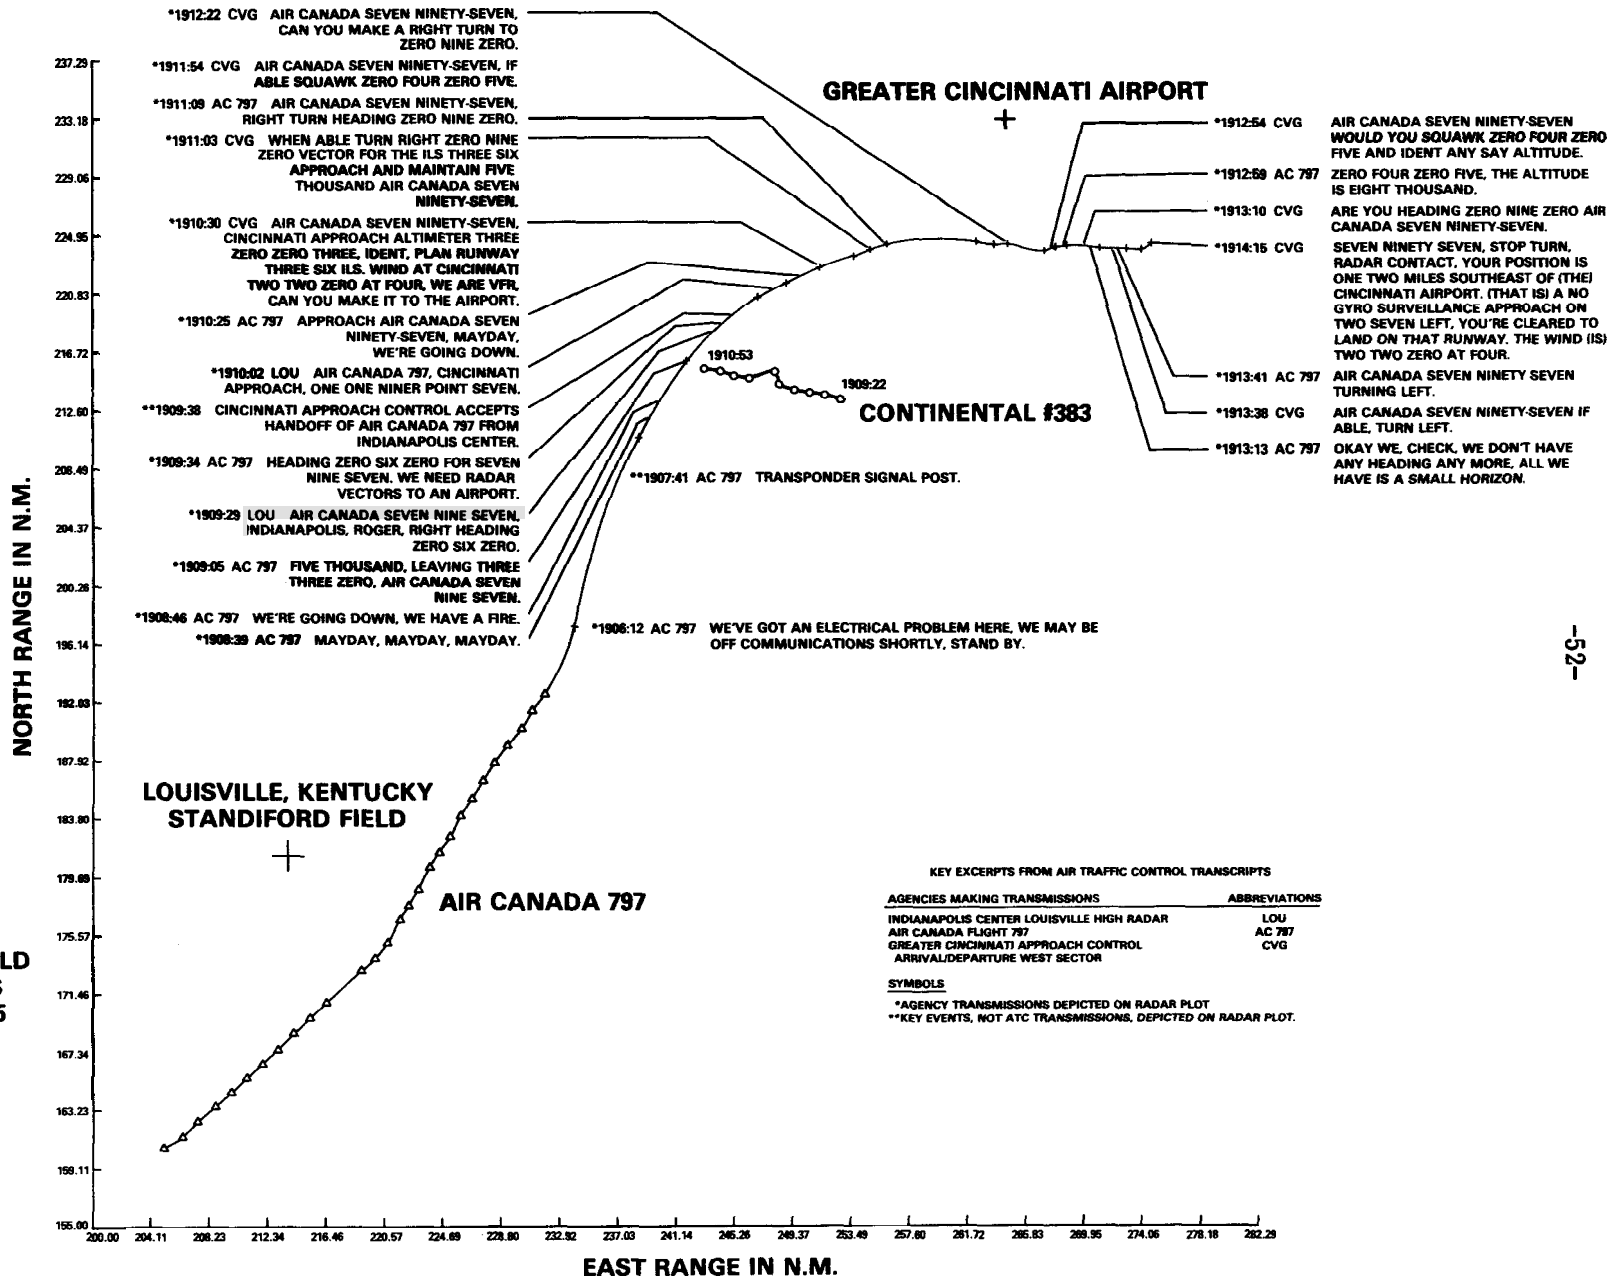
Figure 13.—Ground radar tracks for Flights 797 and 383.

18-36 of the Greater Cincinnati Airport were digitized and plotted with the ground tracks. Times of key transmissions and selected key events were included along Flight 797's radar ground track. The last radar fix retrieved from the DART's data occurred at 1914:15, and the last transponder information from Flight 797 was received at 1906:12. (See figure 13.)

The field elevation at Standiford Field, Louisville, Kentucky, is 497 feet. The Safety Board estimated that 10 minutes 11 seconds would have been required to descend from 33,000 feet and land at Standiford Field.
