NATIONAL TRANSPORTATION SAFETY BOARD

AIRCRAFT ACCIDENT REPORT

**COLLISION OF
AERONAVES DE MEXICO, S.A.
McDONNELL DOUGLAS DC-9-32, XA-JED
AND PIPER PA-28-181, N4891F
CERRITOS, CALIFORNIA
AUGUST 31, 1986**

NTSB/AAR-87/07

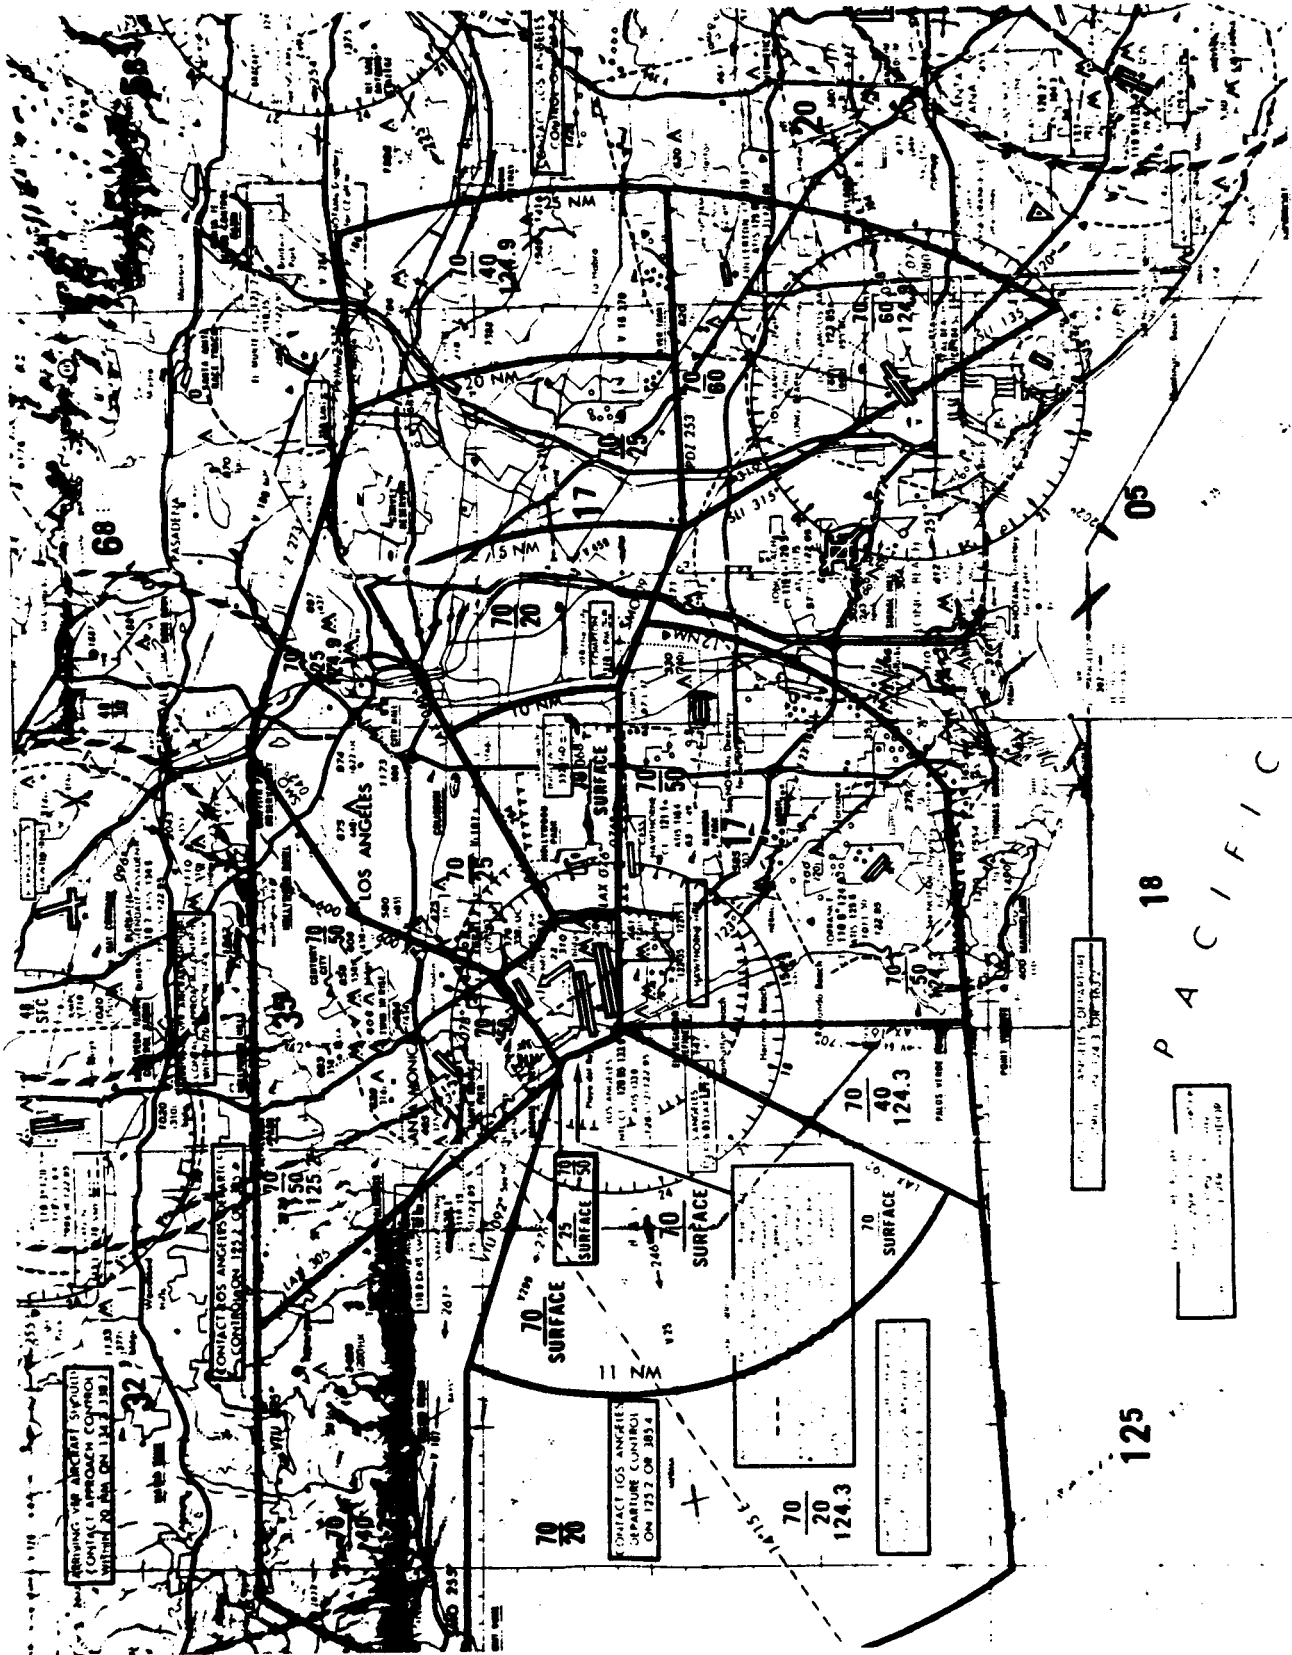
Figure-1.--Los Angeles Terminal Control Area (TCA).

L.A. International is located near the center of its TCA. Except for a triangular segment in the vicinity of Long Beach, California, the apex of which extends northward from its southern boundary, the TCA is essentially a parallelogram. Its western and eastern boundaries are about 20 nmi and 25 nmi, respectively, from the western edge of L.A. International. The TCA's northern and southern boundaries are essentially parallel to the extended centerlines of L.A. International's four runways and are each about 10 nmi from the center of the airport, respectively. (See figure 1.)

Vertically, the TCA resembles an "upside down" wedding cake, beginning at the surface at L.A. International and rising to a ceiling of 7,000 feet. Proceeding westward from the airport and aligned with the extended centerlines of the airport's runways, the floor of the TCA remains at the surface. Between 11 nmi and 20 nmi west of the airport, the floor rises to 2,000 feet. A similar gradient exists along the eastward extensions of the four runway centerlines. To the north and south of the airport and the extended centerlines of the four runways, the floor of the TCA rises sharply. (See figure 1.)

The lateral and vertical dimensions of the Los Angeles TCA are depicted on the Los Angeles VFR Terminal Area Chart. On one side of the chart, the TCA is superimposed on a Lambert Conformal Conic Projection map (figure 1); the chart's overleaf contains a Charted VFR Flyway Planning Chart of the TCA (figure 2). In addition to depicting the numerous airports in the Los Angeles area, the plan view also depicts prominent landmarks within and adjacent to the TCA. For example, the planning chart shows that Disneyland and the Anaheim Stadium are just east of the TCA's eastern boundary. It also depicts and names the freeways located within and around the TCA. Finally, the planning chart depicts the north-south VFR flyway over L.A. International and the altitudes to be flown when using this flyway (figure 2).

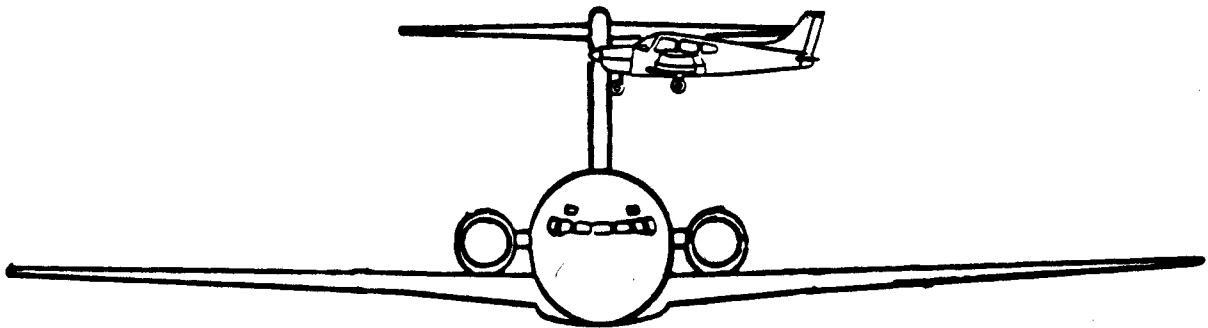
Figure 6.--Collision geometry as viewed from above the DC-9.

The damaged areas on the DC-9 vertical and horizontal stabilizers contained propeller slice marks, paint transfer marks from the nose wheel area and vertical stabilizer of the Piper, and embedded pieces from the cabin roof area of the Piper. The location and angles of these marks and damage on the DC-9, when matched to their respective locations on an intact Piper PA-28, showed that the front of the Piper had struck the left side of the DC-9 vertical stabilizer and that the impact angle was perpendicular to the longitudinal axis of each airplane. (See figure 6.) The impact angle was generally consistent with the flight tracks of the airplanes shown on the radar data plots.

Estimated positions of aircraft at impact, based on the propeller damage and scratch marks on the DC-9 Vertical and Horizontal Stabilizers.
