# **NATIONAL TRANSPORTATION SAFETY BOARD**

## **AIRCRAFT ACCIDENT REPORT**

**ALOHA AIRLINES, FLIGHT 243  
BOEING 737-200, N73711,  
NEAR MAUI, HAWAII  
APRIL 28, 1988**

**NTSB/AAR-89/03**

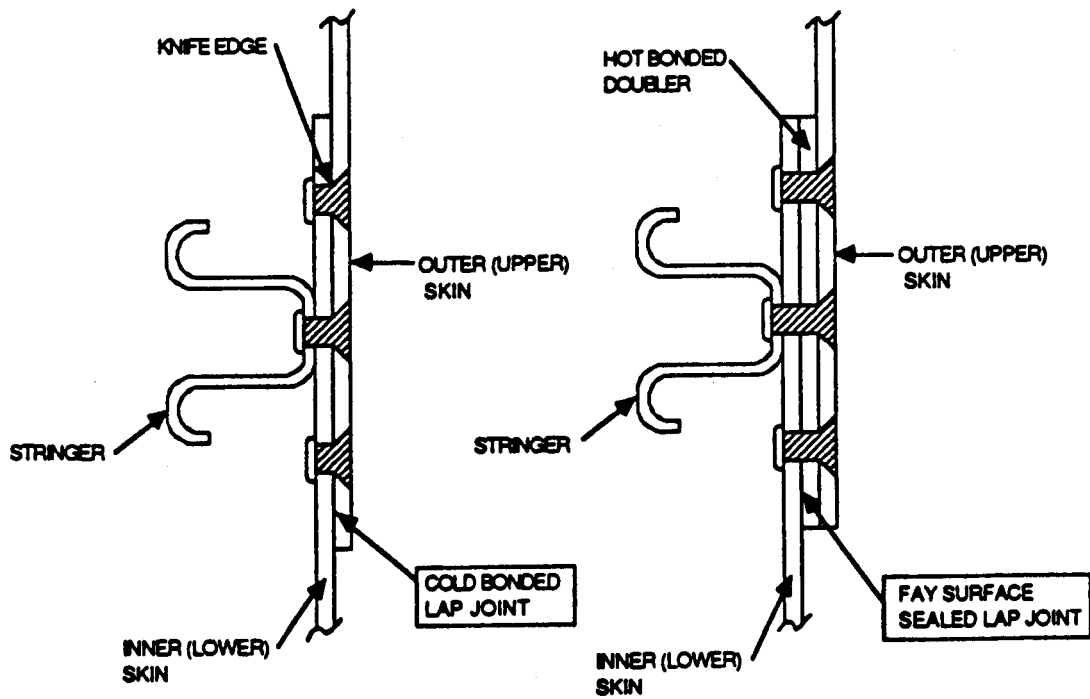
Figure 4a.--Lap joint section between tearstraps

On the early model airplanes (through production line number 291), the doubler sheet was milled away chemically at the lap joint locations; for production line number 292 and the subsequent numbers, the doubler sheet was retained on the outer panel of each lap joint to provide an extra 0.036 inch of material thickness in the joint. (See figures 3, 4a and 4b.) Additionally, for production line number 465 and the subsequent numbers, an improved bond surface pretreat process using a phosphoric acid anodize was employed.

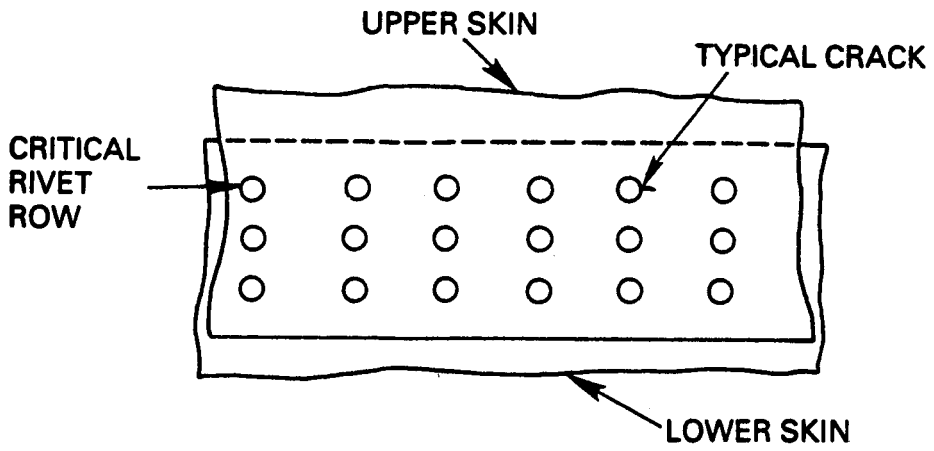
Figure 6a.--Typical lap joint

initially is expected to occur in the outer layer of skin along the lap joint because the outer layer contains a knife edge at each of the countersunk rivet holes. Furthermore, the fatigue cracking primarily is found in the upper row of the outer skin panel lap joint rivet holes because this area carries the greatest stress. For the underlying skin of the lap joint, the area of greatest stress is through the lower row of lap joint rivet holes. However, since the rivet holes in this skin panel are not countersunk, fatigue cracking is not as likely to initiate at this location.

The lap joint piece, S-4L, from BS 519 to BS 536, exhibited fatigue cracking from 16 consecutive rivet holes along the upper row of lap joint rivets. The largest single fatigue crack in one direction measured 0.18 inch from the knife edge of the countersink. (See figure 6.) The longest total combined crack length in both directions across a rivet hole (end to end of the crack including the hole) measured 0.53 inch. Both the cold-bonded lap joint and the hot-bonded tear straps in this area had disbonded. Light to moderate corrosion was present on the previously bonded surfaces.

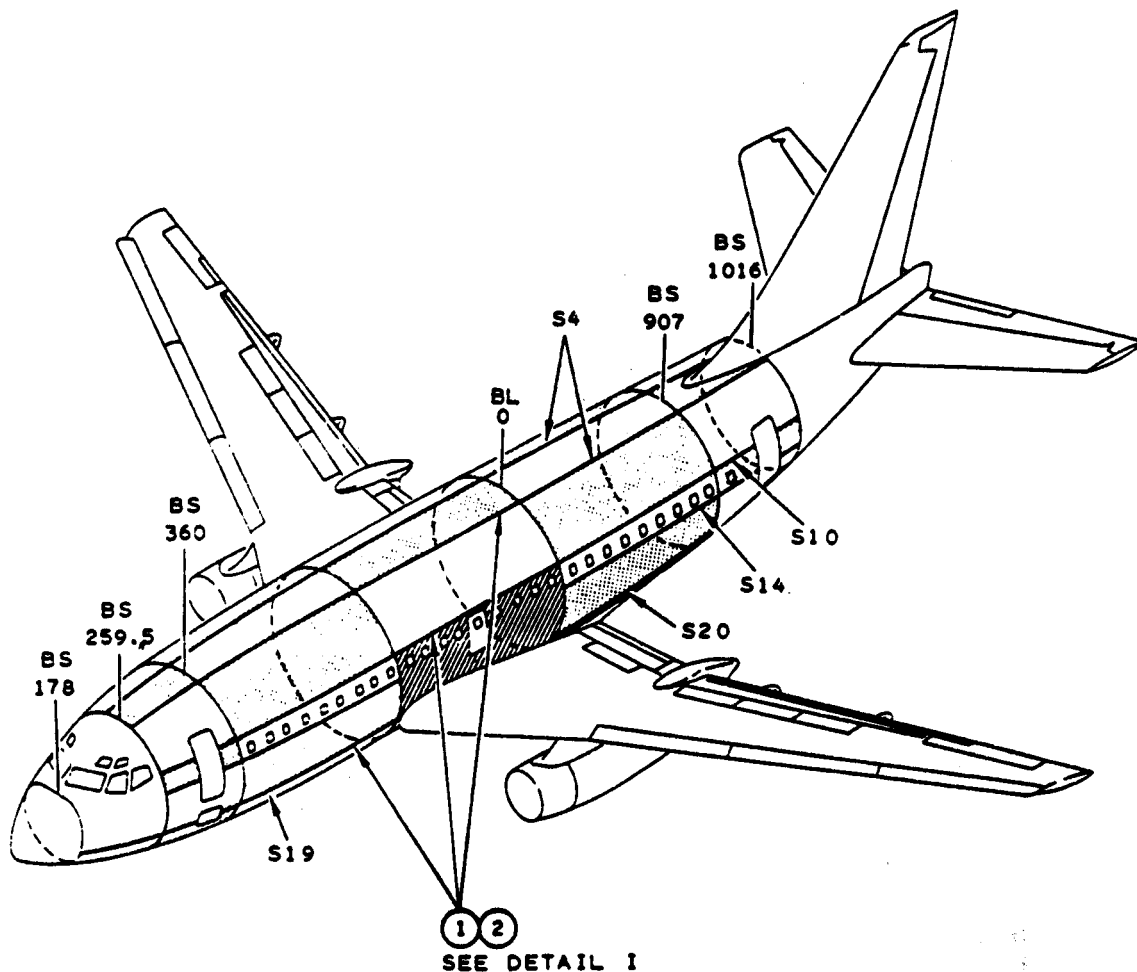
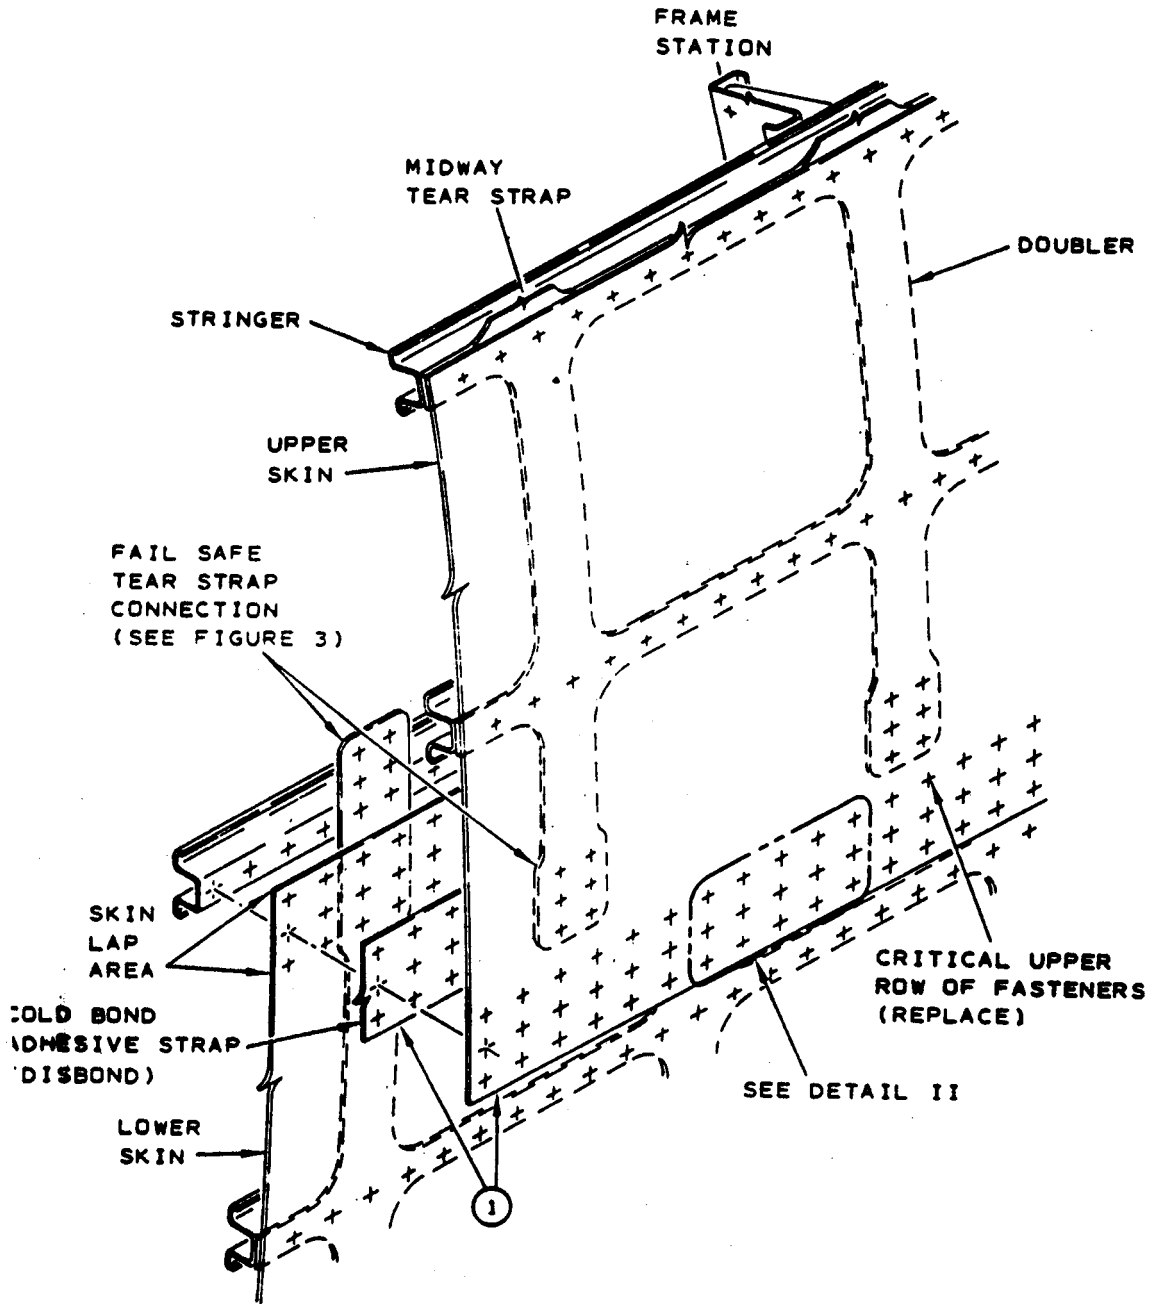
FIGURE 1. LAP JOINT INSPECTION

- A. To find cracks in the critical (upper) row of fasteners of longitudinal skin lap joints using high frequency eddy current, without removal of fasteners.
- B. The cracks usually start on the inner surface of the outer skin at the edge of the countersink. From there they propagate out along the faying surface. See Fig. 3 for an illustration of a typical crack. This inspection can find cracks 0.040 inch or longer beneath the countersunk fastener heads in skin of 0.036 inch and 0.040 inch thick.
