PB91-910409  
NTSB/AAR-91/08

## AIRCRAFT ACCIDENT REPORT

RUNWAY COLLISION  
OF USAIR FLIGHT 1493, BOEING 737  
AND SKYWEST FLIGHT 5569 FAIRCHILD METROLINER  
LOS ANGELES INTERNATIONAL AIRPORT  
LOS ANGELES, CALIFORNIA  
FEBRUARY 1, 1991

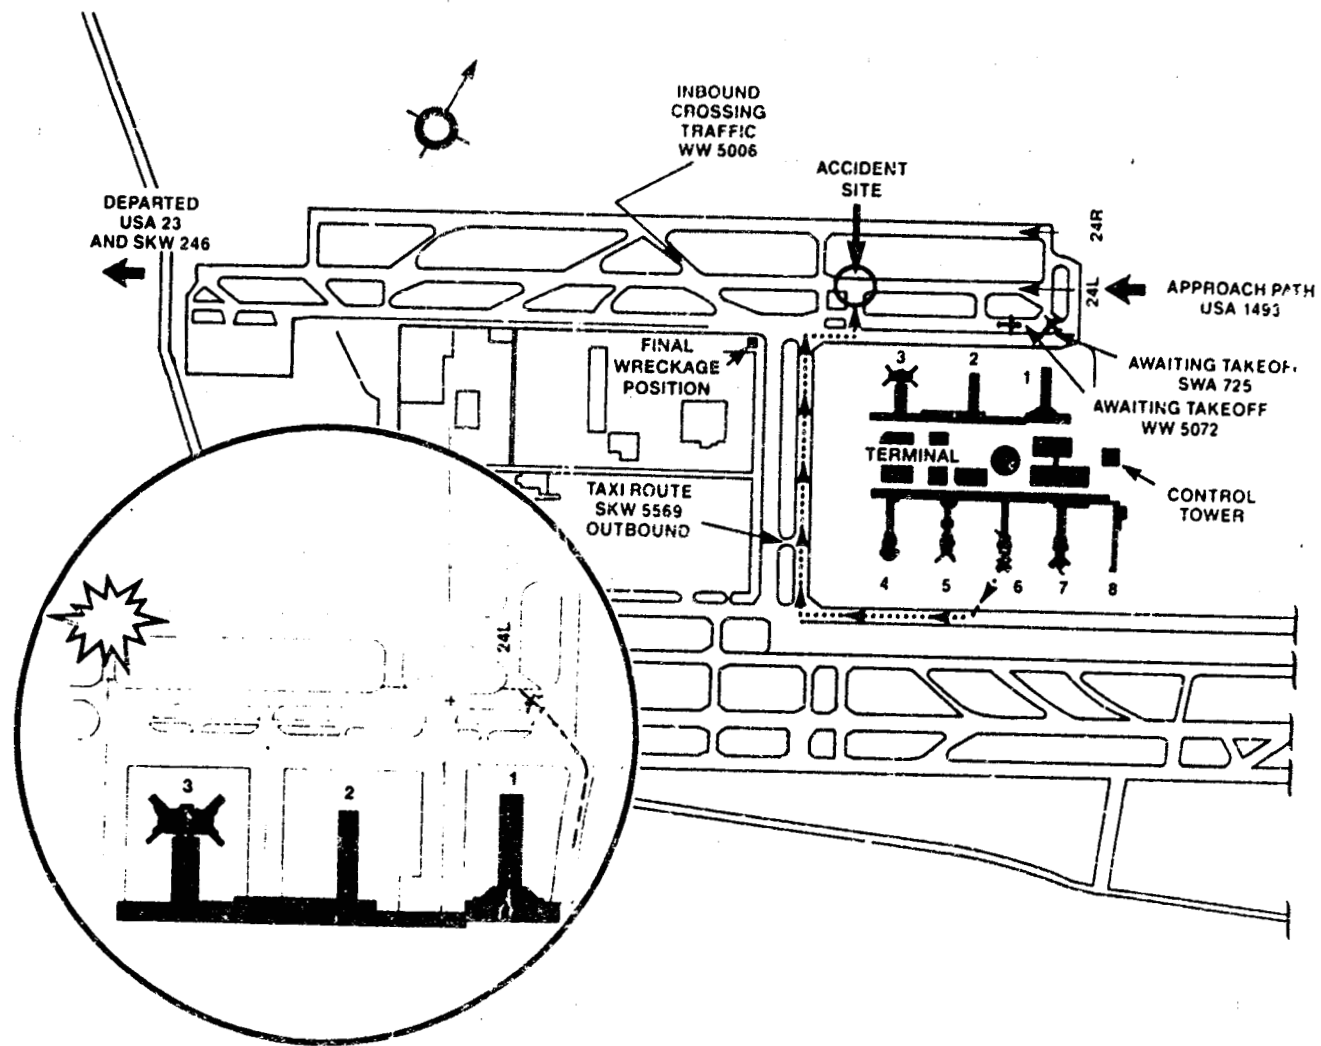
Figure 3.--Airport layout with traffic movements.

About 5 minutes earlier, around 1758, SKW5569 had begun to taxi via the north route from Terminal 6, Gate 32 to runway 24 left for departure (See figure 3). At 1801:43, SKW5569 advised the ATC tower's north ground controller (GC2) "...number two at [taxiway] Tango behind an Aero Mexico airplane." At 1801:49, the GC2 advised SKW5569, "...roger, hold short Tango for right now, Aero Mexico will be moving in just a minute."

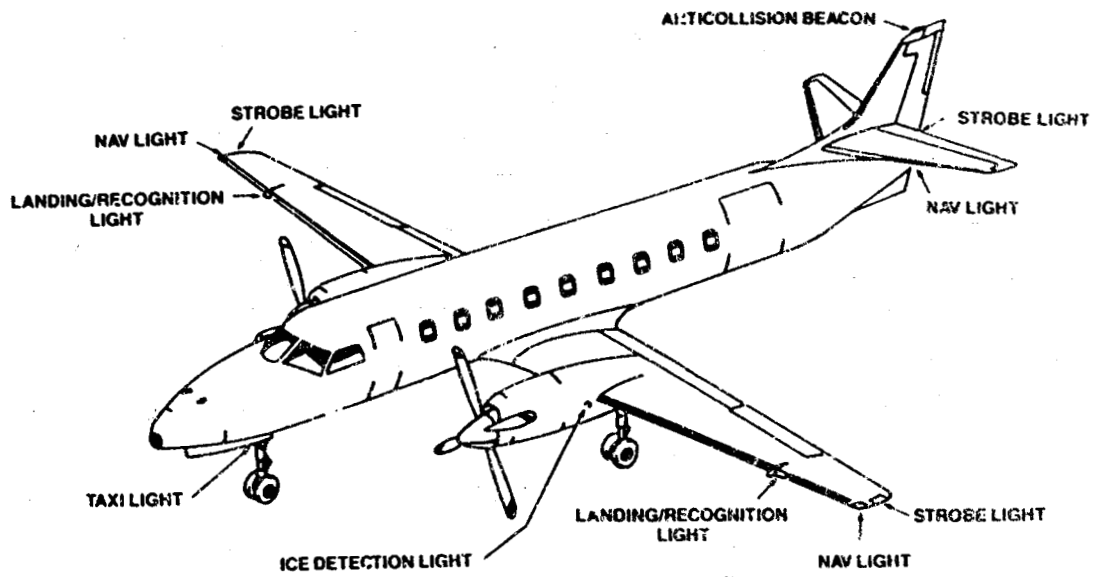
Figure 4.--Metroliner external lighting.

External lighting on N683AV consisted of navigation lights, landing/recognition lights, a taxi light, ice detection lights, strobe lights, and a red anticollision beacon (See figure 4). The beacon light assembly is located on top of the vertical stabilizer forward and below the rudder cap and rudder trailing edge (See figure 5). The location of the beacon light relative to the rudder cap results in some light obstruction; 14 CFR Part 23 permits such obstruction. The rudder cap blocks visibility of the light to an angle of 5.4 degrees above the horizontal and 2.6 degrees left and right of the centerline directly to the rear of the airplane. The beacon light luminance for certification was a candle power of 100 candles; actual luminance was 110 candles.

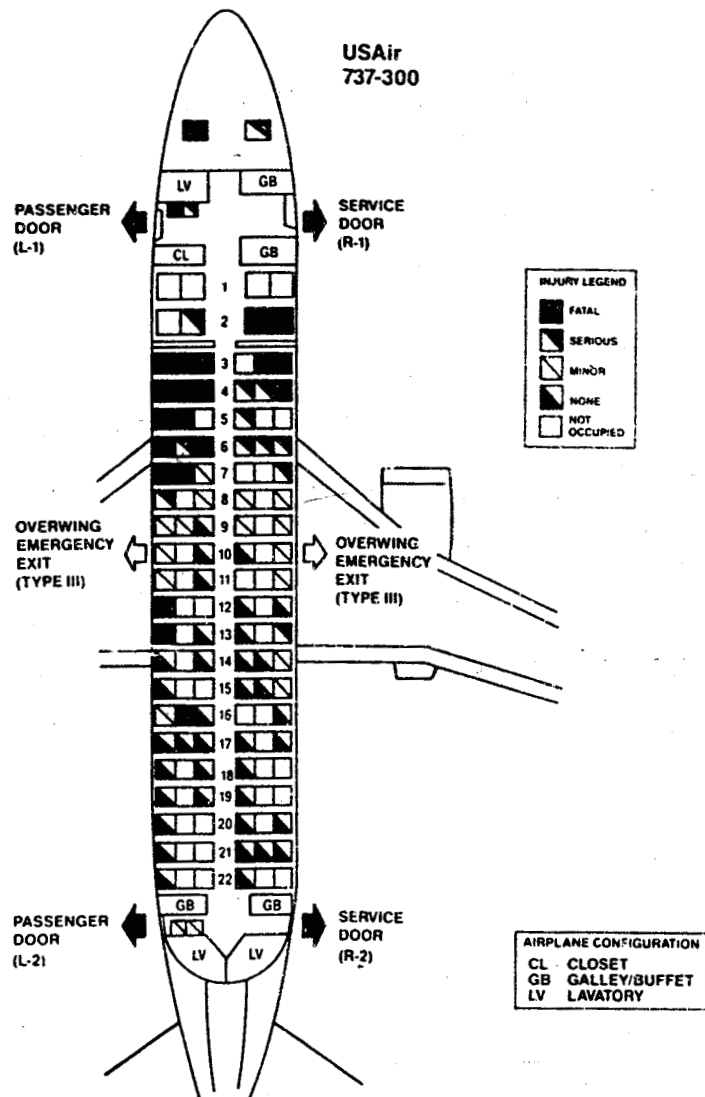
Figure 10.--Seating and injury chart.

Three cabin crewmembers and 63 passengers aboard the B-737 survived (See figure 10), of which 48 persons were interviewed during the on-scene investigation. The following summarizes their interviews:
