# **NATIONAL TRANSPORTATION SAFETY BOARD**

## **AIRCRAFT ACCIDENT REPORT**

**AIR ILLINOIS HAWKER SIDDELEY  
HS 748-2A, N748LL  
NEAR PINCKNEYVILLE, ILLINOIS  
OCTOBER 11, 1983**

**NTSB/AAR-85/03**

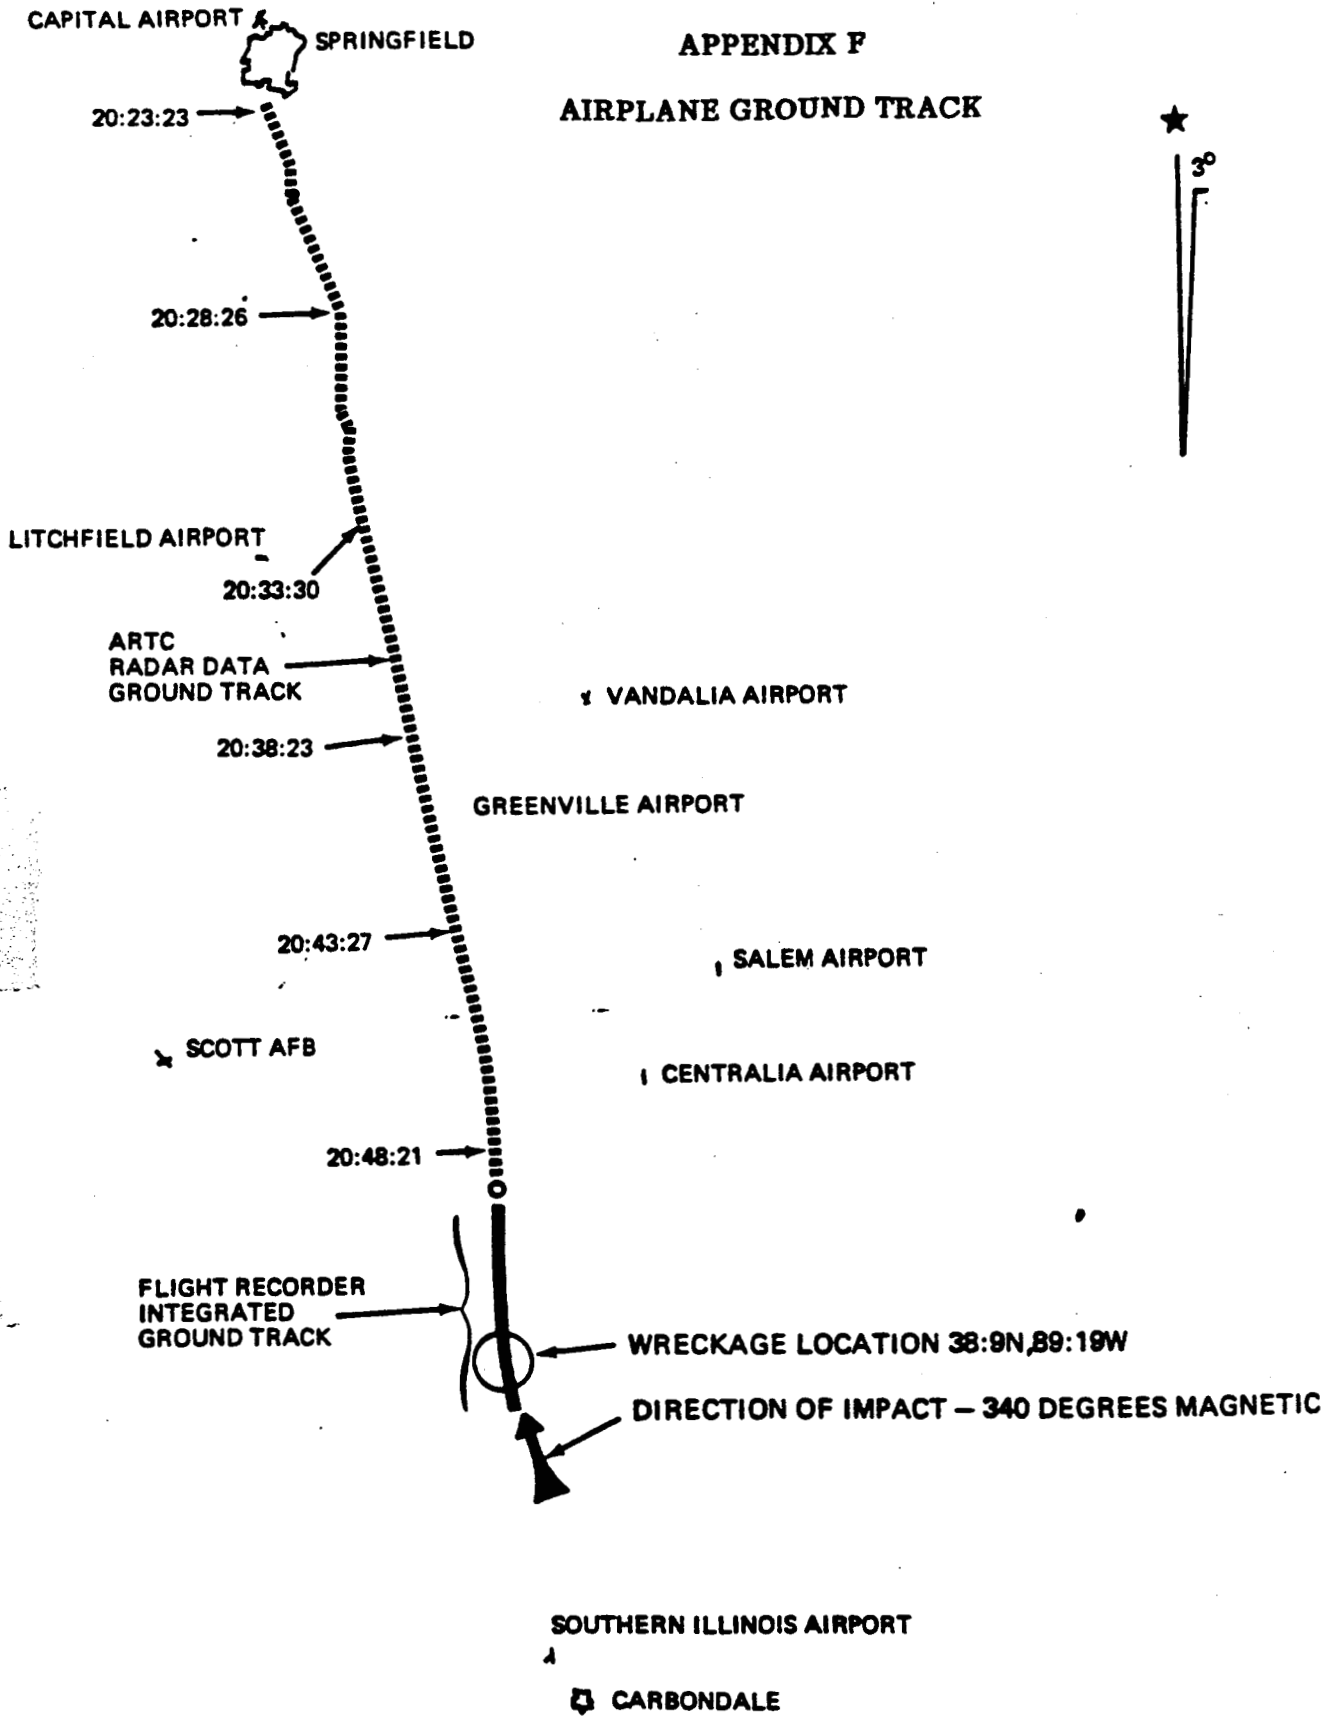
APPENDIX F

AIRPLANE GROUND TRACK
